# **Rapid Road Inventory of Select Roads in Deadwood Creek for BLM & Treatment Recommendations**

**Five Counties Salmonid Conservation Program**

**July 2019**

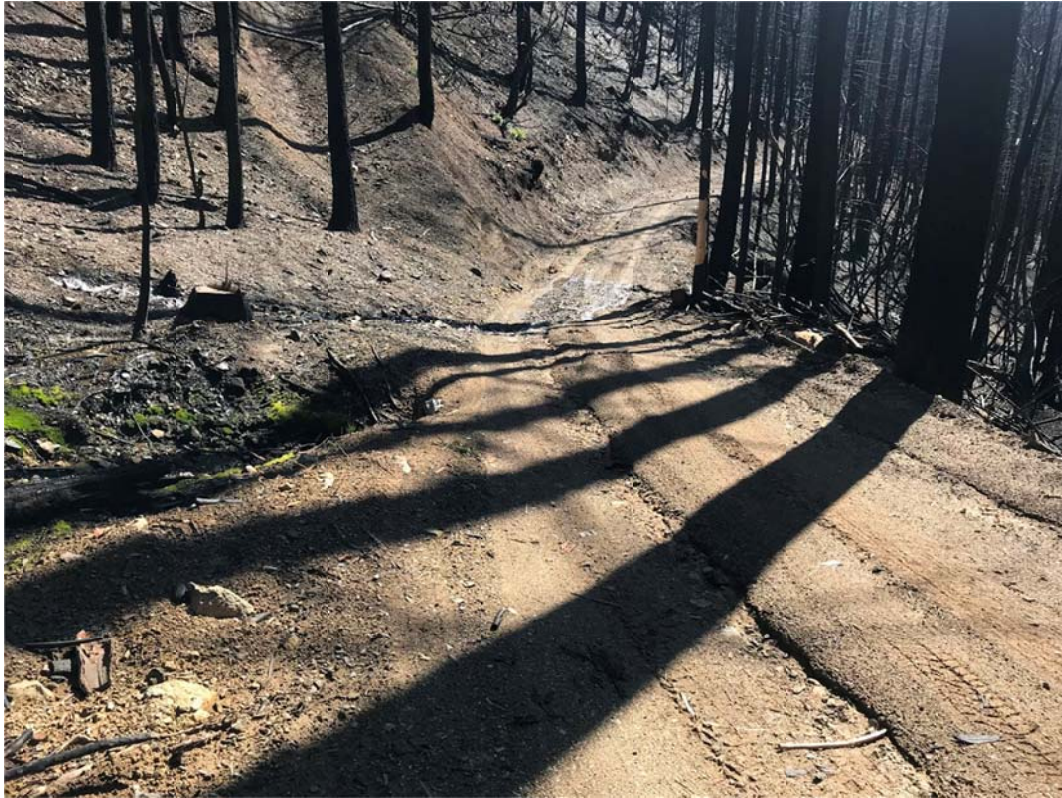
Figure 1 (above): A rill/gully (center of photo) on the 200 Road (Site 200.4). The site also contains a diverted stream crossing and a non-functioning 24" CMP culvert crossing.

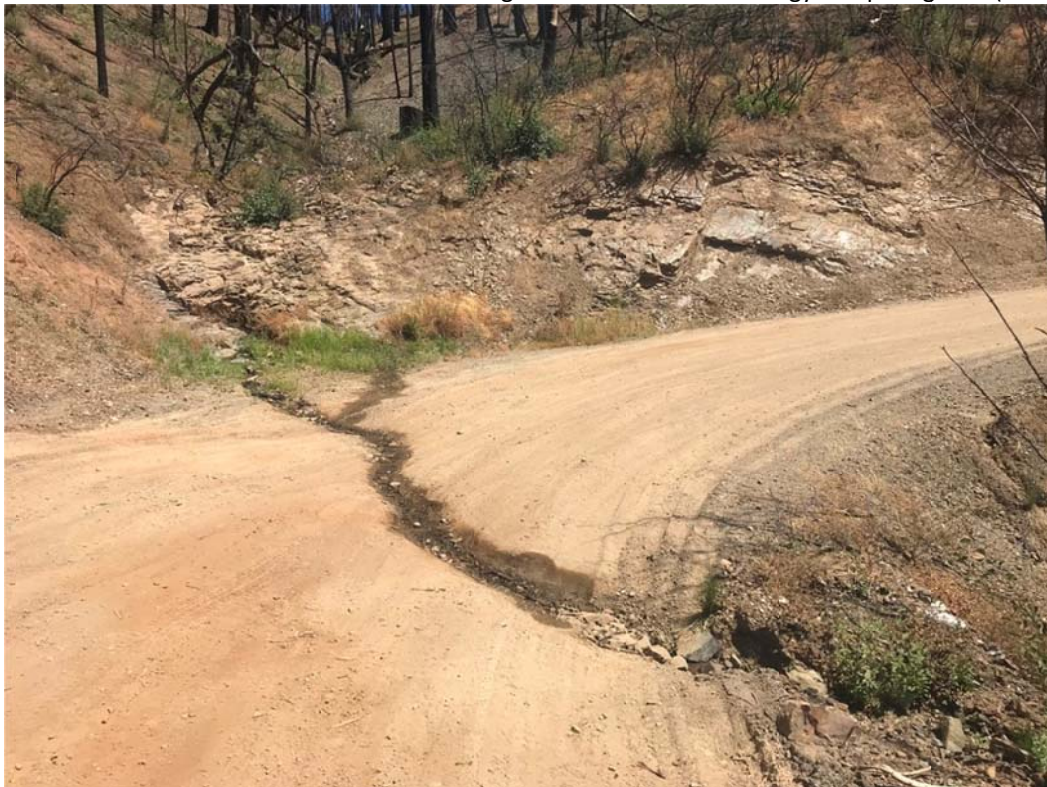
Figure 2 (below): A non-culverted stream crossing in bedrock with a critical dip and minimal future erosion potential in the road. Note the outlet of the crossing can be treated with energy dissipating rock (site 1498).

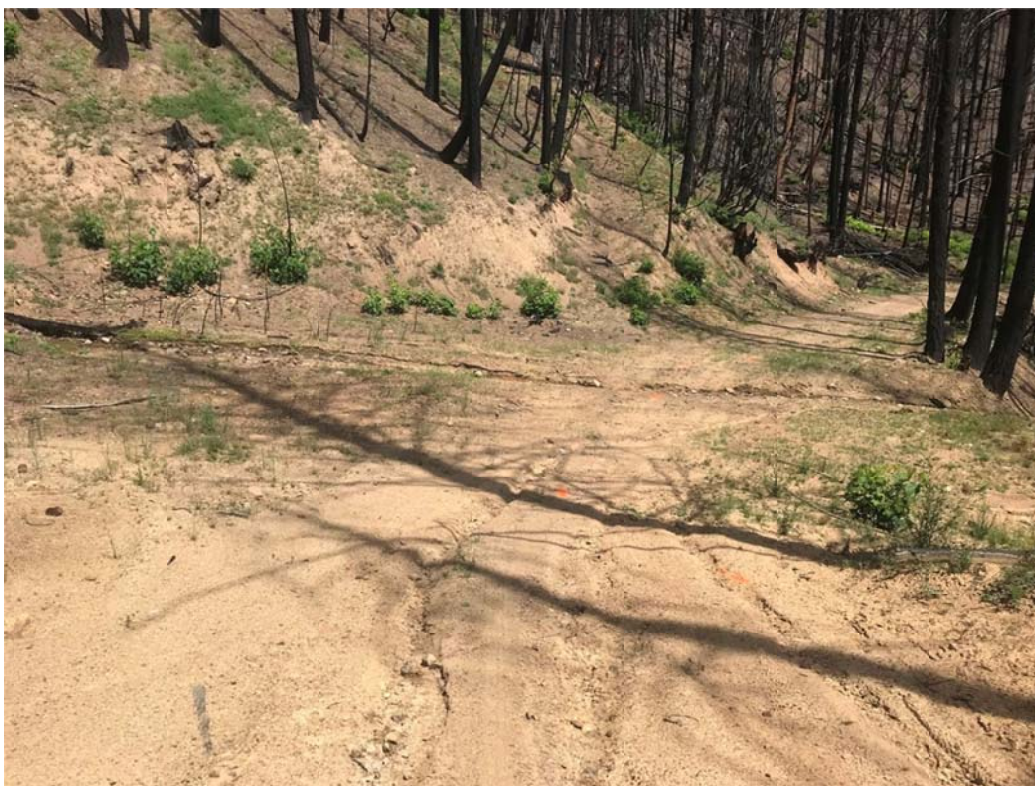
Figure 3 (above): A very large fill in a stream channel (with two logging roads entering it) with significant incision and large volumes of sediment capable of delivering to Deadwood Creek. This site also has diversion potential down the road (Site 200.5).

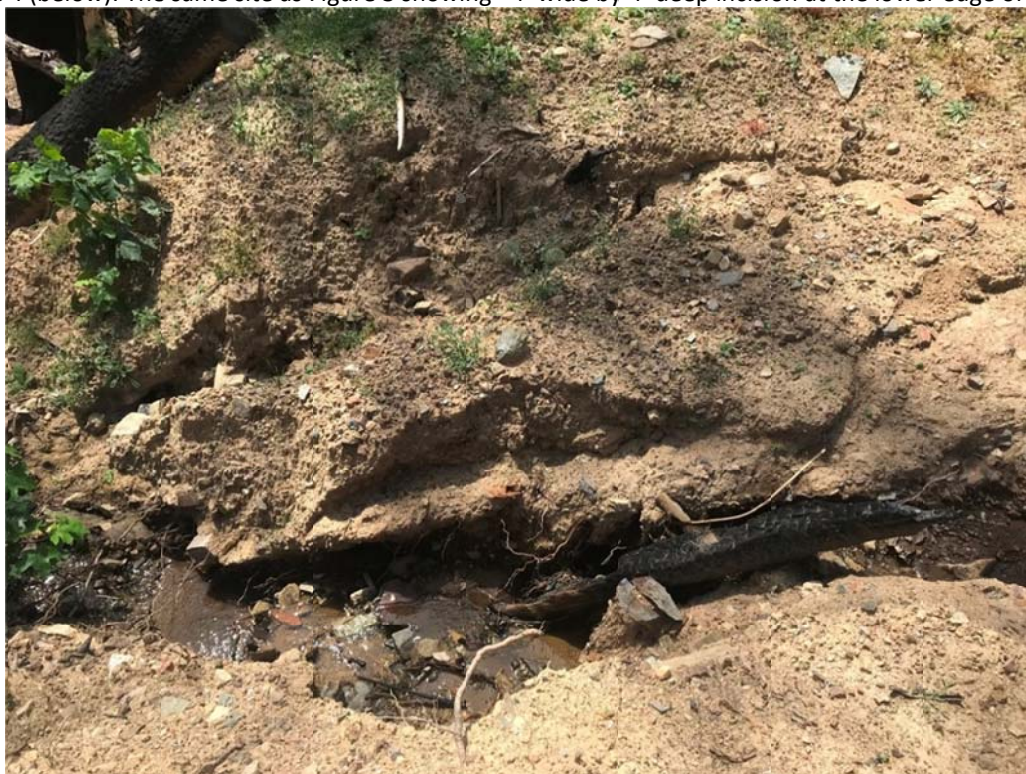
Figure 4 (below): The same site as Figure 3 showing ~4' wide by 4' deep incision at the lower edge of the fill.

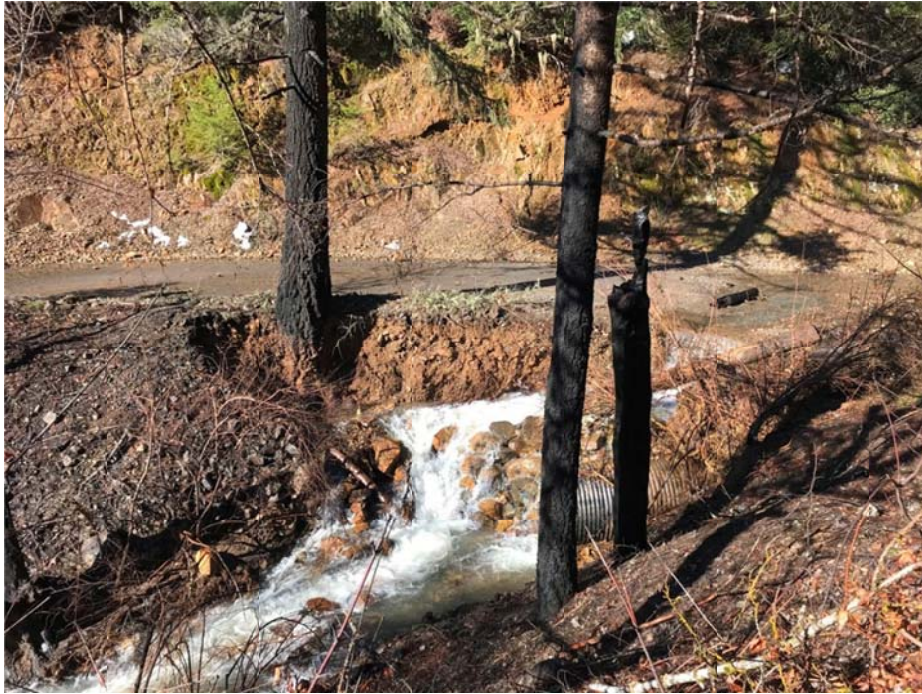
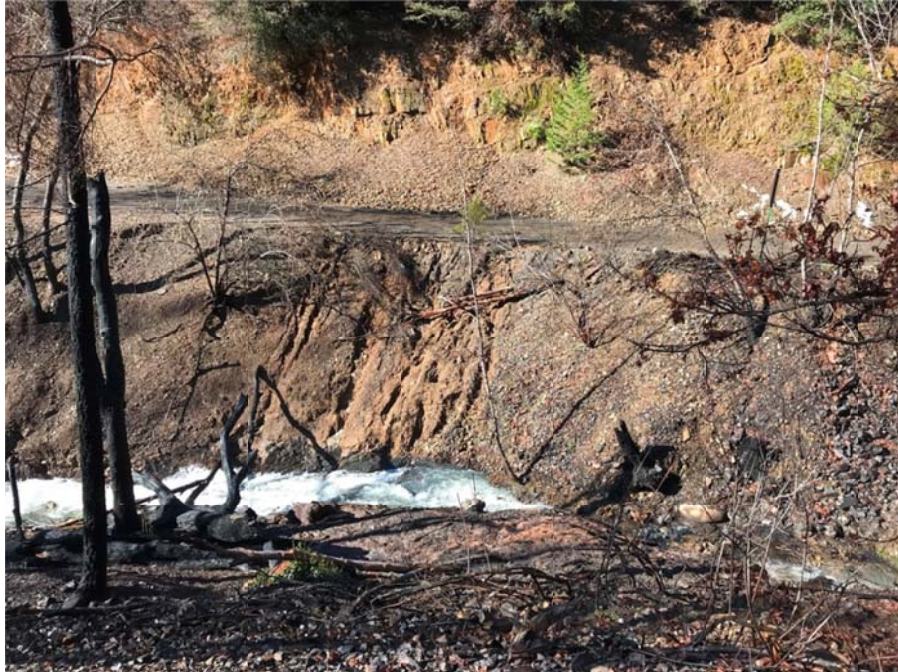
Figure 5 (above): Site 1490 on Deadwood Road. Plugged culvert crossing and diverted stream channel.  
Figure 6 (below): Site 1490 diverted stream channel re-entering the stream downstream of the road crossing.

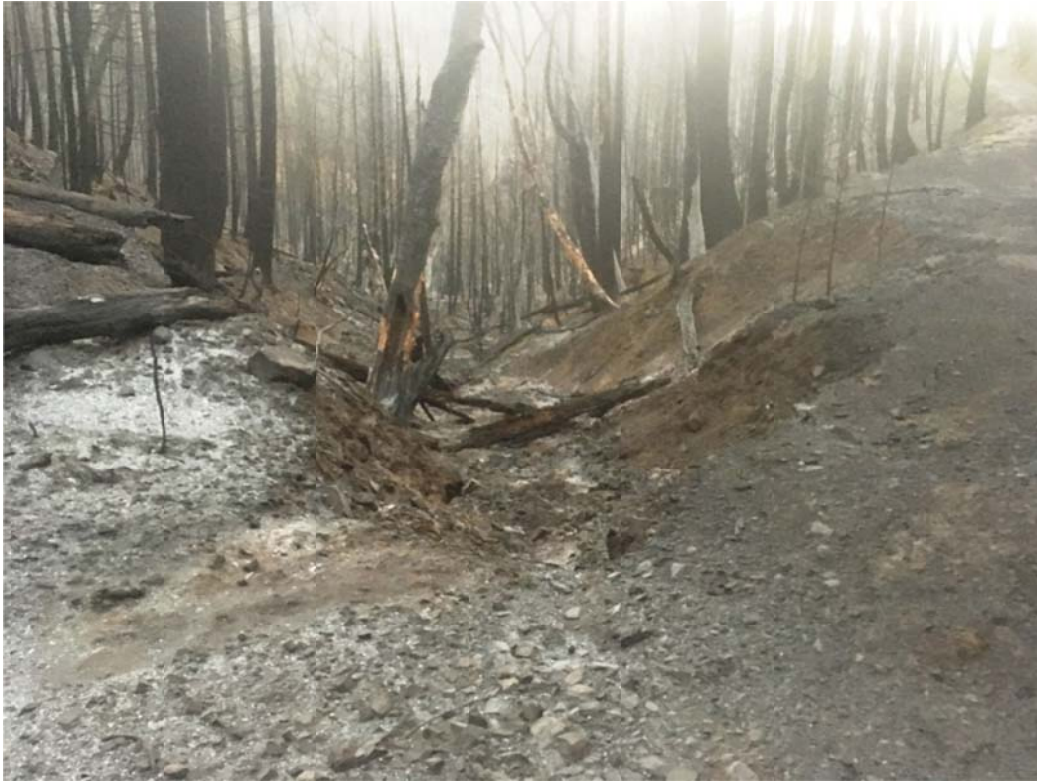
Figure 7 (above): Road crossing on the 400 Road showing aggraded fill and bank failure.

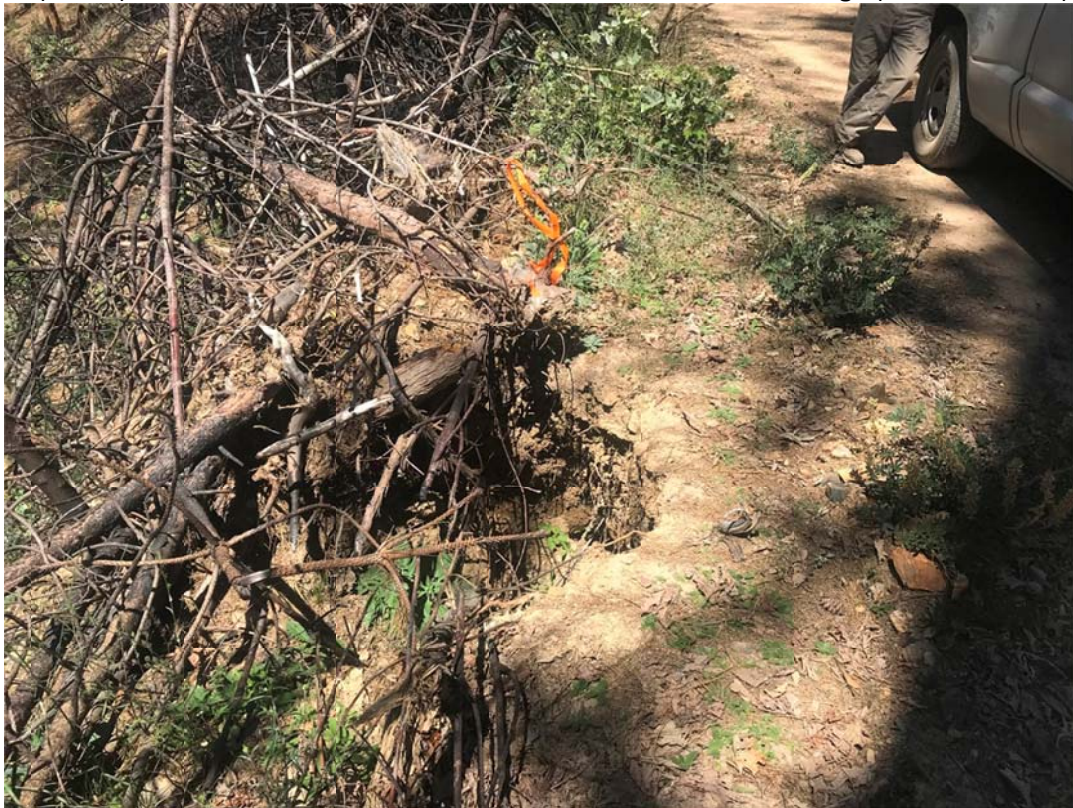
Figure 8 (below): Burned out wood in road fill creates a void on the road edge (Eastman Gulch). Road.

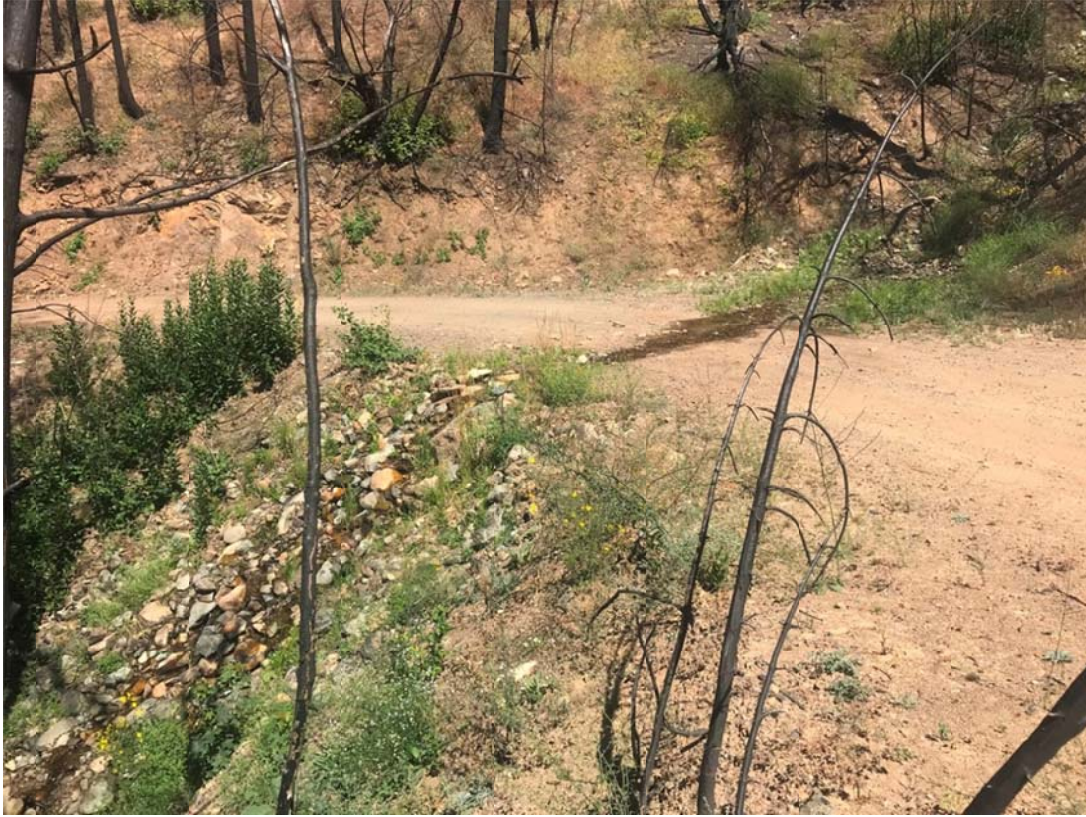
Figure 9 (below): Rock armor ford on Deadwood Road installed in 2005 showing performance post fire and high winter flows.

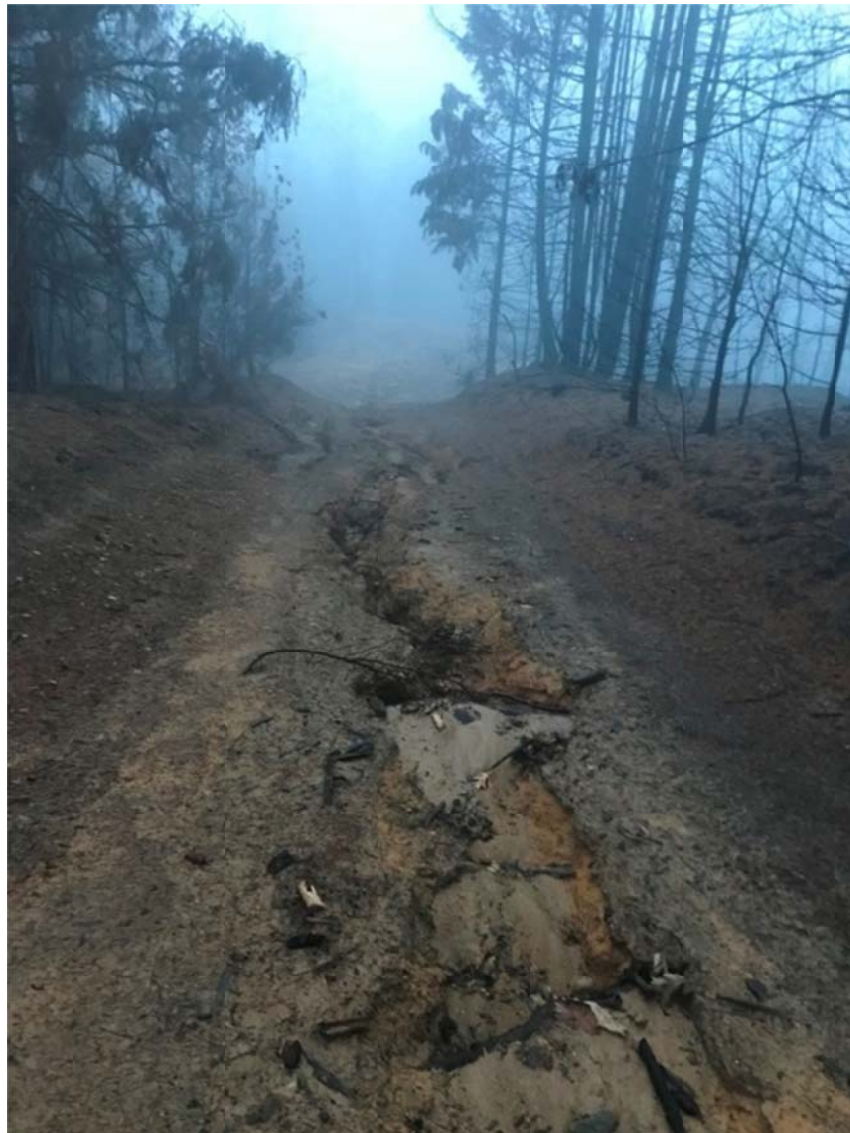
Figure 10. Significant gully erosion down the PG&E power line. The location of the road on a ridge line minimizes sediment delivery to a stream.

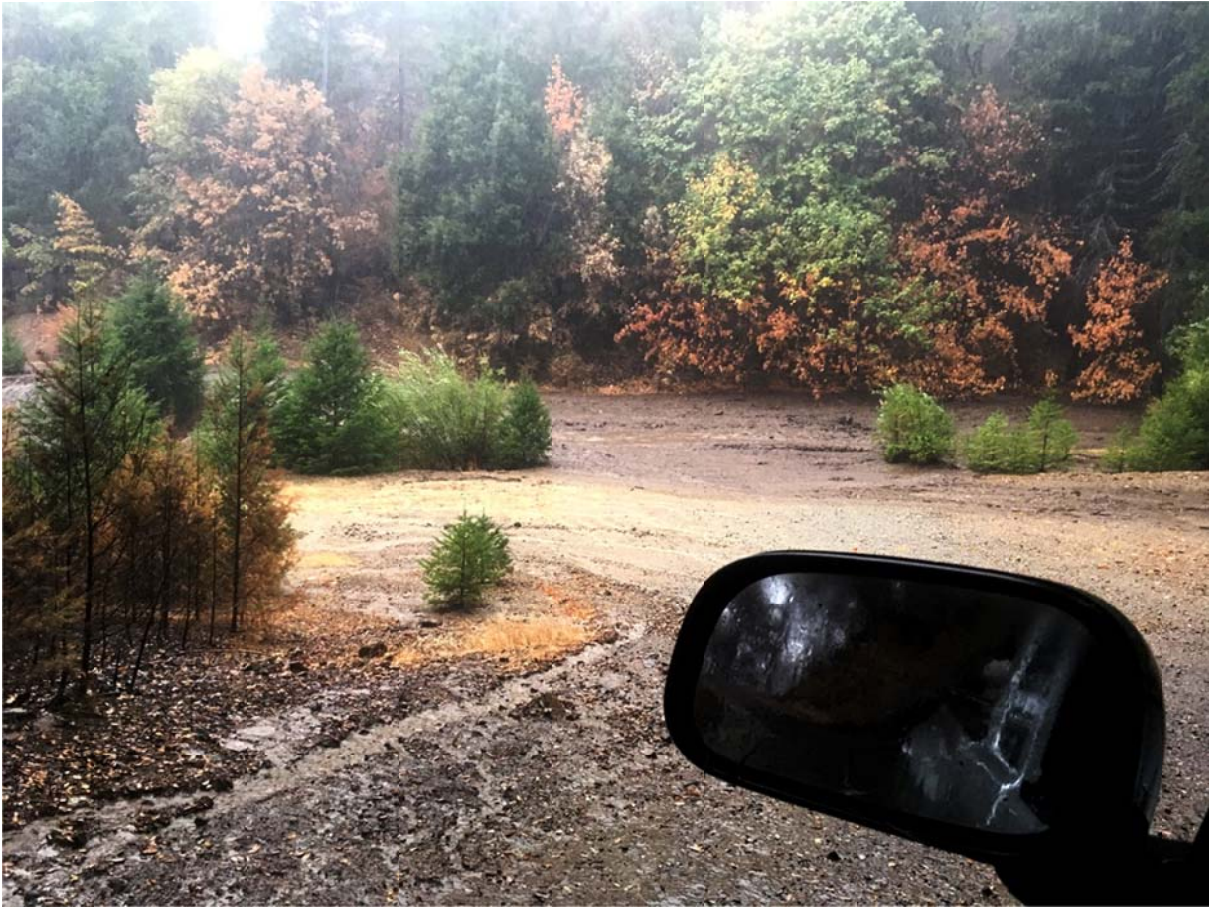
**Figure 11** (above). Mill Gulch stream crossing at Deadwood Road, October 4, 2018. The culvert plugged and the channels diverted west and down the road (note the dark ash laden sediment in the middle distance and the lighter yellow road erosion sediment in the middle foreground).

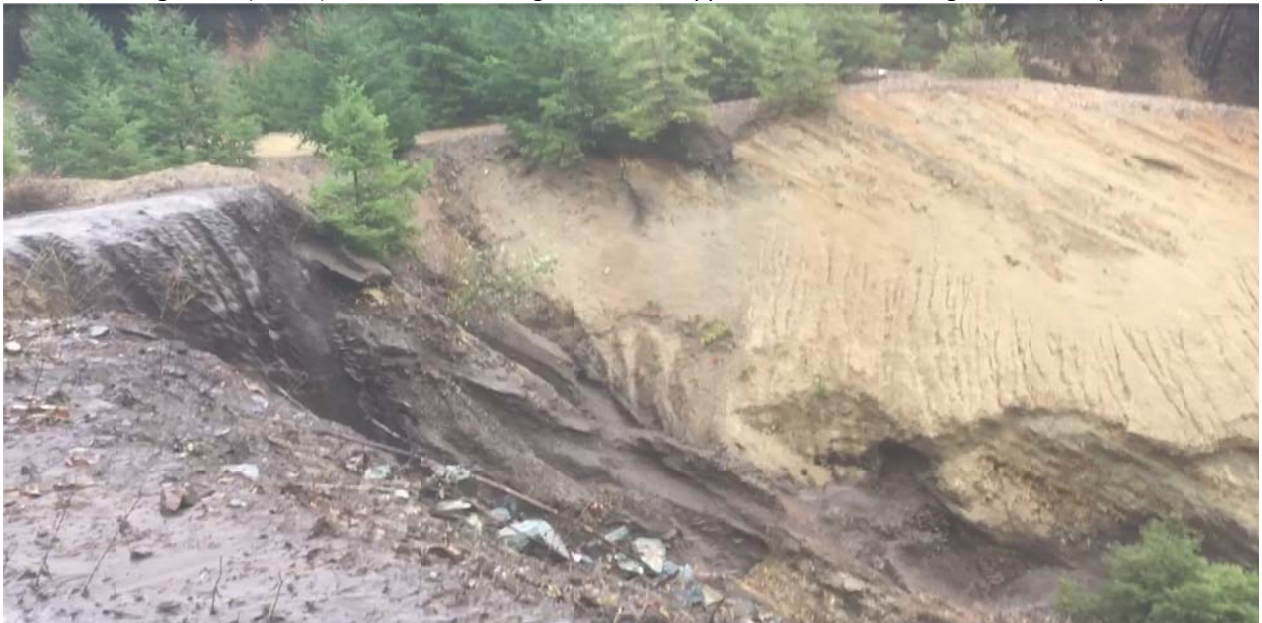
**Figure 12** (below): Mill Gulch crossing outlet overtopped and flow returning over road top.

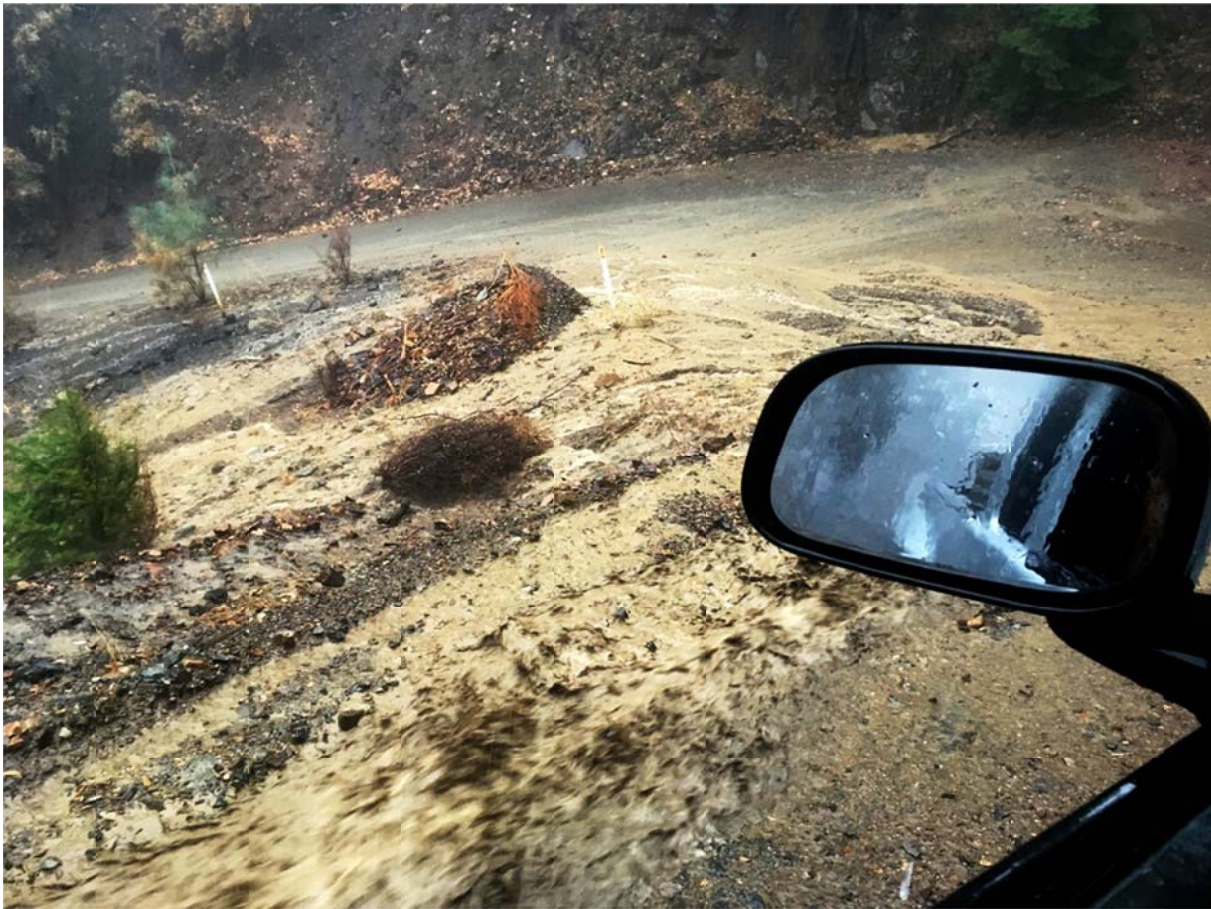
**Figure 13** (above): Tunnel Gulch crossing October 4, 2018. The culvert has been completely plugged and diverted both over the road and down the road.

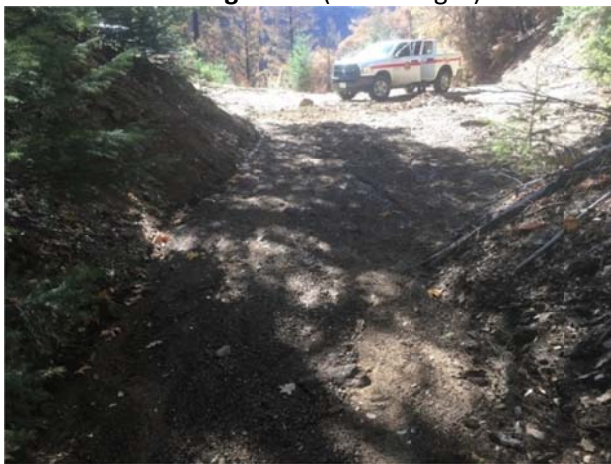
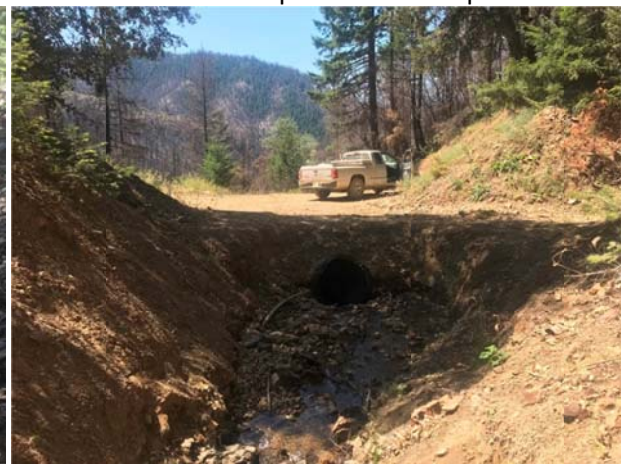
**Figure 14** (below Left): Tunnel Gulch channel was completely filled in following the October 2018 thunderstorm. **Figure 15** (Below Right). Tunnel Gulch was excavated out post storm and post winter.

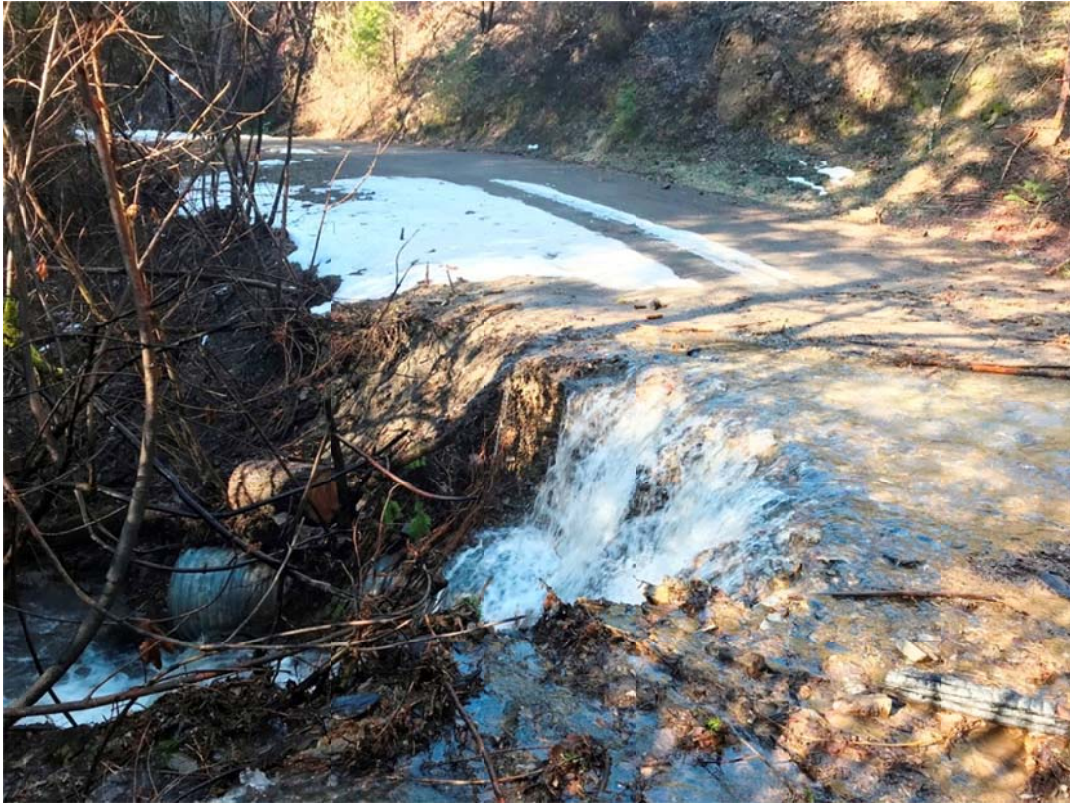
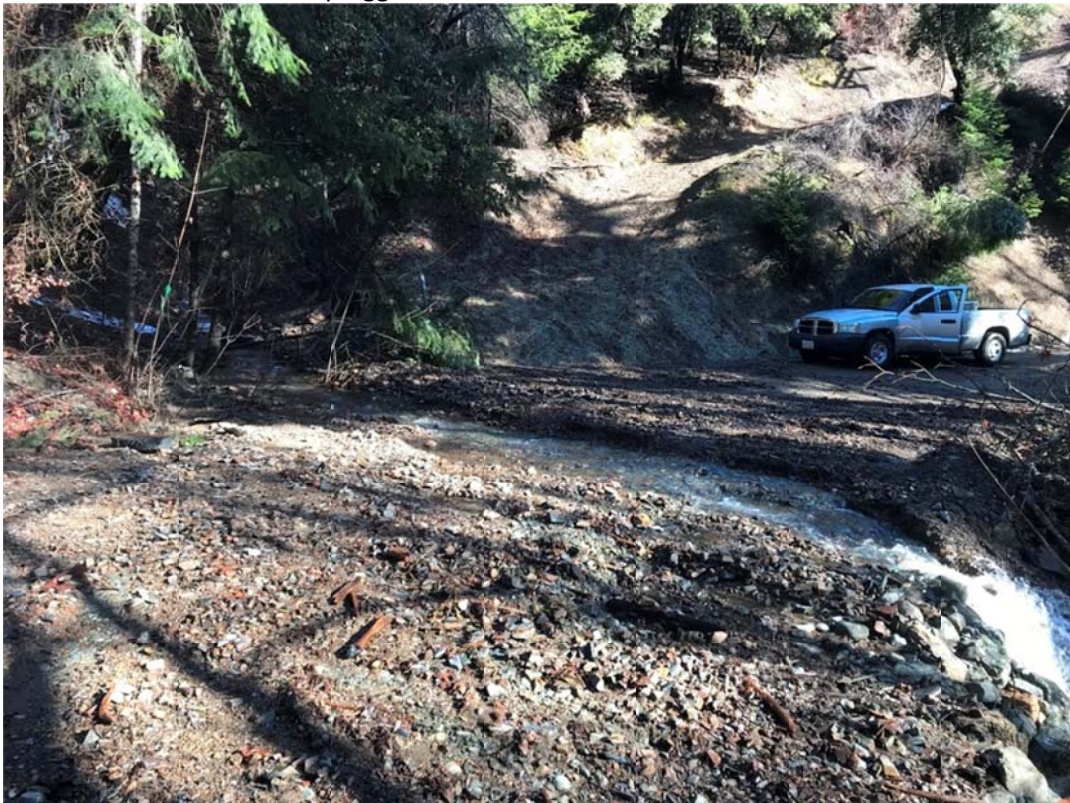
Figure 16 (above) and Figure 17 (below): Diverted streams on Deadwood Road. Site 1490 Donnelly Gulch plugged culvert and washed out fill.
