SRH-2009-47

River Spanning Rock Structures Field Investigations 2008

Pacific Northwest Region

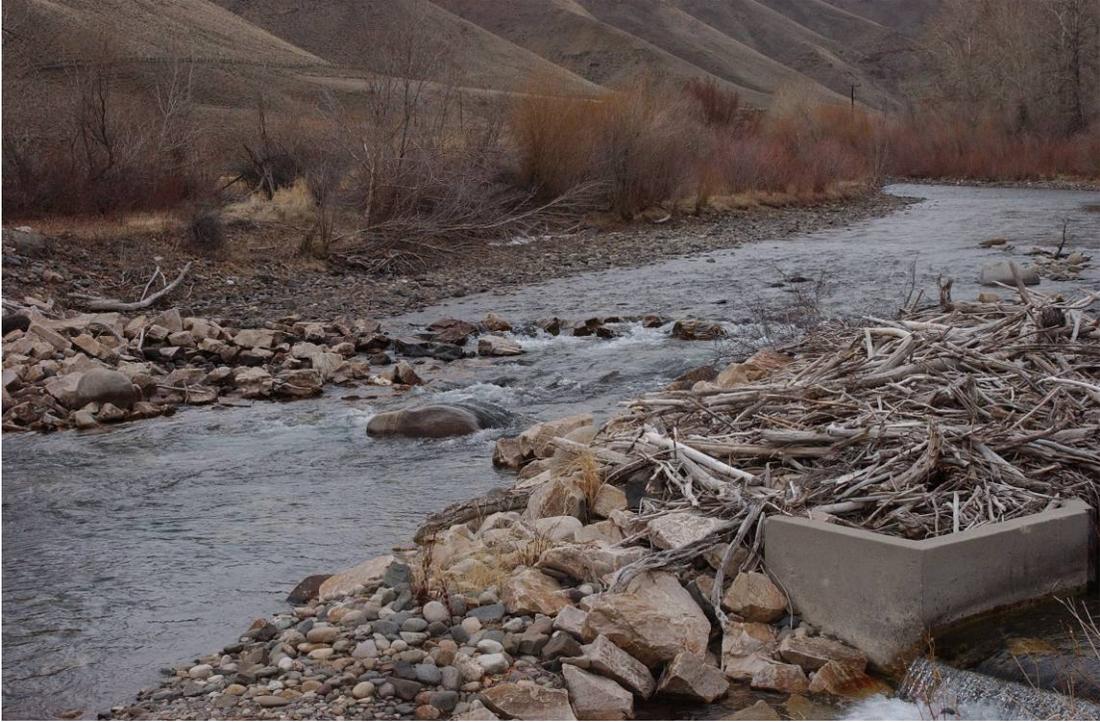
Figure 9. Looking upstream at the East Fork Salmon EF 7-8 structure in March 2003. Loose woody debris has piled up along the diversion channel and structure.

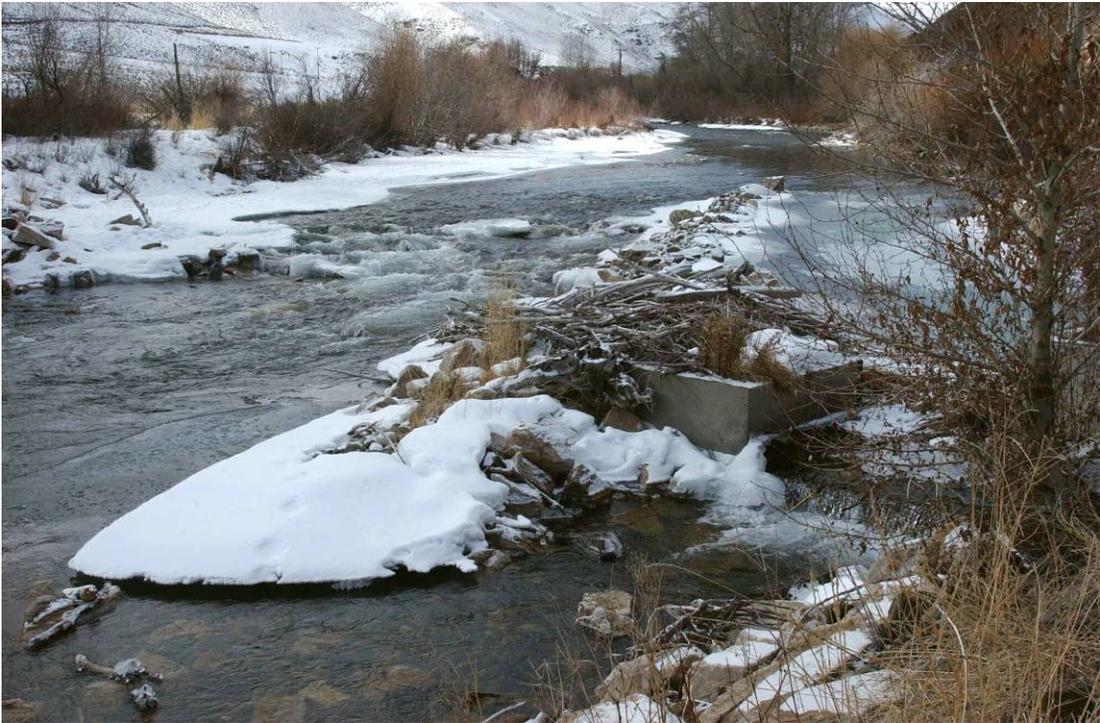
Figure 10. Looking upstream at the East Fork Salmon EF 7-8 structure in February 2006. Notice the berm extending upstream of the structure to guide flow toward the diversion gate.

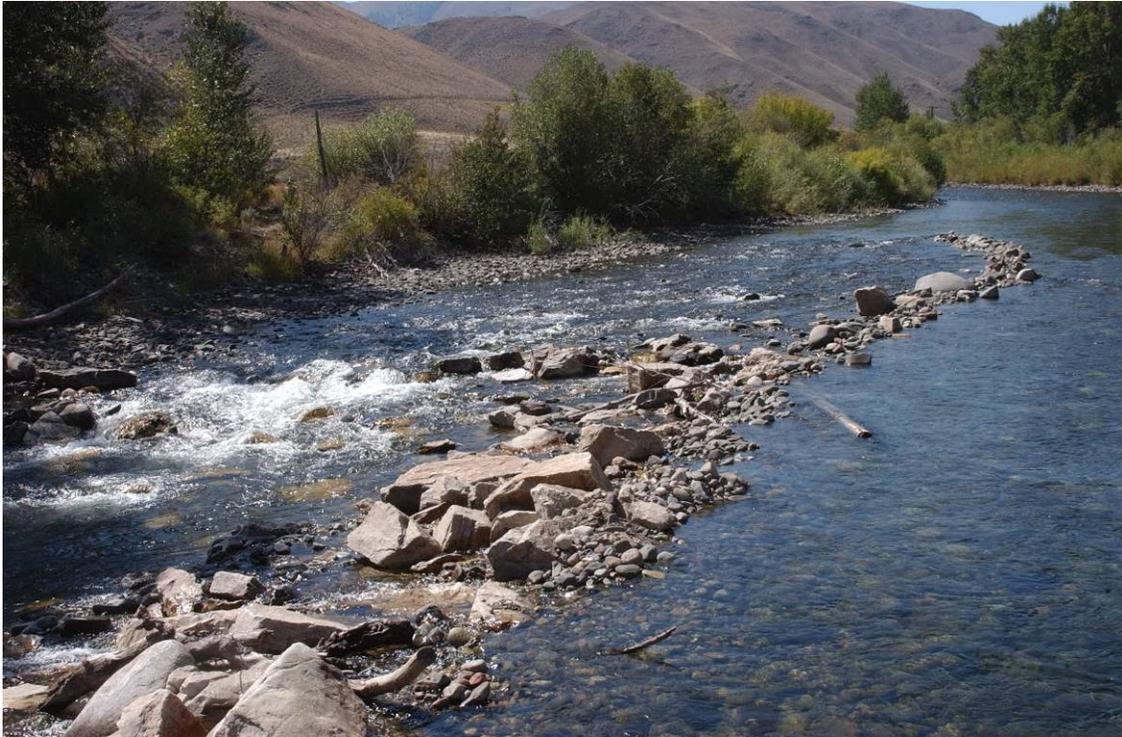
Figure 11. Looking upstream at the East Fork Salmon EF 7-8 structure in September 2007. The berm has been extended well beyond the head of the structure. Also, note seepage through the left arm of the structure.

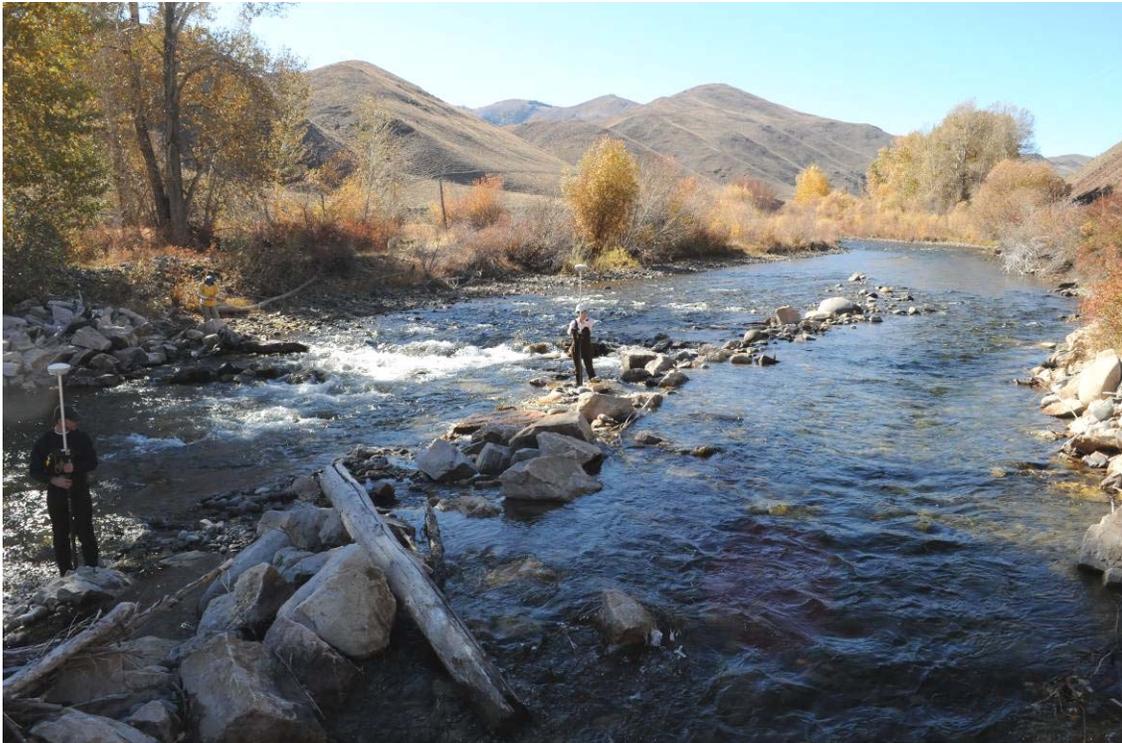
Figure 12. Looking upstream at the East Fork Salmon EF 7-8 structure in October 2008. Remnants of the berm from the previous year are visible.

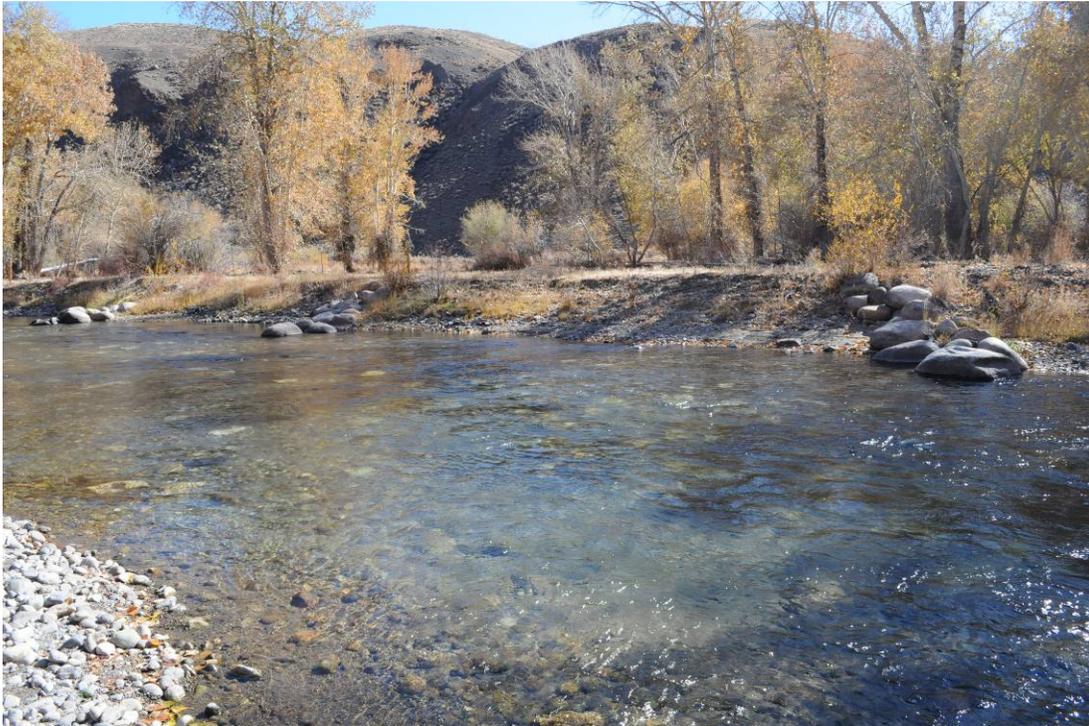
structure, a series of non-river spanning rock structures are present in efforts of protecting the right bank from erosion (Figure 15).

Figure 15. Several rock structures along right bank downstream from East Fork Salmon EF 7-8 structure (October 2008).

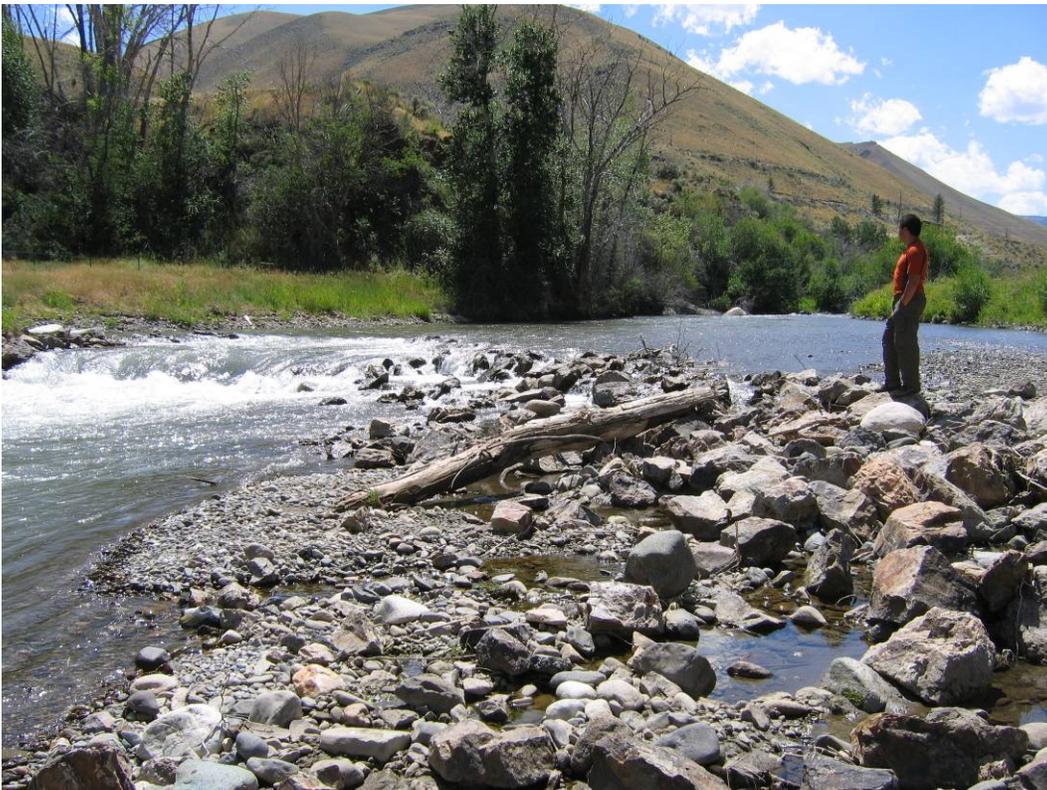
Figure 21. East Fork Salmon EF 10-11 in July 2005. Note depositional zone upstream from structure on right side of the photo (left bank)

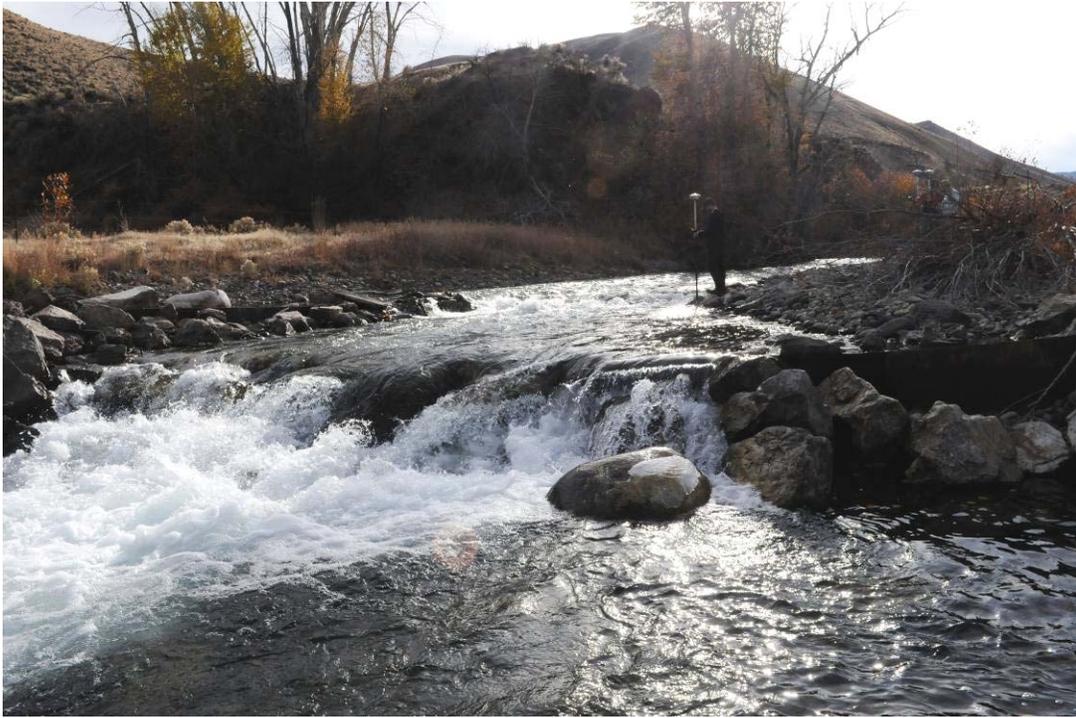
Structure EF 10-11 is located in a system with a high sediment load. The structure is located just downstream from a geologic constriction of the channel where bedrock was noted in the bed of the channel. Just upstream from the structure, the valley changes from a more confined configuration upstream to a slightly wider valley with a low surrounding surface across which the channel likely migrated historically (in geologic time). The structure currently is not meeting fish passage criteria regarding jump height and velocity. Since installation of the rock weir, the channel downstream from the structure has eroded at least one foot vertically and widened substantially (up to 10 feet) due to erosion along the right bank. The irrigation canal has filled with sediment, and the land owners have returned to using a push-up berm to meet diversion requirements. Figure 20 through Figure 22 provide evidence of structure changes since construction in August of 2003 to October 2008. Although the structure is still intact, the metal plate is now exposed in several locations and some of the headers have moved into the deep scour pools (Figure 23). The metal plate provides a hard point in the river and strongly influences the structure's persistence. The drop over the throat is currently greater than 2.5 feet, and the drop over the cross bar greater than 4 feet.

Figure 22. East Fork Salmon EF 10-11 in October 2008. Note significant change in drop height since construction, mobilization of larger boulders, and excessive deposition upstream of structure.

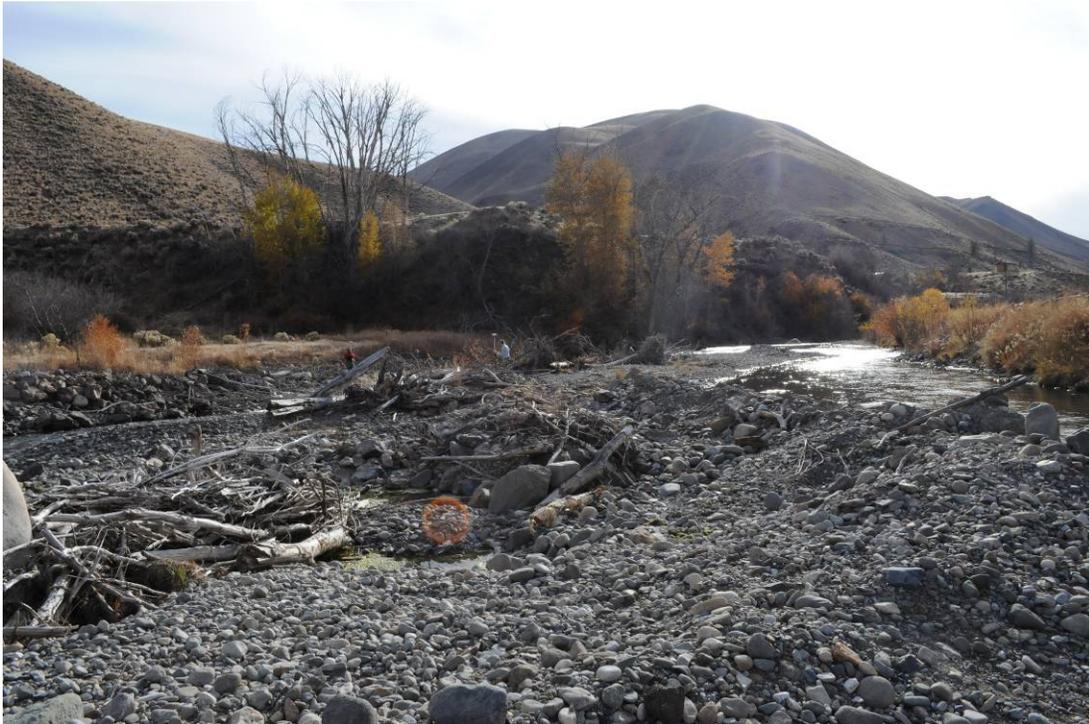
Figure 25. Looking upstream from where the left arm of the East Fork Salmon EF 10-11 structure lies buried under large gravel bar and large woody debris (October 2008).

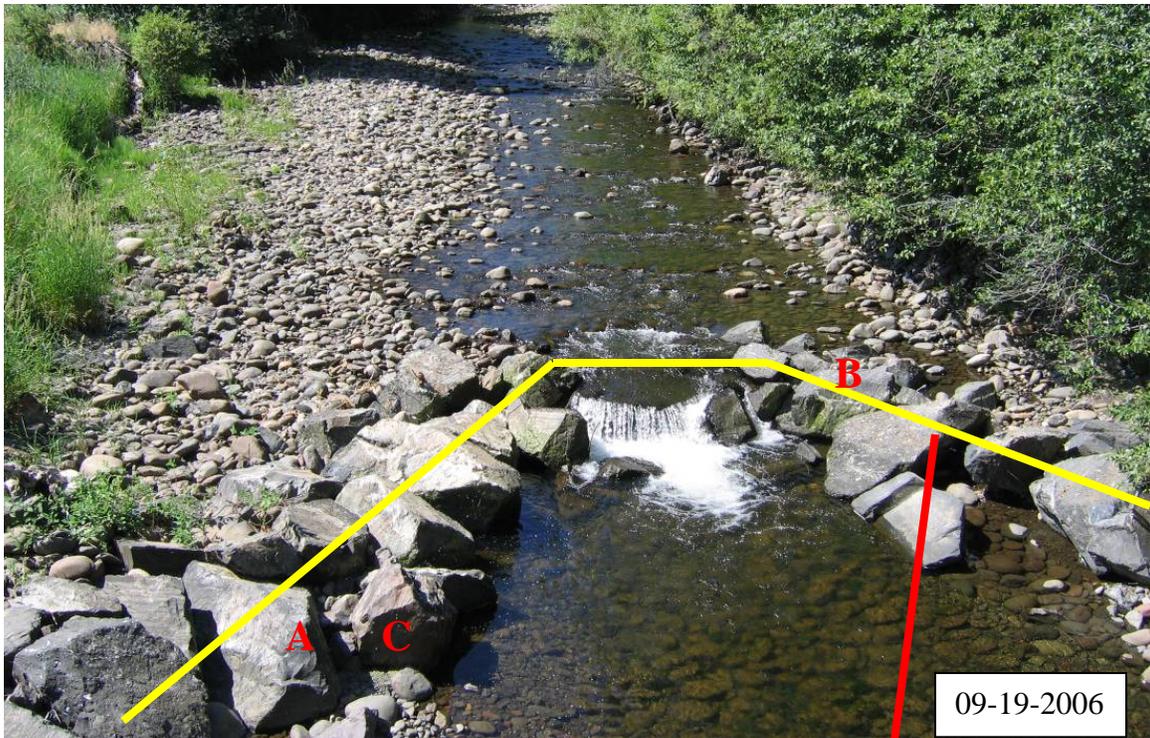
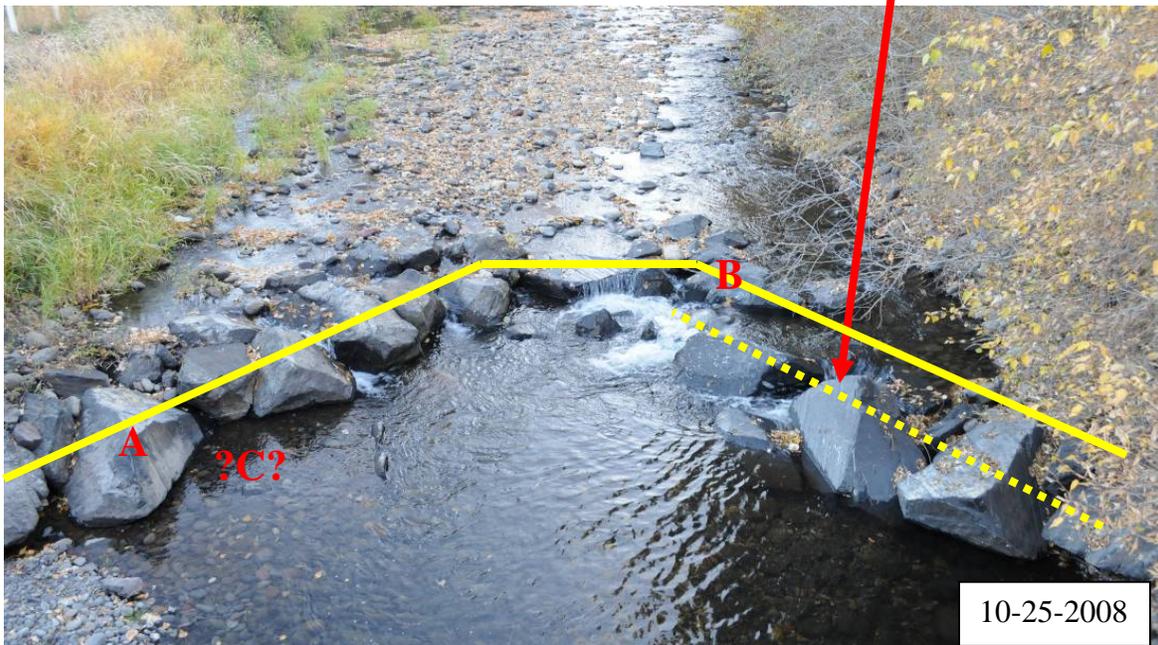
The structures are believed to have functioned well prior to a 1,300 ft³/s flow in May 2006 which moved header and footer rocks and filled in the middle of the channel upstream of the structures. Additional high flows in May 2007 and November 2007 appear to have caused additional movement of the header rocks.

Figure 35. Bear Creek Site B U-Weir Looking Upstream showing rock movement along the left arm.

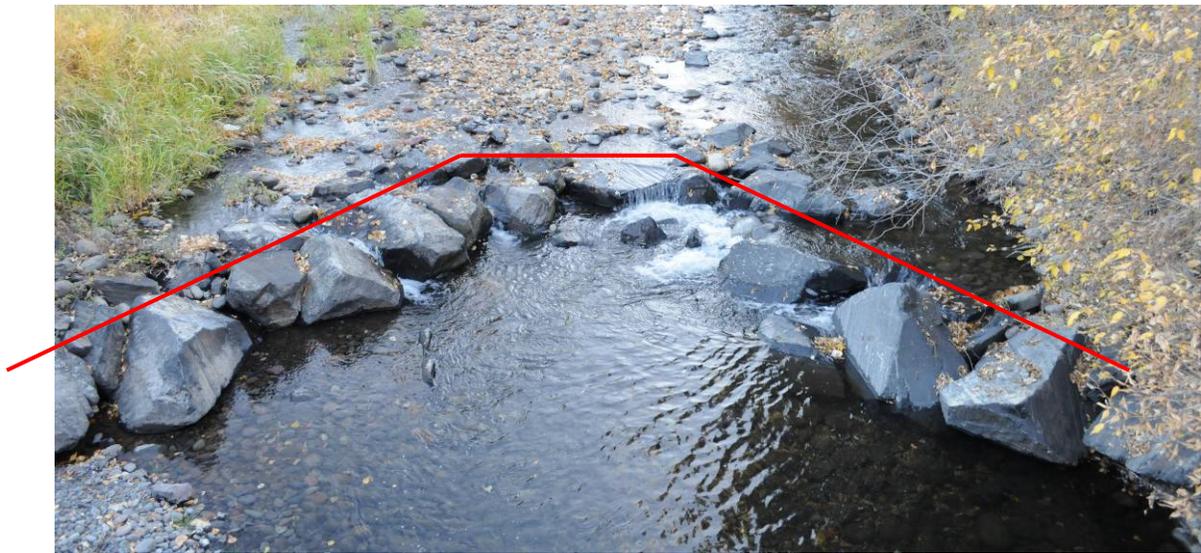
Figure 37. Hypothesized Locations of the Original Header Rocks at Bear Creek site B1.

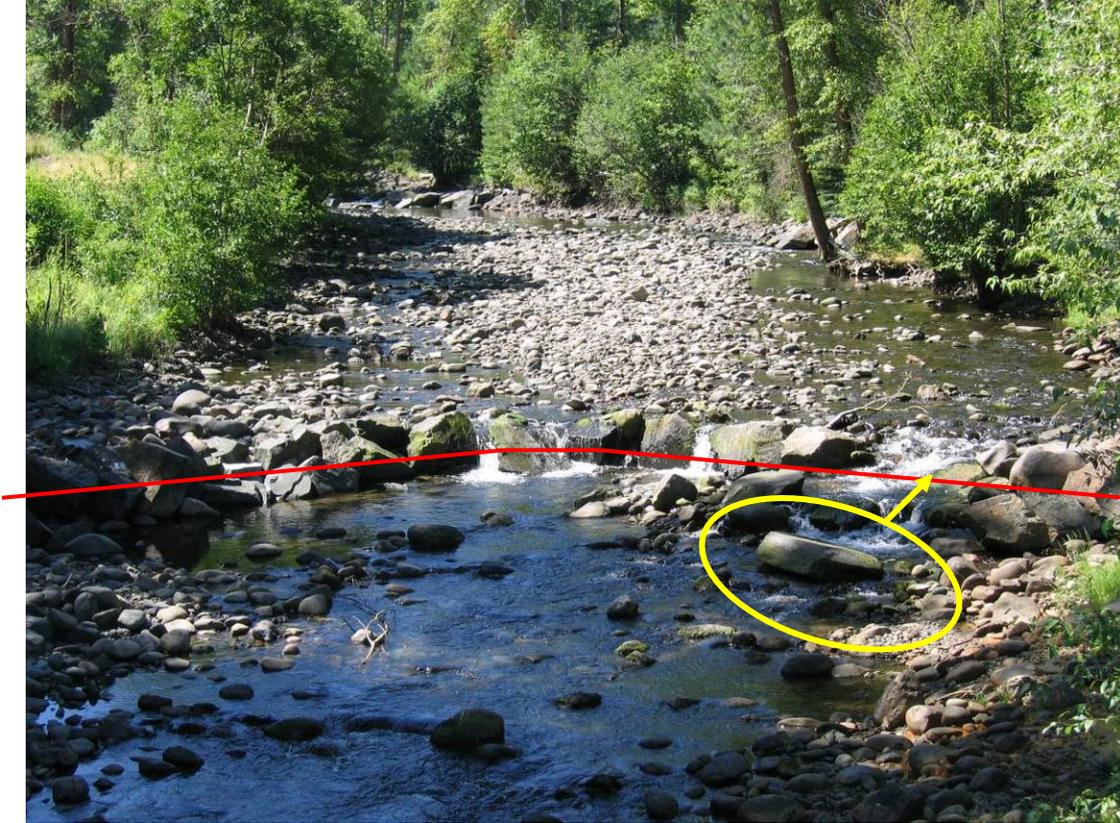
Figure 38. Hypothesized Locations of the Original Header Rocks at Bear Creek site D1.

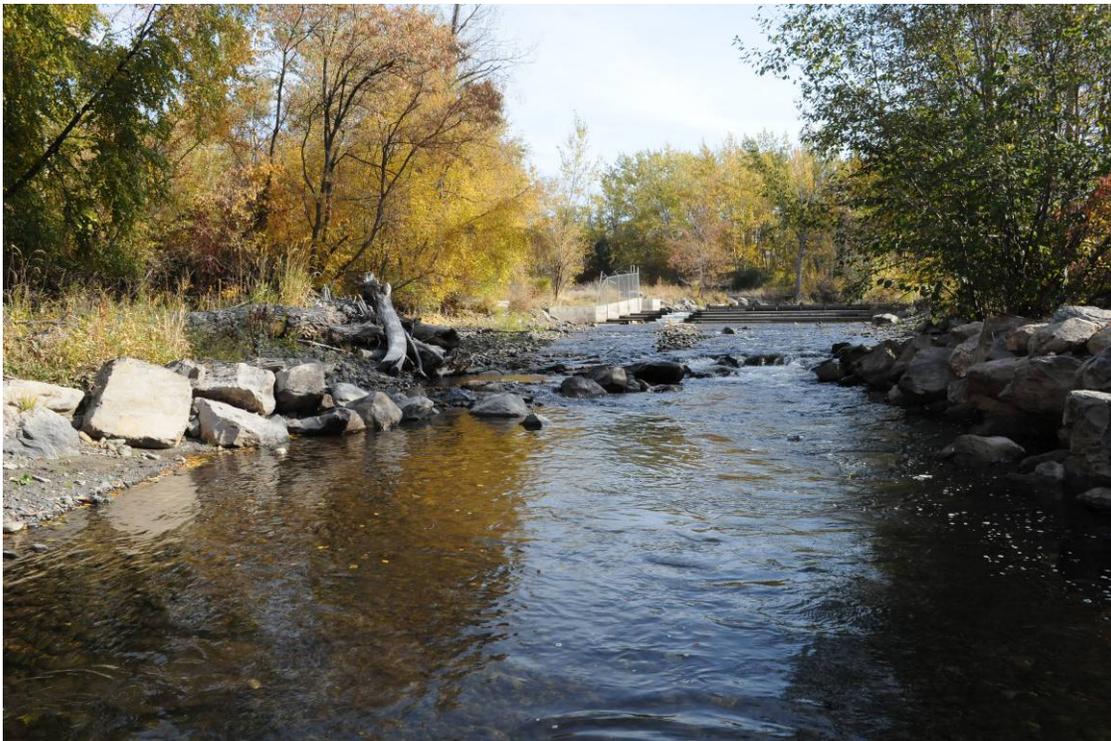
Figure 45. Looking upstream in the same location at Swackhammer as the previous figure in October 2008. Note the growth of the gravel bar and the disconnection of the side channel.

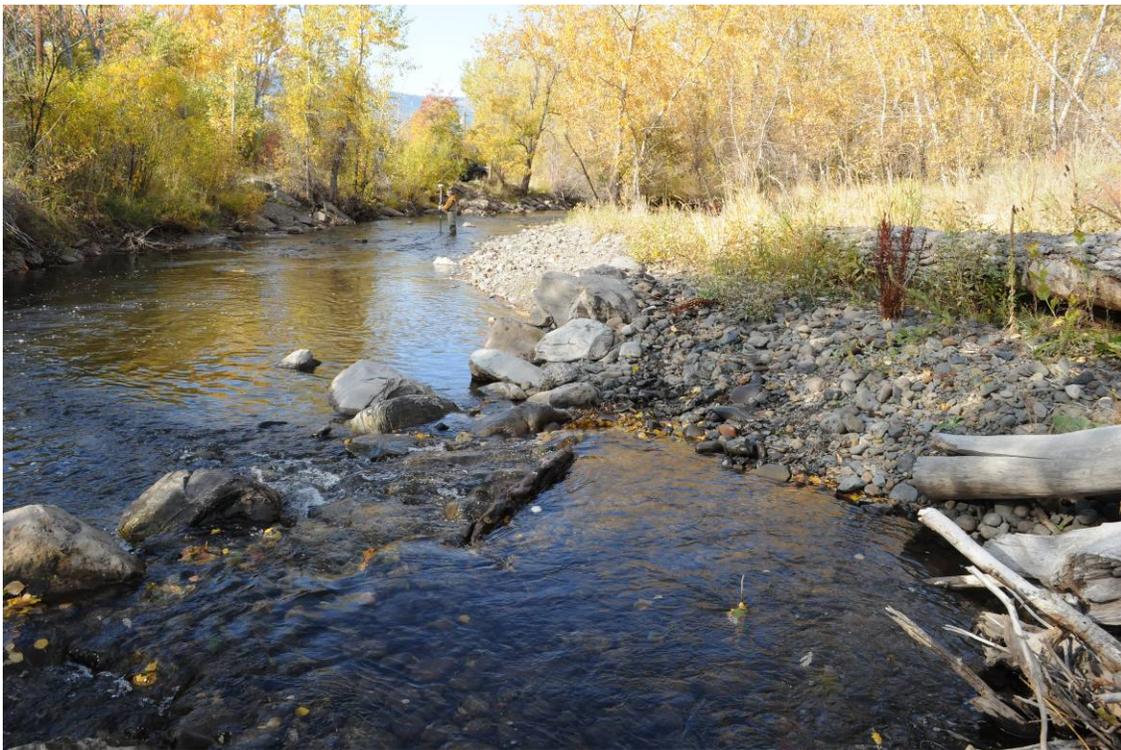
Figure 46. Right arm of left U-weir at Swackhammer. The center section and right arm of the structure are completely buried. October 2008.

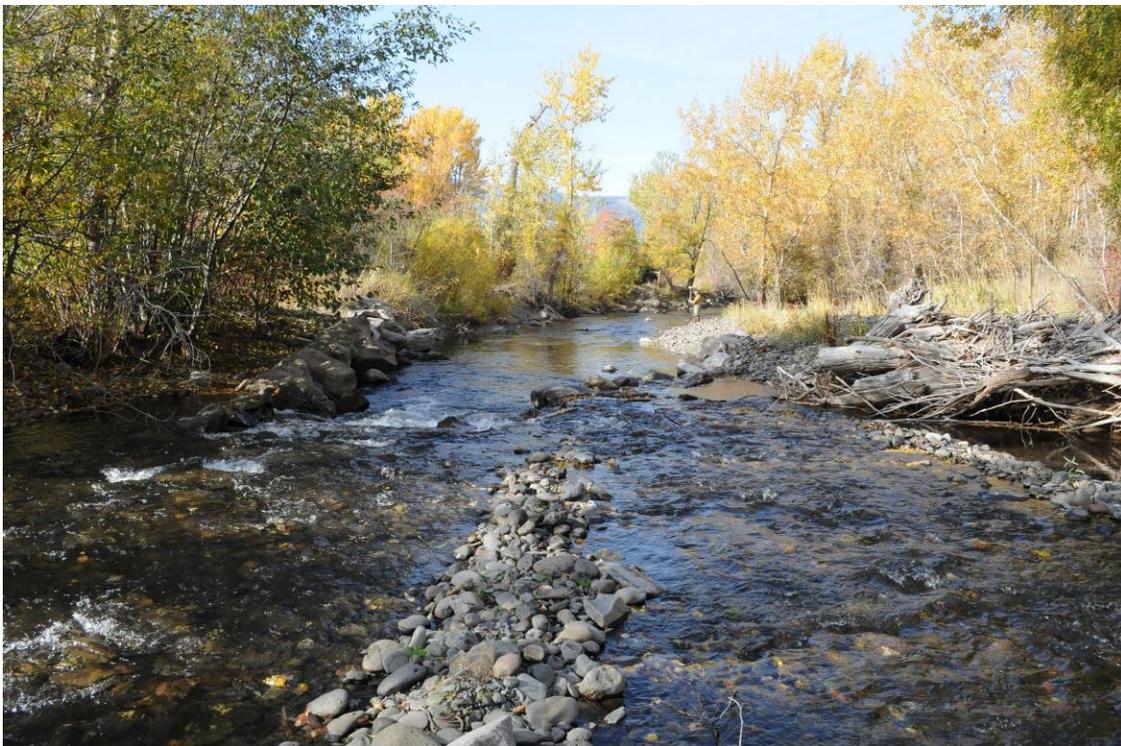
Figure 48. Looking downstream across W-weir at Swackhammer. Note the entire center and right arms have completely filled in with sediment and debris. October 2008.

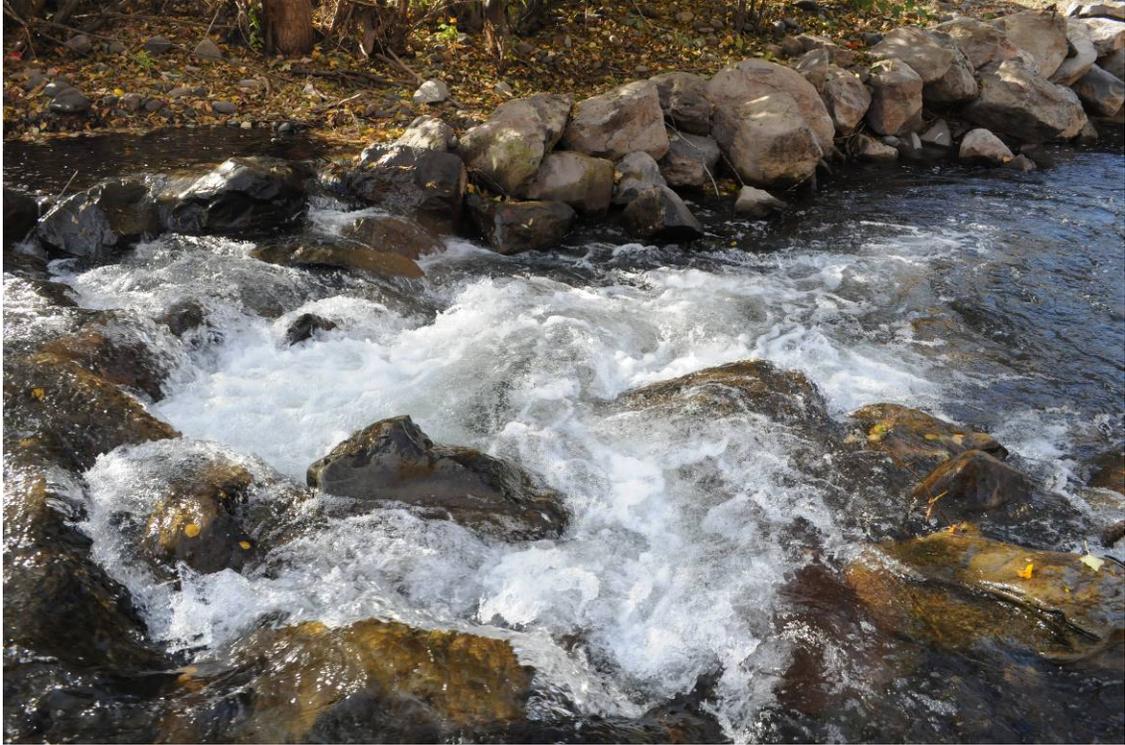
Figure 49. Throat of structure at Swackhammer. Several rocks have slumped into downstream scour pool, creating a series of steps, rather than a steep drop. October 2008.

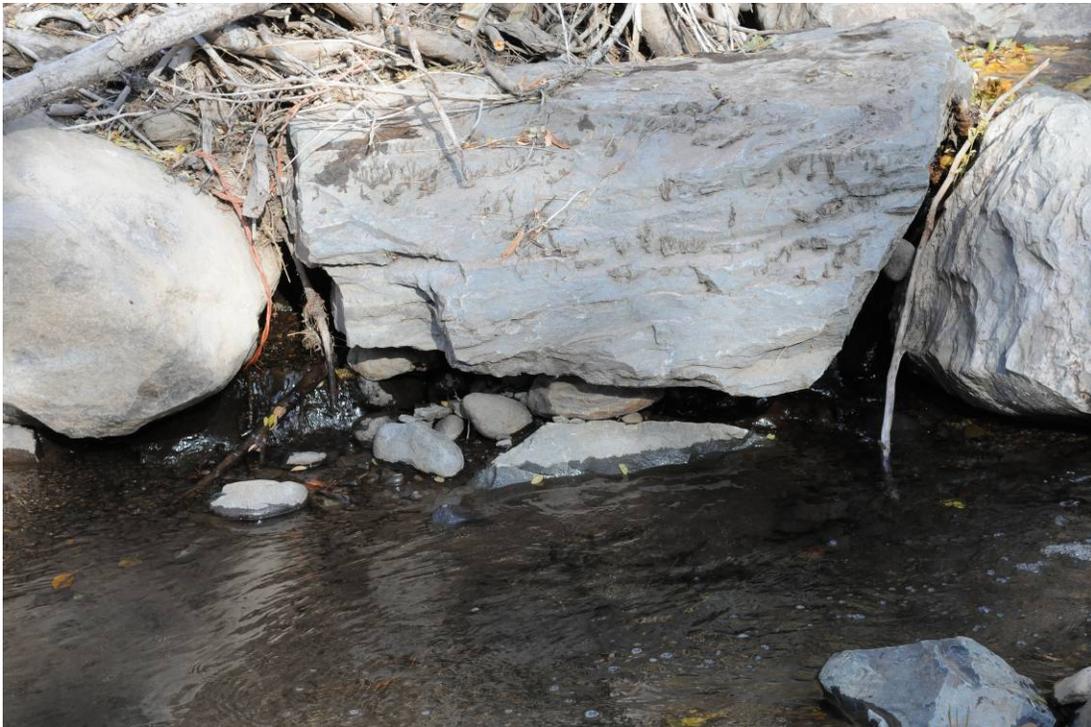
Figure 50. Rocks along right arm of left U at Swackhammer, illustrating minor seepage underneath and between the header rocks. October 2008.

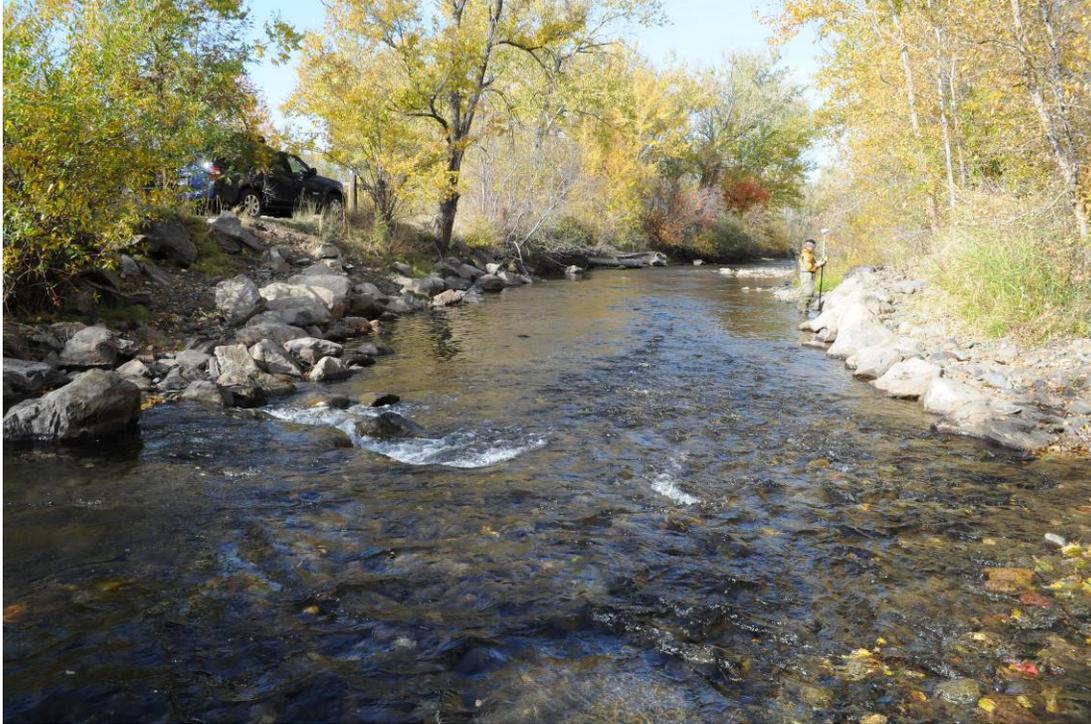
Comparison of the U-weir condition just following construction (Figure 54) with the condition during the October 2008 field visit (Figure 55) suggests that structural components of the U-weir have not experienced substantial mobility. The native backfilled material provided a natural appearance post-construction and filled in voids between the larger rocks. However, a large portion of the exposed gravels and small cobbles have been transported out of the structure and voids remain between the larger rocks where the angularity of the rocks prevented interlocking (Figure 56).

Figure 55. Same location looking downstream across the U-weir at Swackhammer in October 2008. A lot of the backfilled material has been transported downstream.

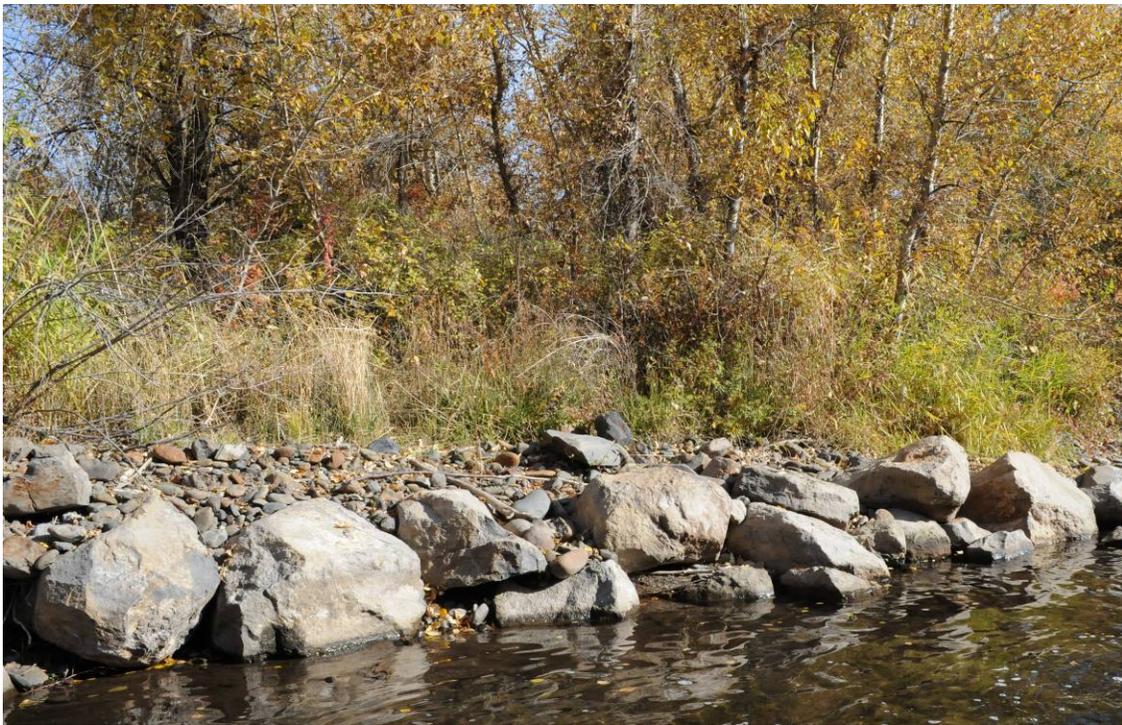
Figure 56. Right arm of U-weir at Swackhammer. Some voids present between larger rocks and a lot of the native backfilled material has been scoured out of structure. October 2008.

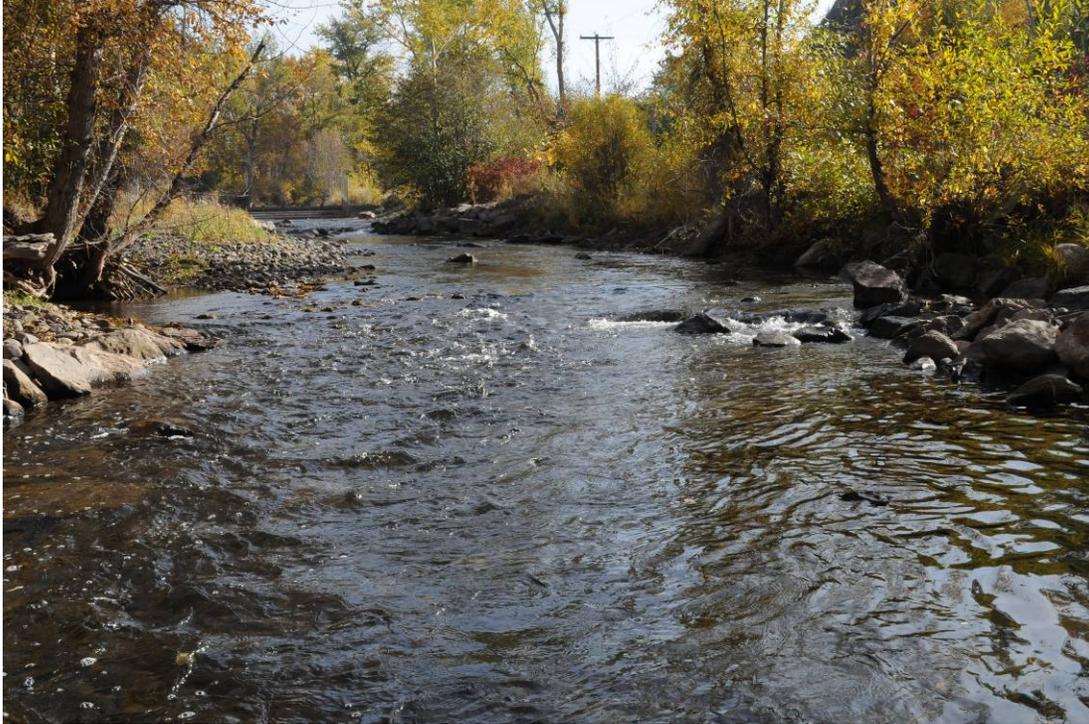
Figure 57. View of the U-weir at Swackhammer looking upstream in October 2008. No pool is present at the structure throat.

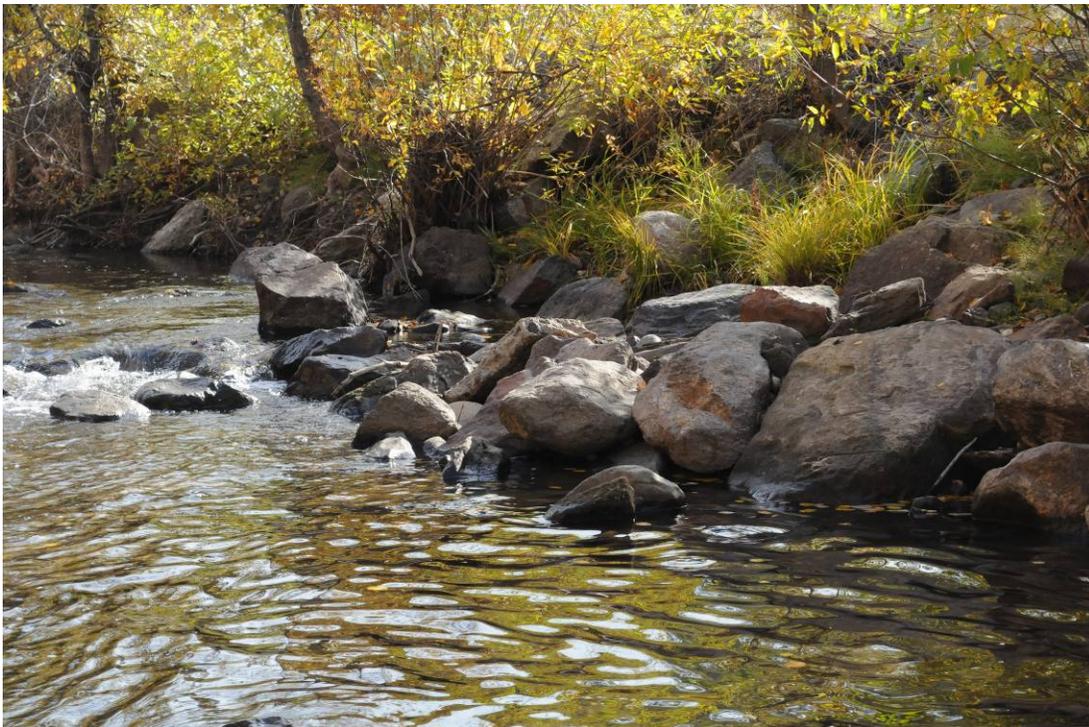
Figure 58. Connection of the throat and left arm of the structure at Swackhammer. Several rocks have fallen into the scour pool along the left arm of the structure.

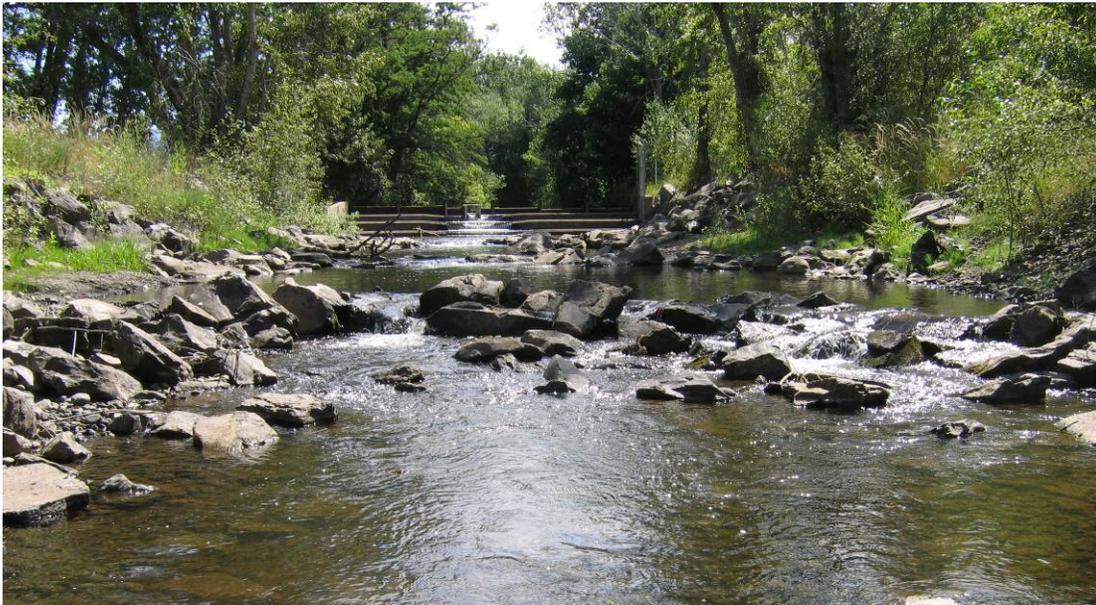
The downstream-most structure currently acts more like a roughened channel feature than a stable U-weir. Photo comparison between 2005 and 2008 suggests that some minor shifting of the structure rocks has occurred over the past few years (Figure 63 and Figure 64). Almost all of the header rocks have slumped inward, part of which may have to do with the angular nature of the rocks used in the structure. Some spaces were noted between the rocks where edges of rock were not interlocking. The size of the voids between the rocks ranged from 6 inches to 1 foot. Some flow was noted between the larger voids along the structure arms. A shallow pool is present just downstream of the structure throat with bed material size of approximately 180 mm on average. Because of the roughened nature of the structure, fish passage through the structure is very good. A depositional zone is present downstream from the structure where coarse sands were noted in the bed. This structure is tied-in to the bank and riprap.

Figure 63. HH1 at Hempe Hutchinson in July 2005. Substantial shifting of the structure material occurred since the date of construction.

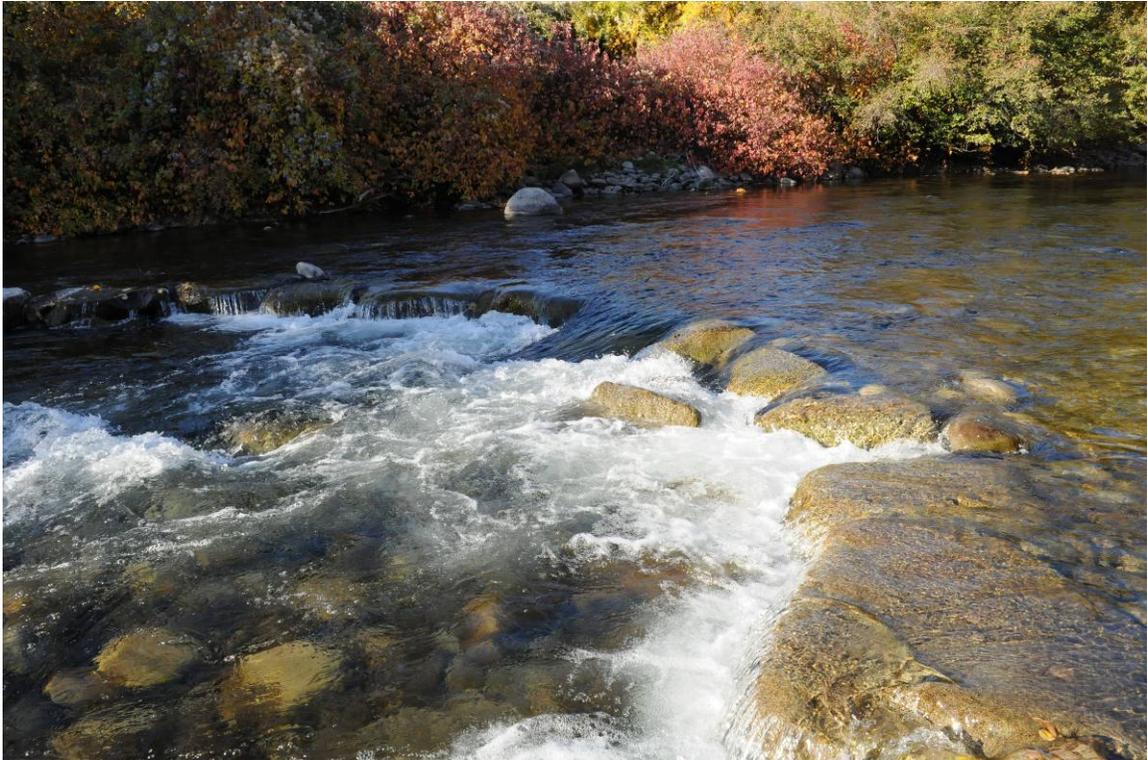
Figure 73 shows a photo of the round nosed U weir structure at RM 3.1 seen in October 2008. The right arm is missing several header rocks and the throat is also missing a header rock (Figure 74 and Figure 75). The left arm is intact with some shifting of the footers. It appears that many of the footer rocks are offset from the headers with material filling in behind structure. Approximately 30% of the flow is going through the right arm where the header rocks dislodged. The scour pool has been partially filled with material consisting of cobbles and boulders with diameters exceeding 500 mm. Because of the filling in the middle of the scour pool, the majority of the scour pool is now located along the right arm upstream and downstream of the gap in header rocks. Based on the 2006 field visit, the movement of the header and footer rocks occurred before 2006. Since that visit it does not appear that there have been major changes in structure form.

Figure 74. Throat of Entiat River structure at RM 3.1 showing movement of several header rocks.

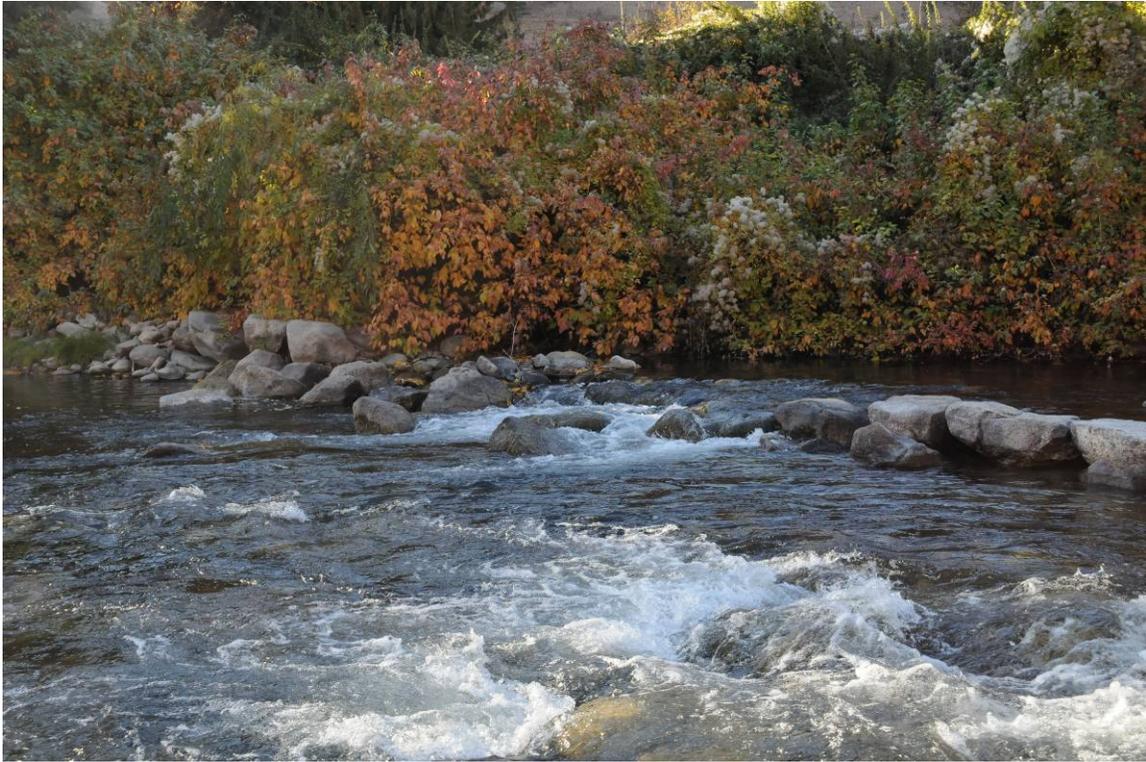
Figure 75. Looking at right arm of Entiat River structure at RM 3.1 with several dislodged header rocks.

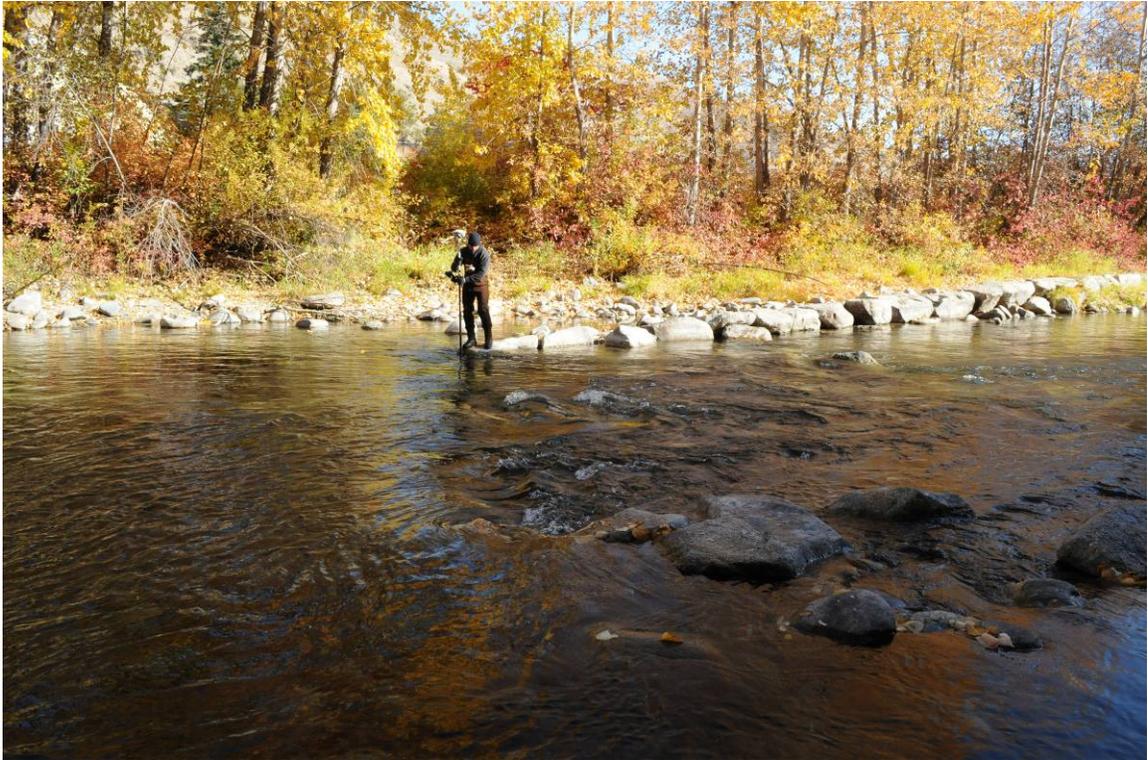
Figure 77. Throat of Entiat River structure at RM 3.2 where the majority of the header rocks have been dislodged.
