SRH-2009-47

River Spanning Rock Structures Field Investigations 2008

Pacific Northwest Region

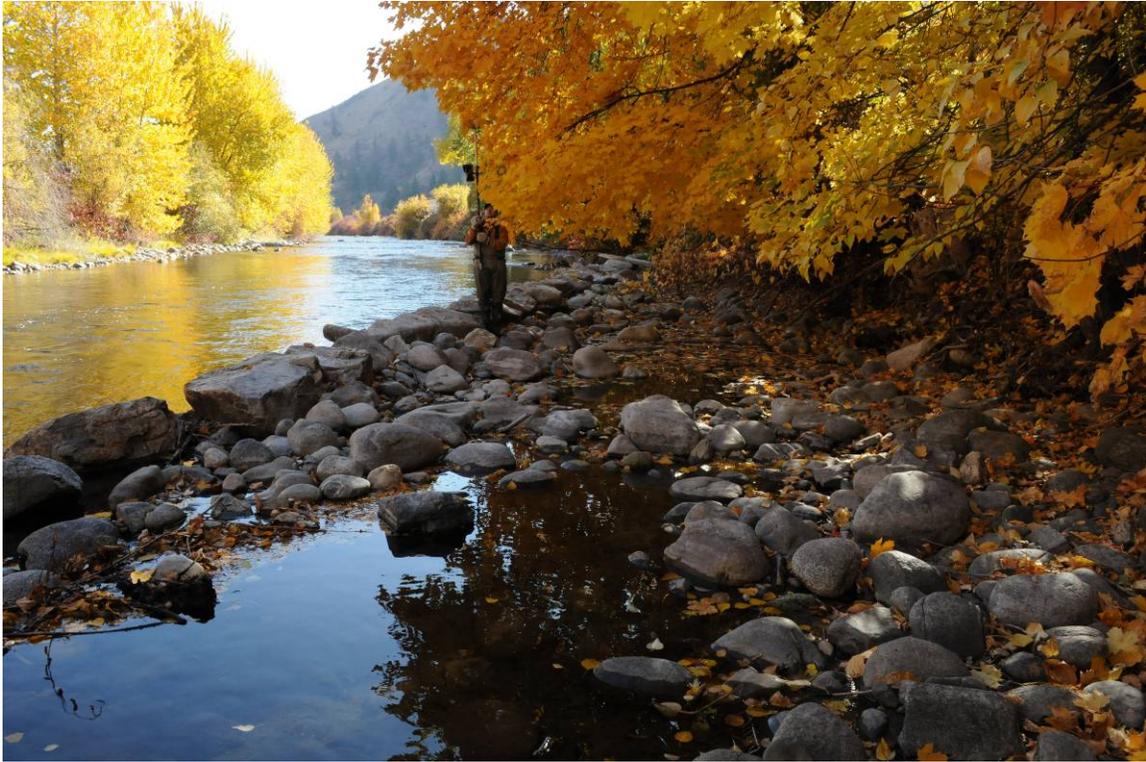
Figure 78. Right arm of Entiat River structure at RM 3.2 where deposition has occurred upstream.

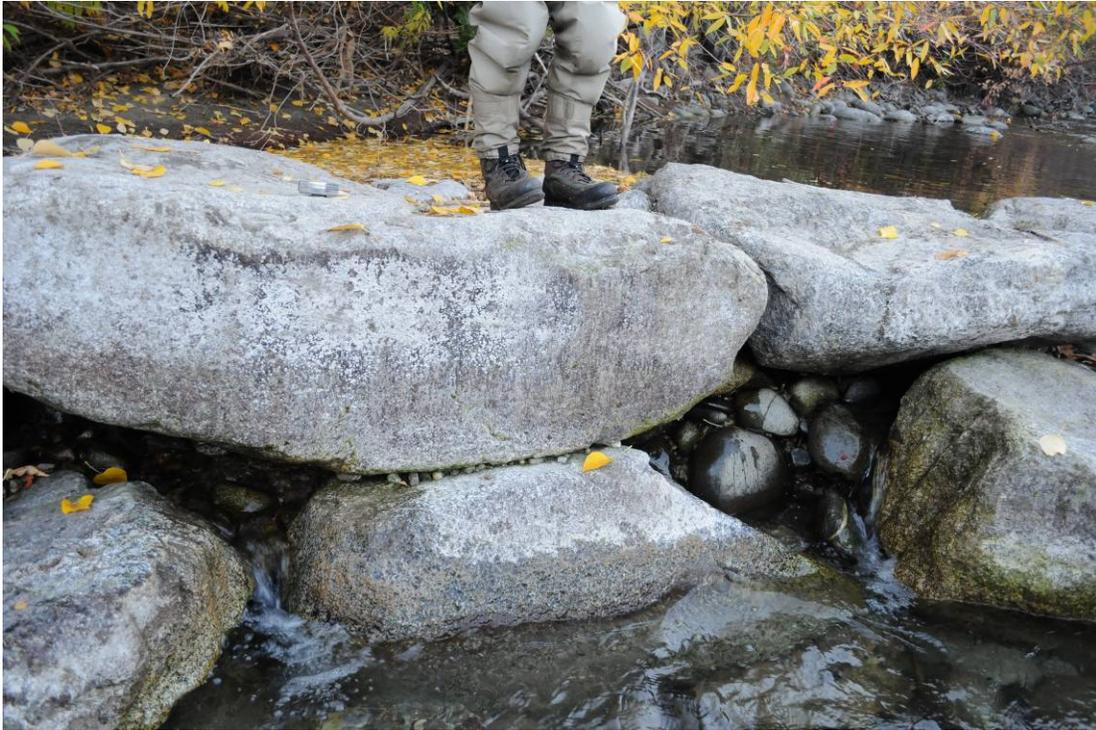
Figure 84. Spacing between header and footer rocks has filled in with sediment at Entiat River structure at RM 4.6.

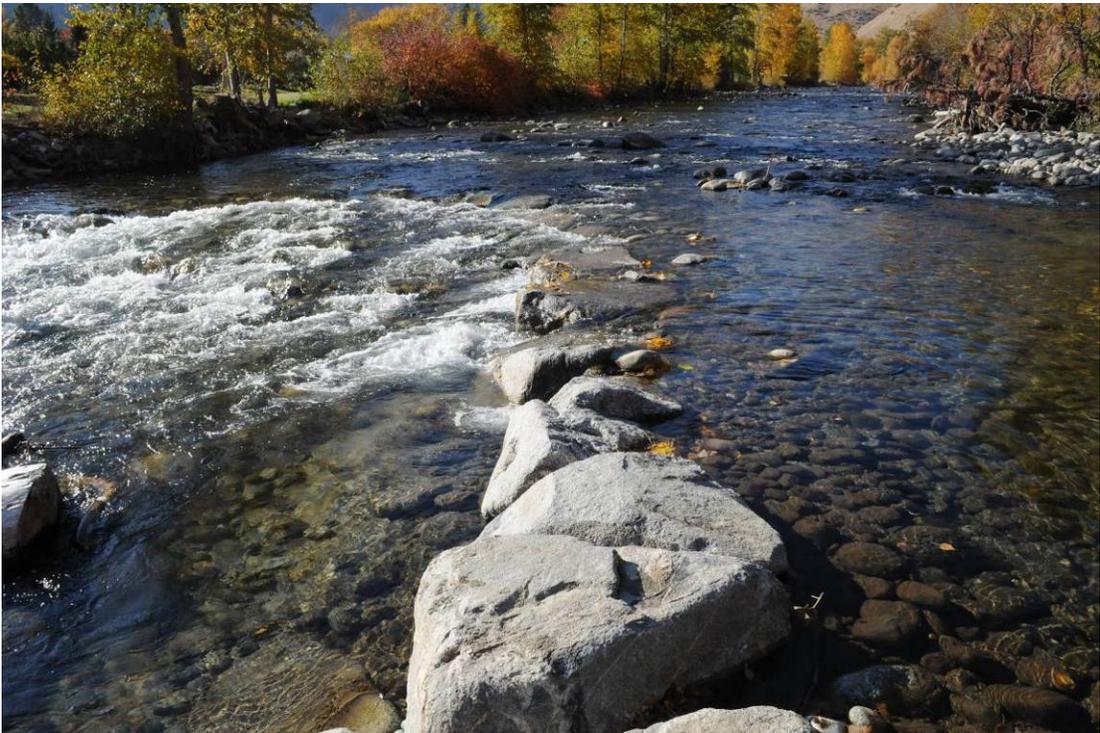
Figure 91. Throat of Entiat River structure at RM 3.4 is acting hydraulically similar to a ramp rather than a drop.

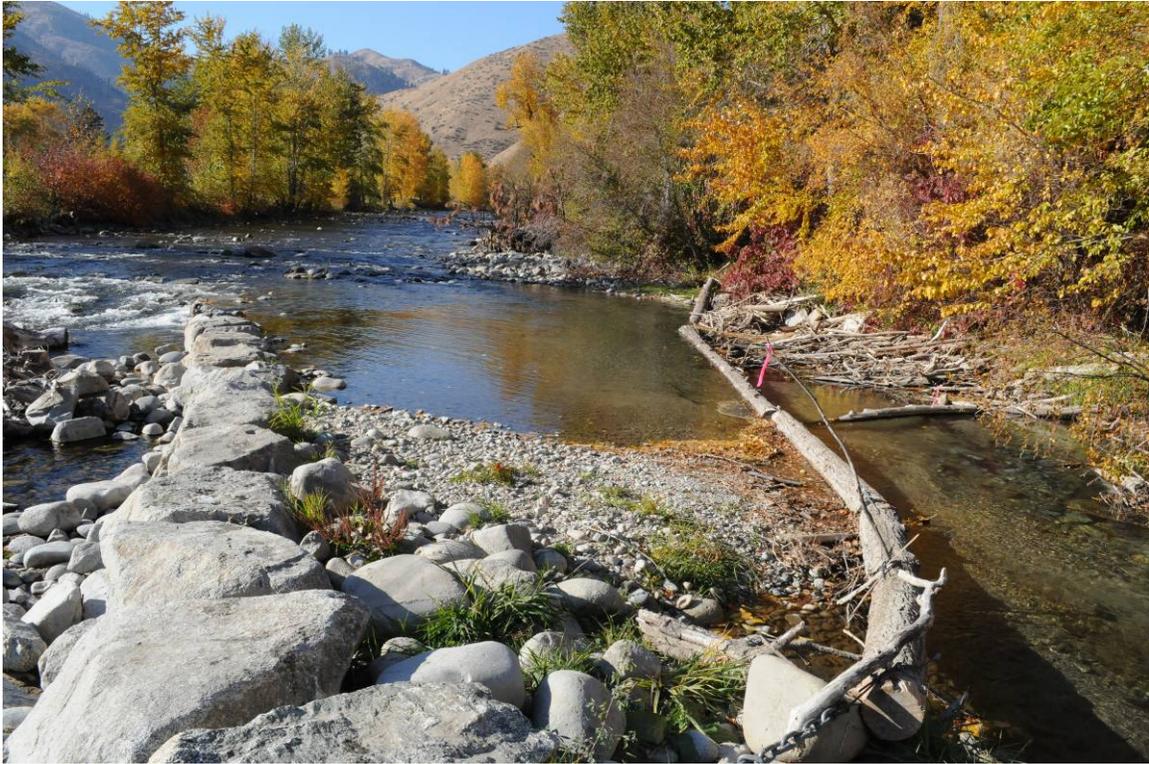
Figure 92. Gravel deposition upstream of the left arm of the Entiat River structure at RM 3.4

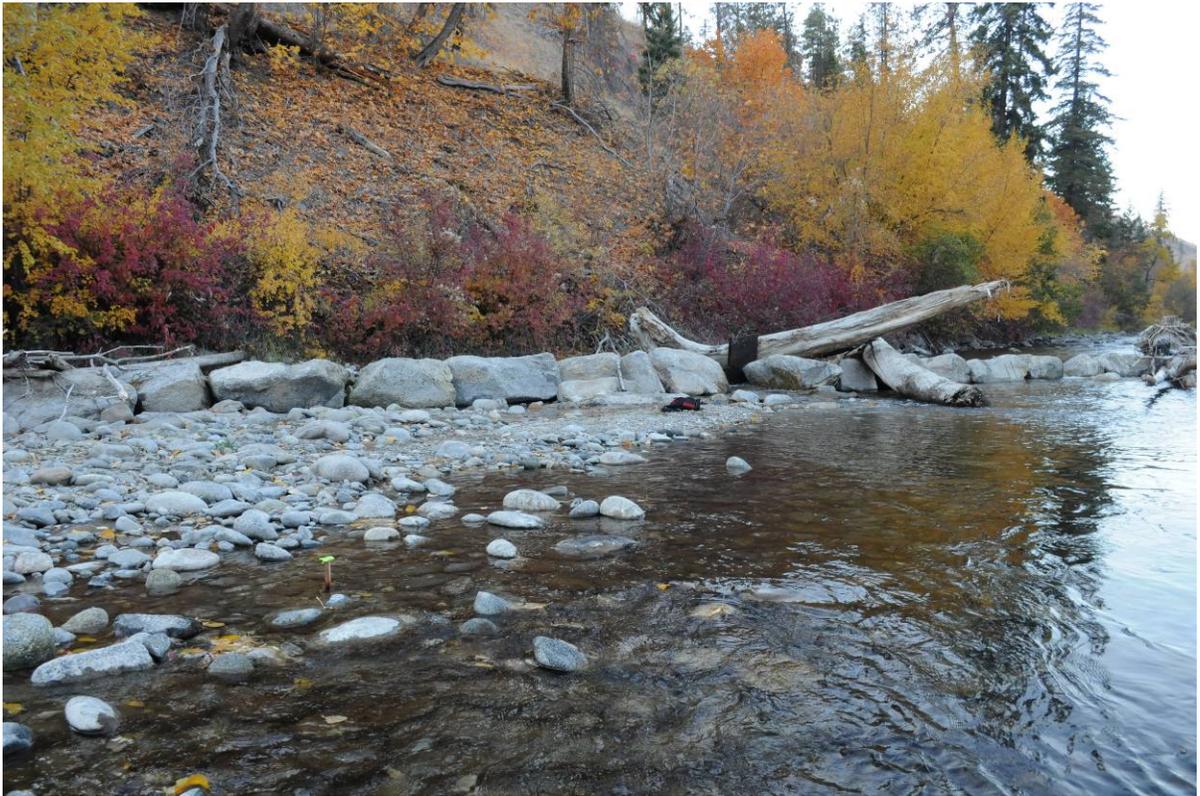
Figure 94. Right arm of Entiat River structure at RM 5.1 with sluice gate blocked by naturally caught wood.
