Alluvial Fans and Salmonid Habitat: The Forgotten and Challenging Landscape In-Between

A Concurrent Session at the 36th Annual Salmonid Restoration Conference held in Fortuna, California from April 11 – 14, 2018.

The Benefits of Restoring Alluvial Fan Processes after a Century of Neglect

Alluvial Fan Construction in the Pacific Northwest

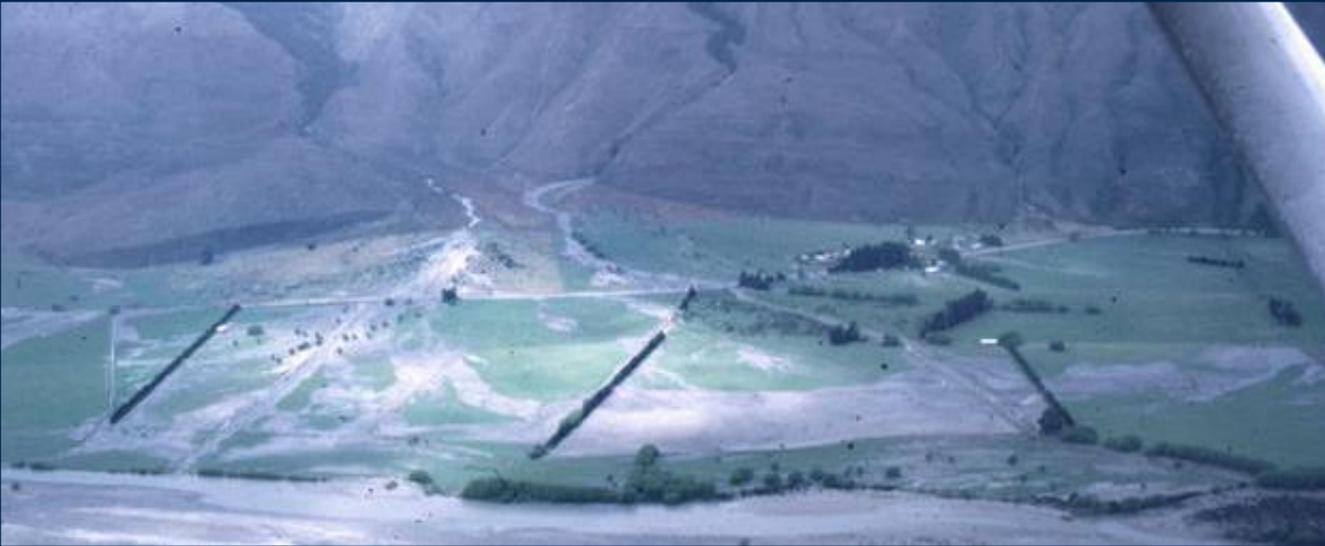
Alluvial fan activity in New Zealand (courtesy of a Otago Regional Council)

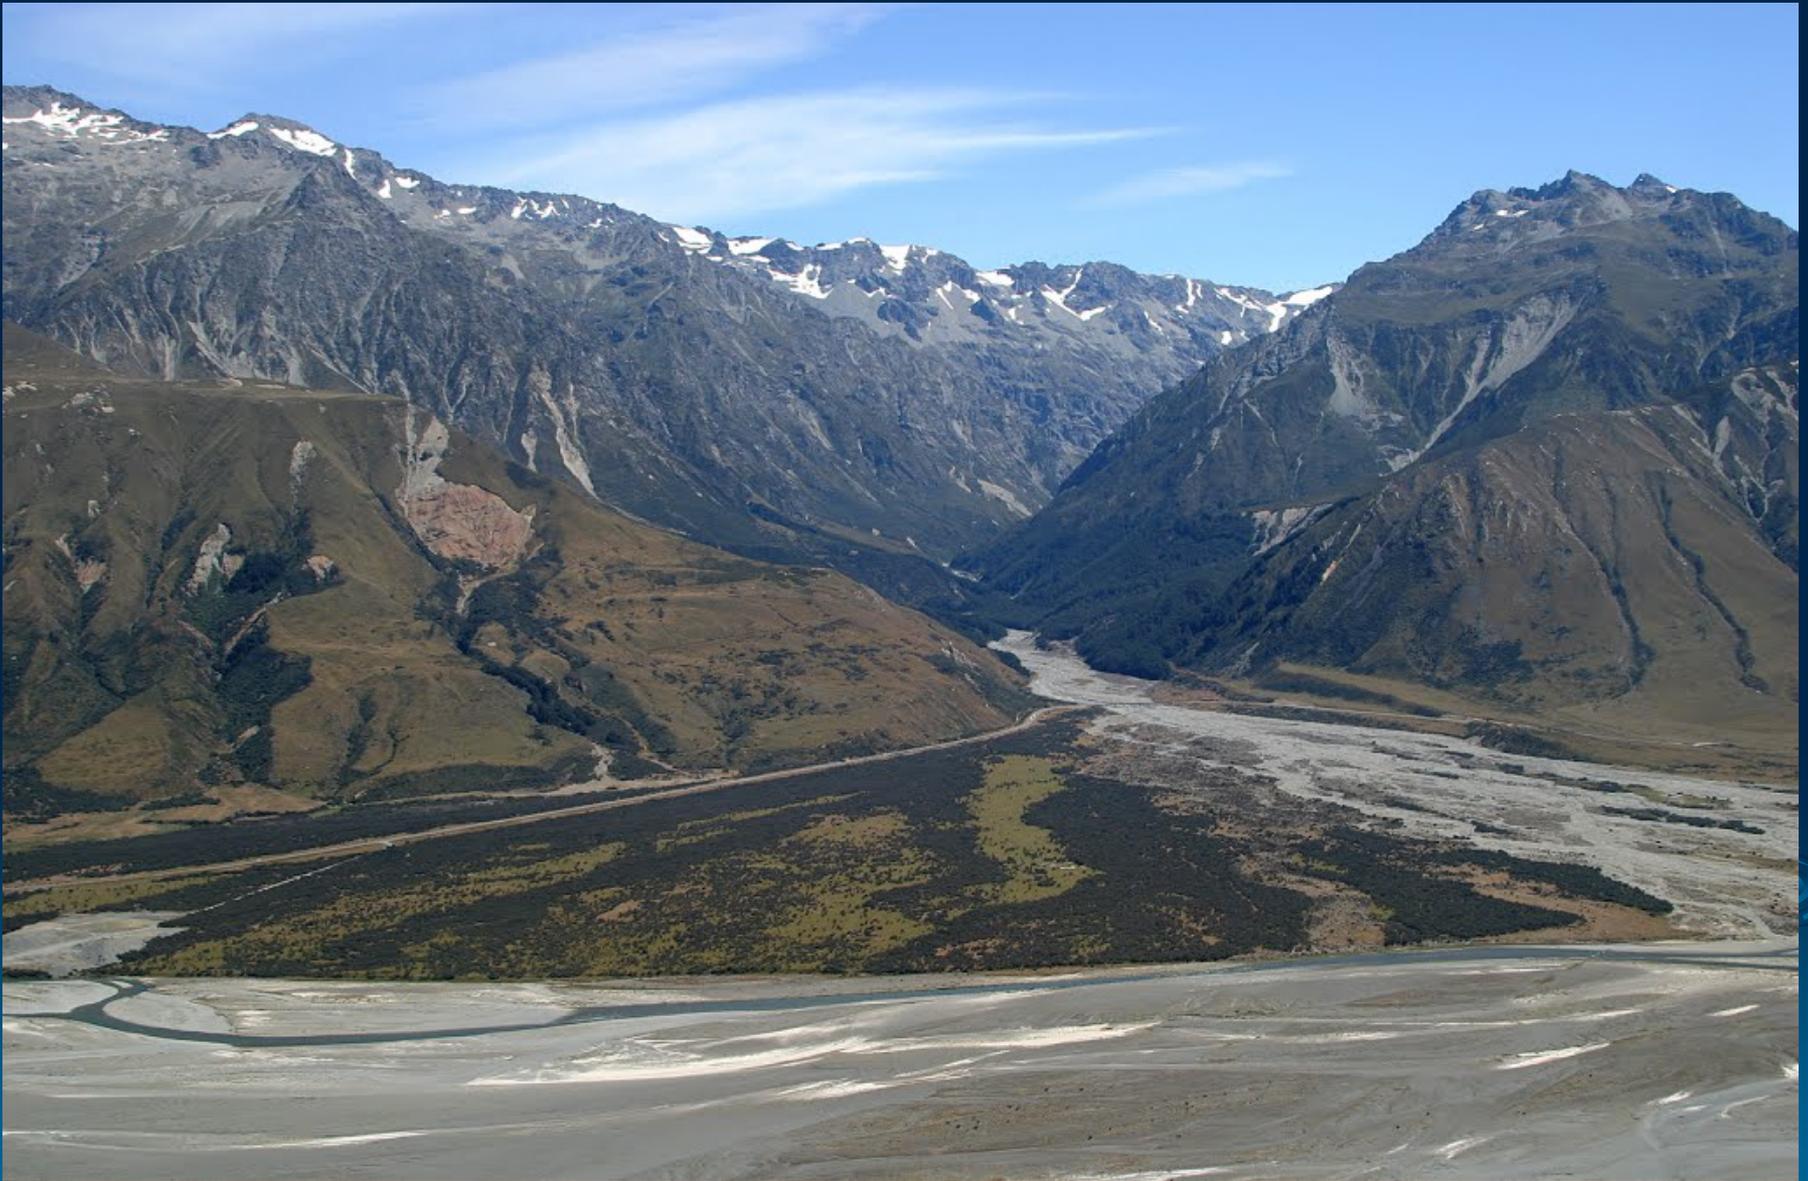
Tasman River, New Zealand

Typical Alluvial Fan

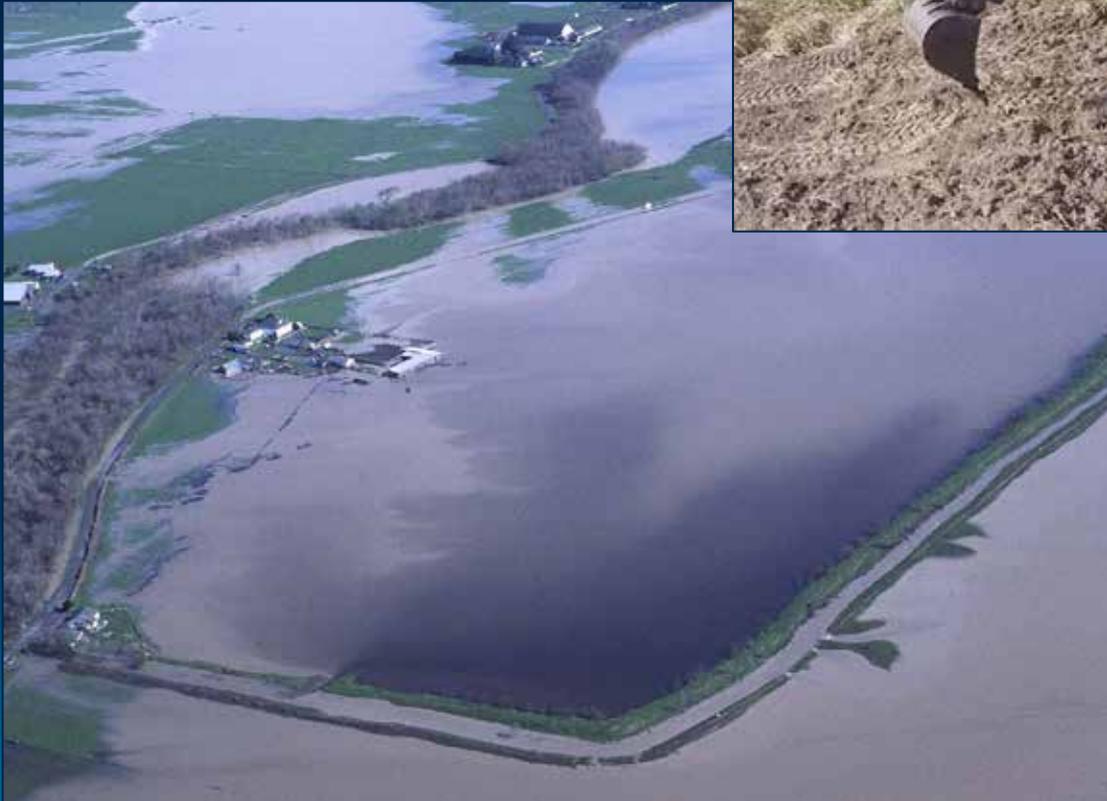
Rees Creek

Francis Creek Dredging to Move Depositional Lobe Further Out onto Alluvial Plain

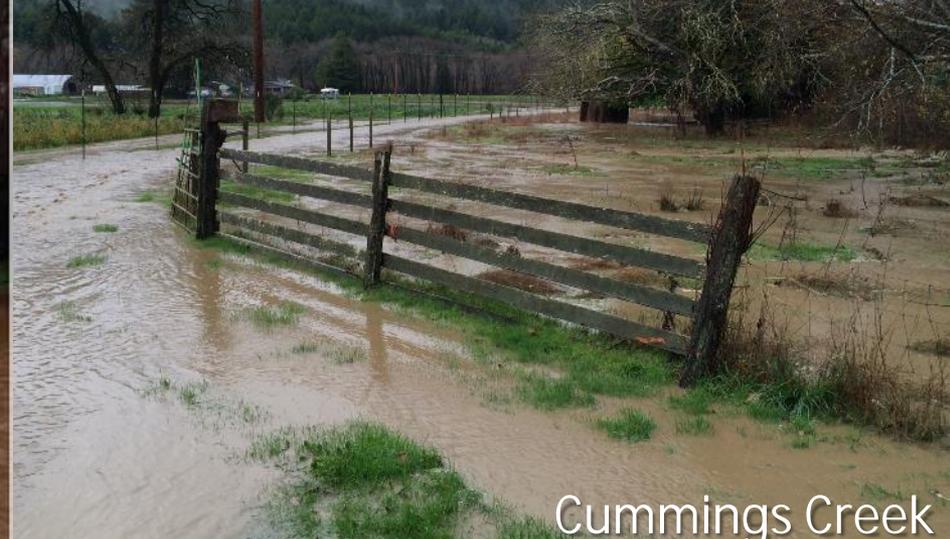
Cummings Creek

Channel Aggradation Leads to Berm Breaching

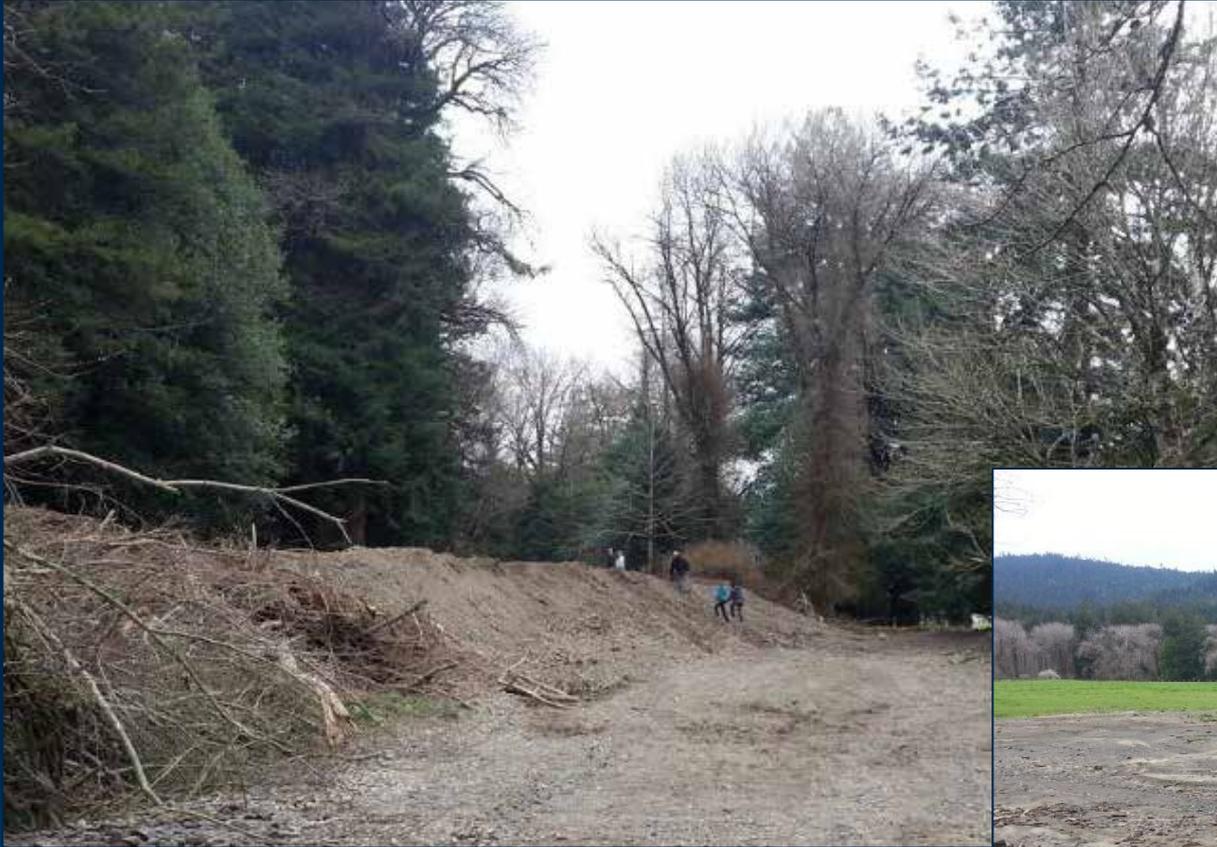
Cessation of "Channel Maintenance" Leads to Flooding/Avulsions

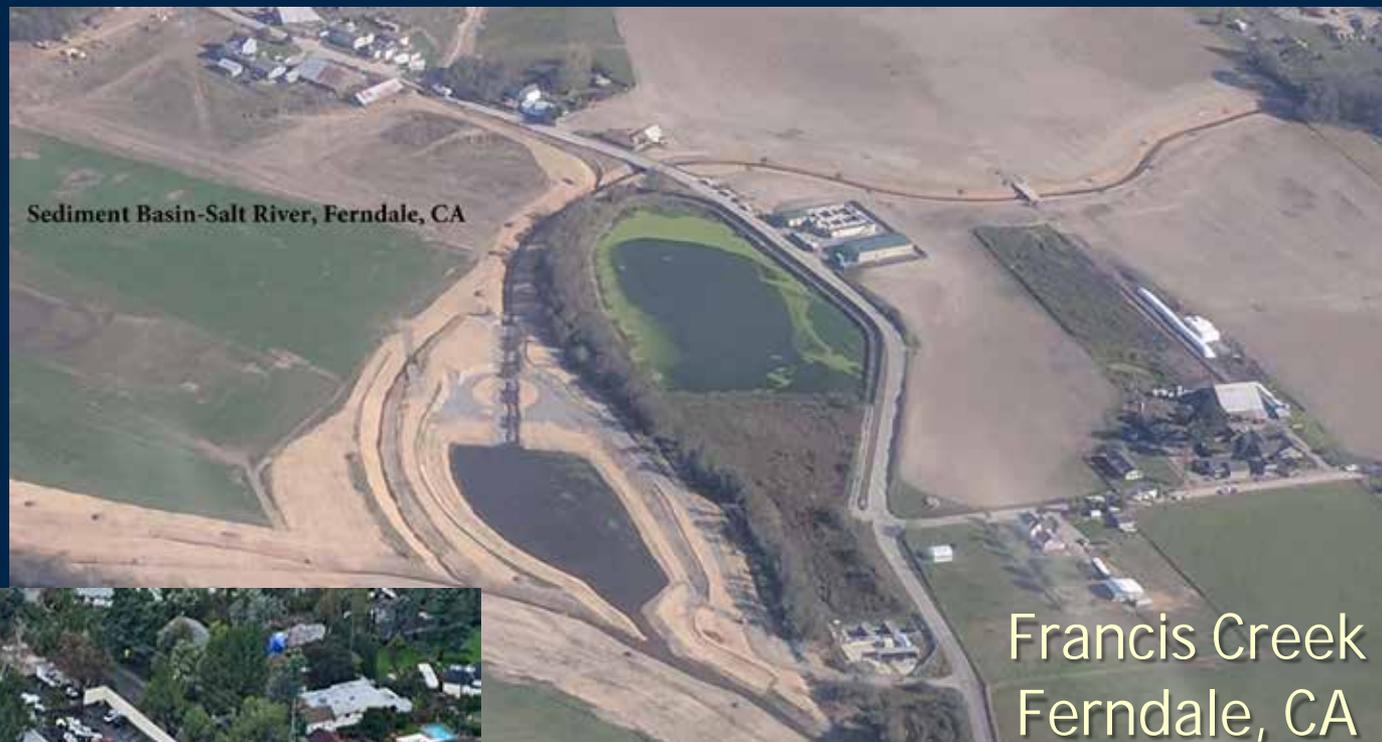
Sediment Basin-Salt River, Ferndale, CA

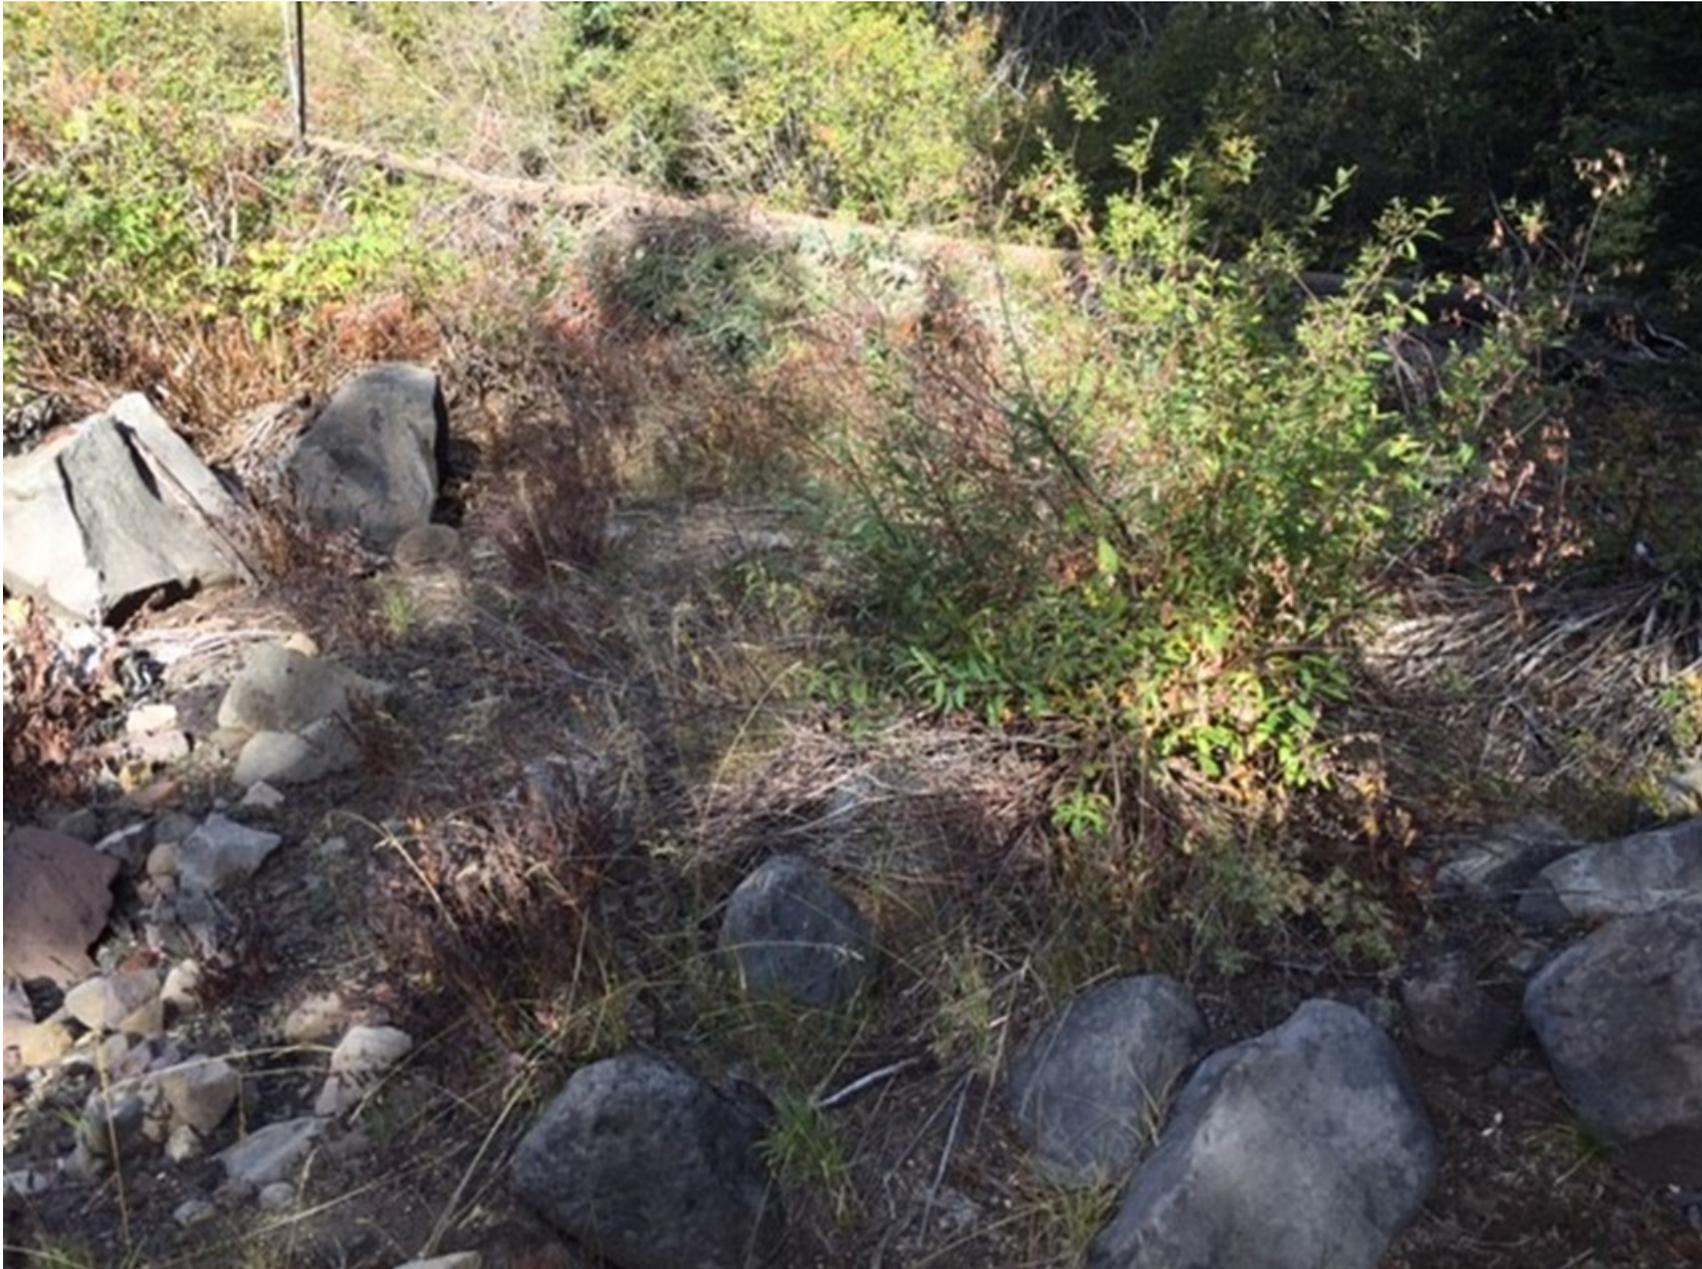
Separation berm blocking flow into relic channels

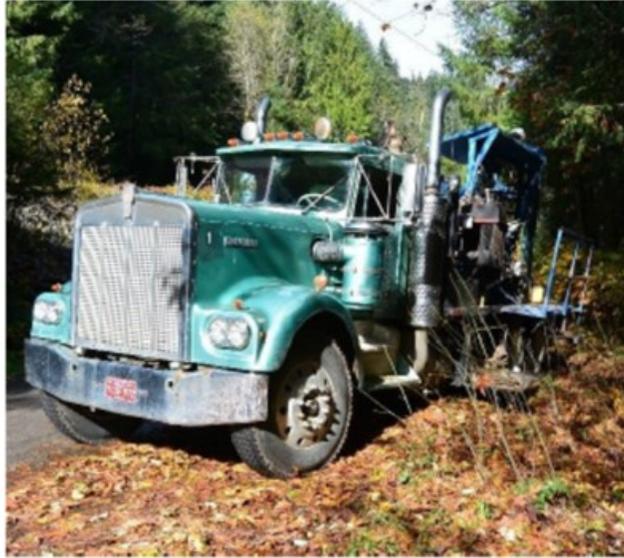
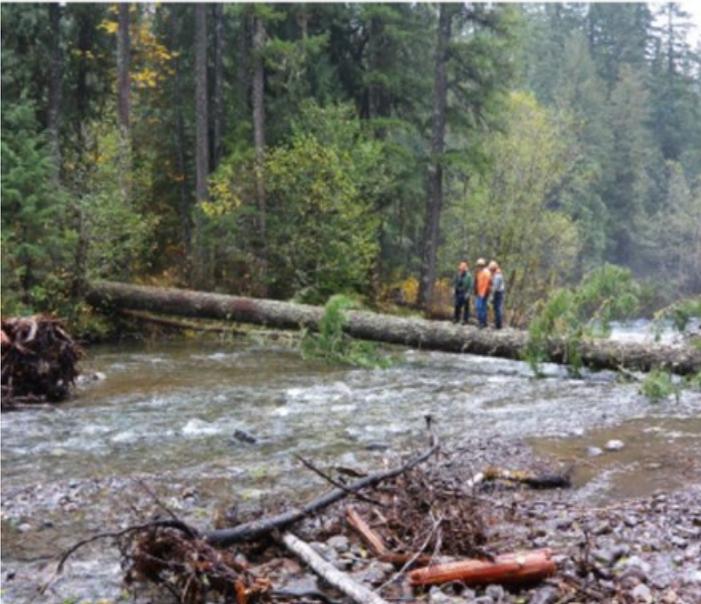
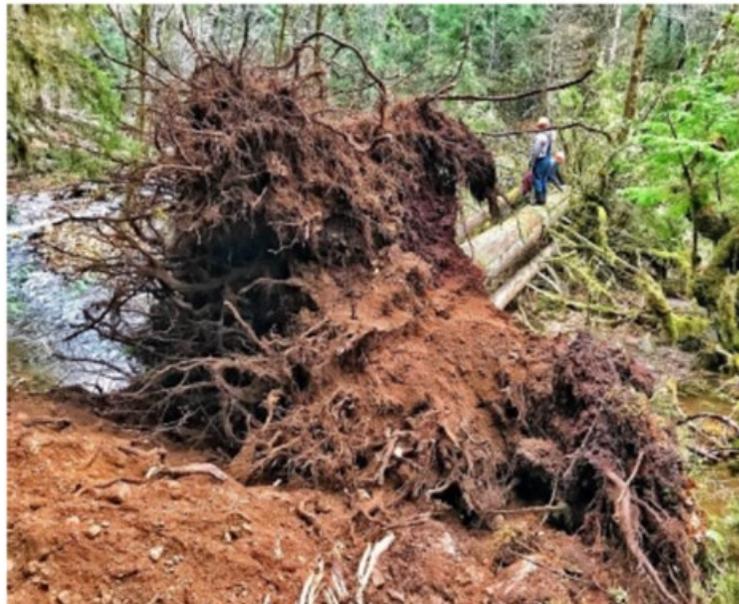
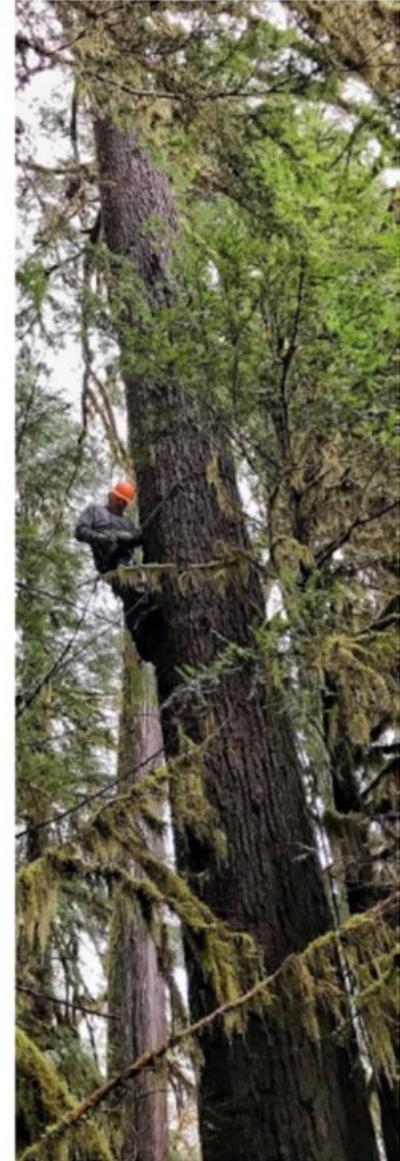
Implementation

- 25 streamside trees (38-63" dbh) were pulled over using a truck-mounted yarder to serve as large, stable key pieces

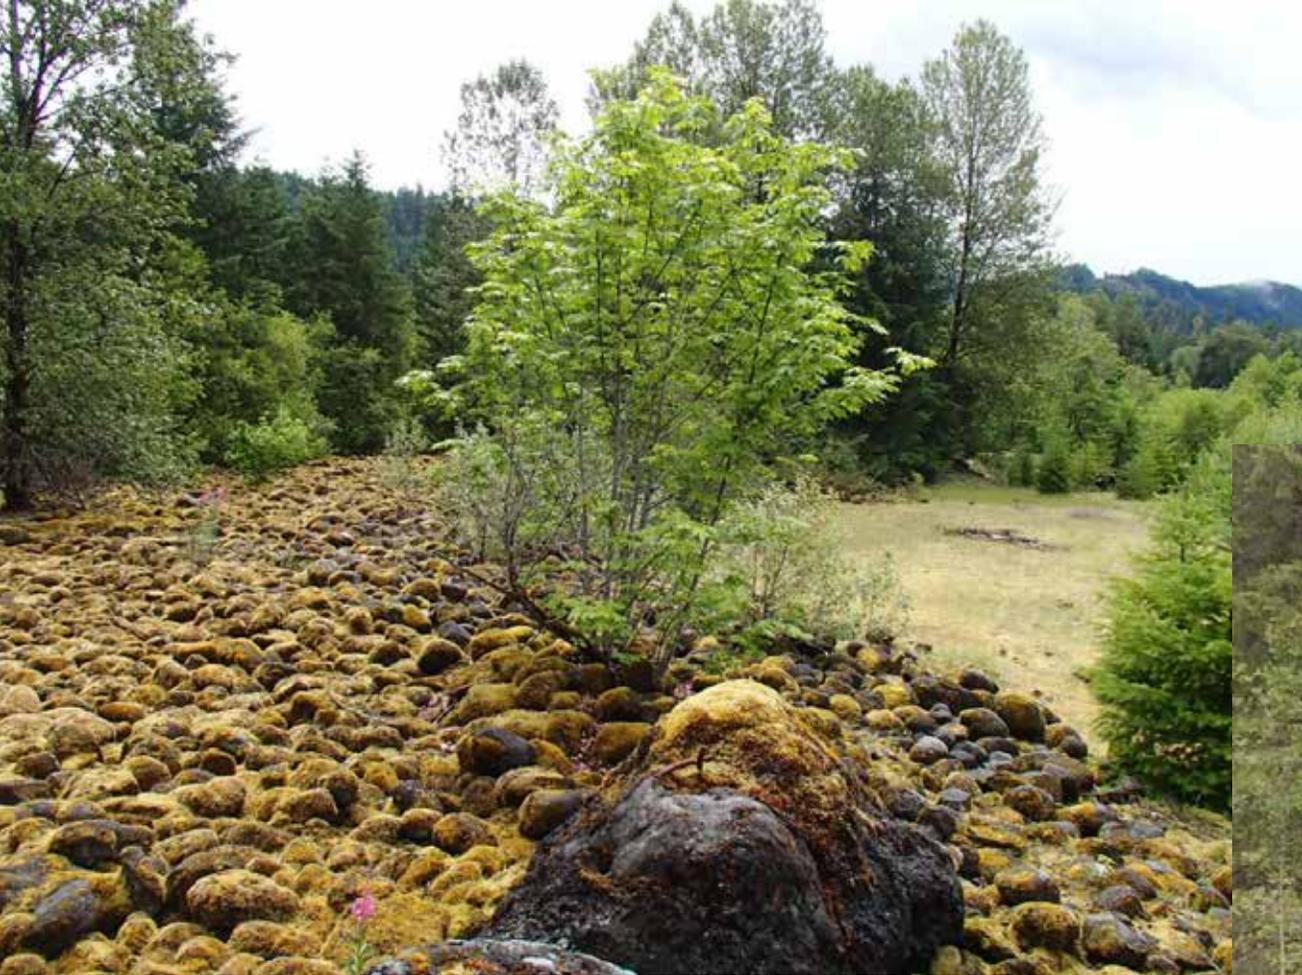
McKenzie River

Flow

Project Area = 600 acres

South Fork
McKenzie River

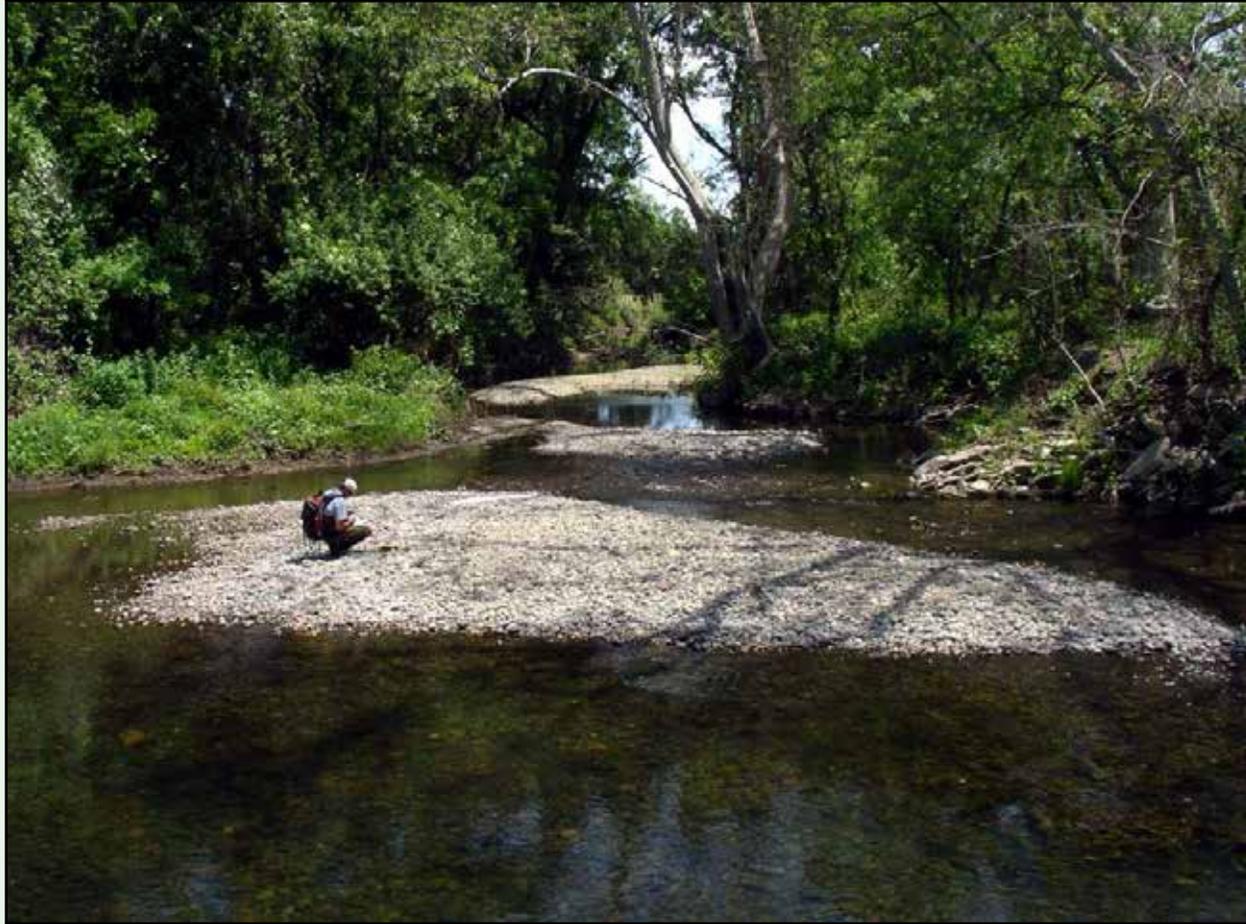
ANTELOPE CREEK-CRAIG CREEK DISTRIBUTARY JUNCTION

Modeled Inflows and Outflows

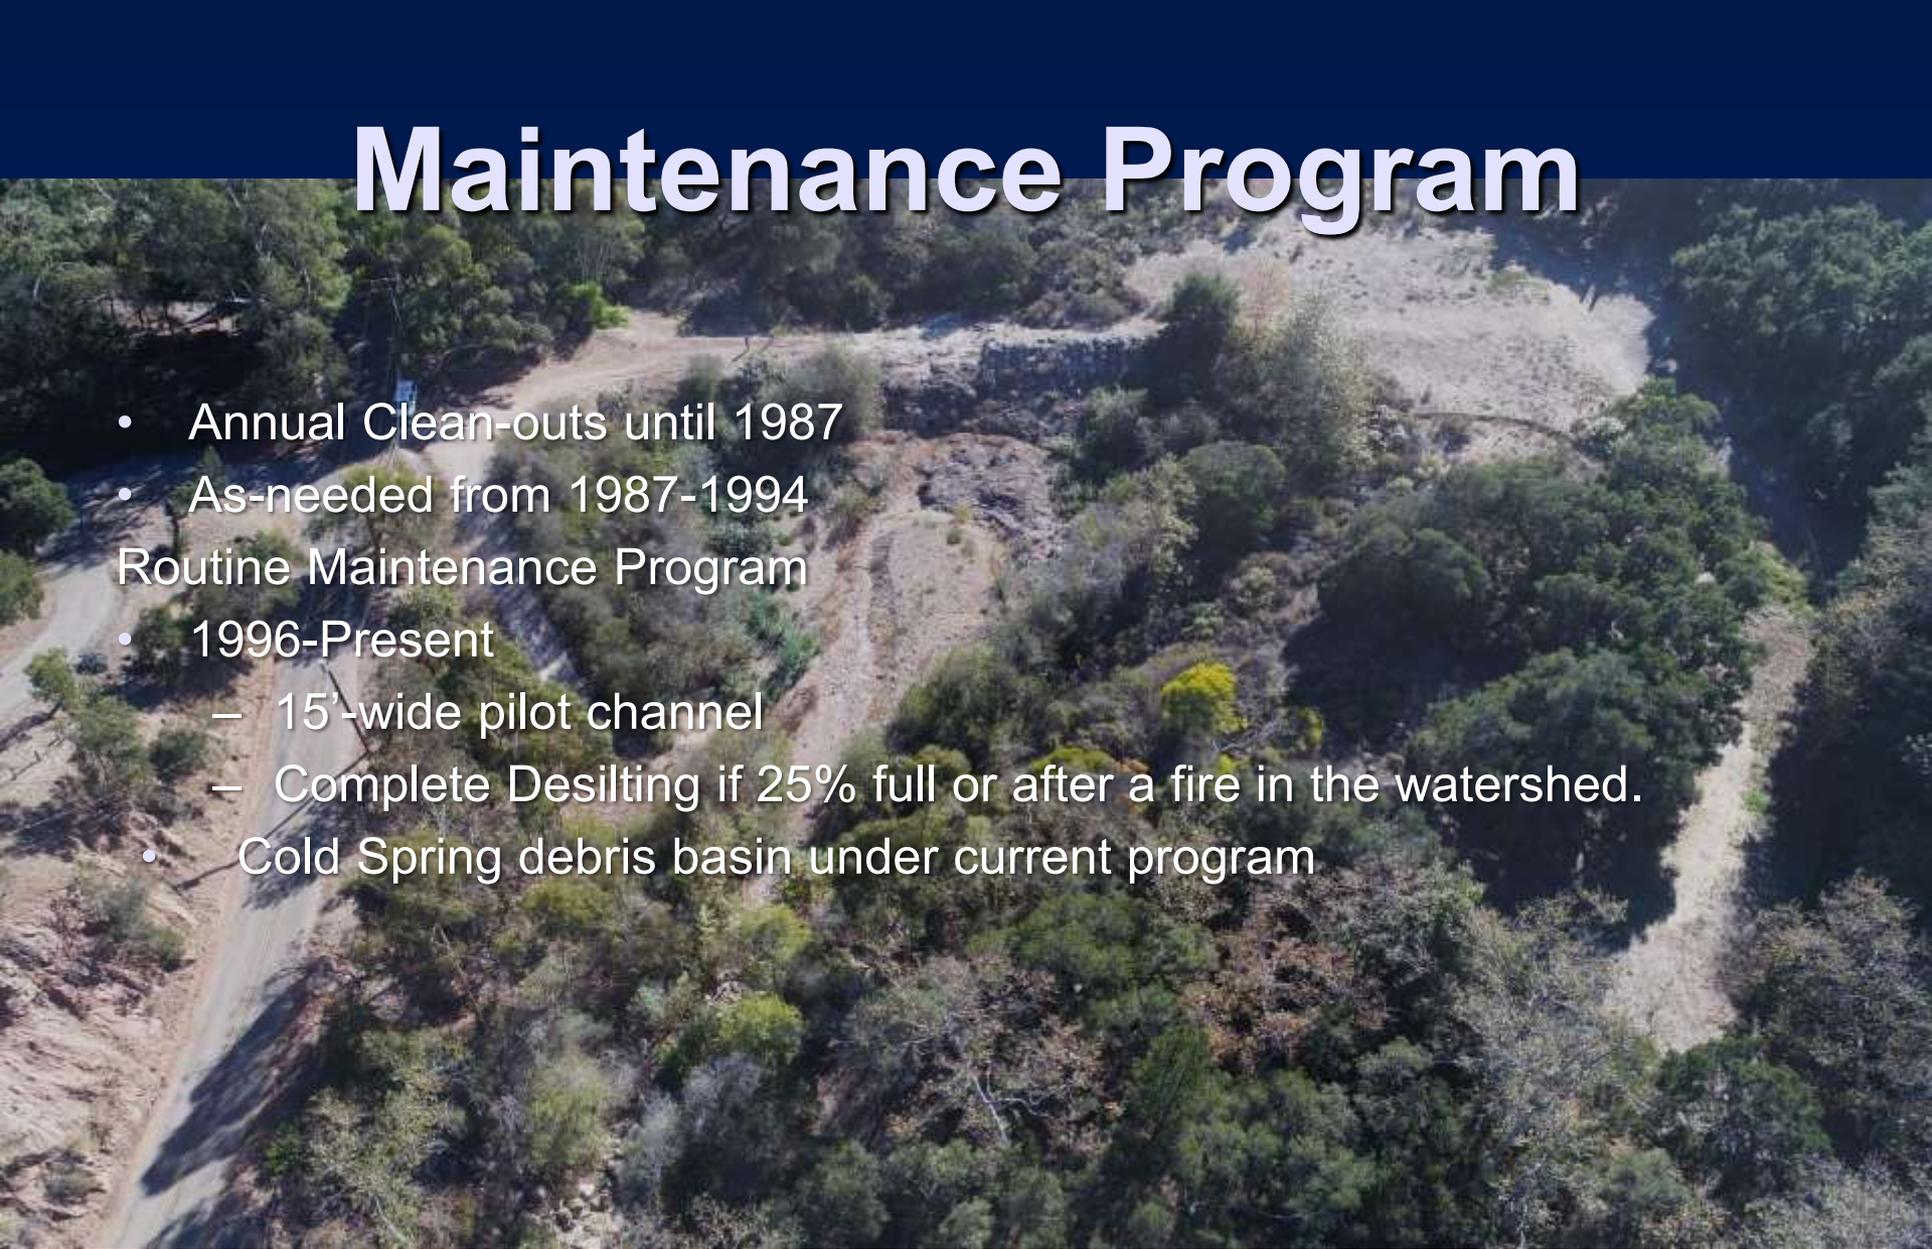
- Annual Clean-outs until 1987
- As-needed from 1987-1994
- Routine Maintenance Program
- 1996-Present
 - 15'-wide pilot channel
 - Complete Desilting if 25% full or after a fire in the watershed.
- Cold Spring debris basin under current program

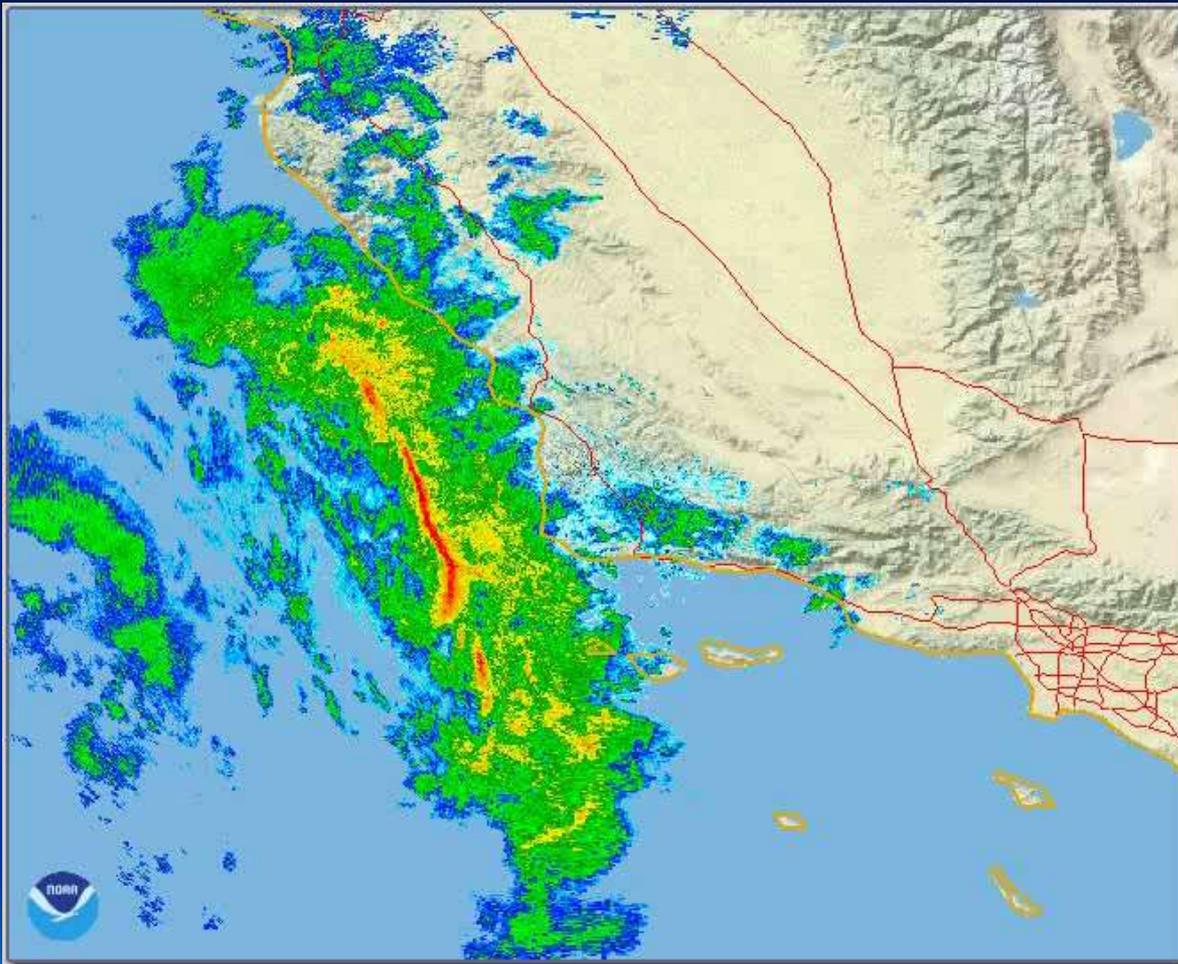
NEXRAD LEVEL-II
KV BX - VANDENBERG AFB, CA
01/09/2018 08:03:18 GMT
LAT: 34/50/17 N
LON: 120/23/44 W
ELEV: 1233 FT
VCP: 12

REFLECTIVITY
ELEV ANGLE: 0.46
SWEEP TIME: 08:03:21 GMT

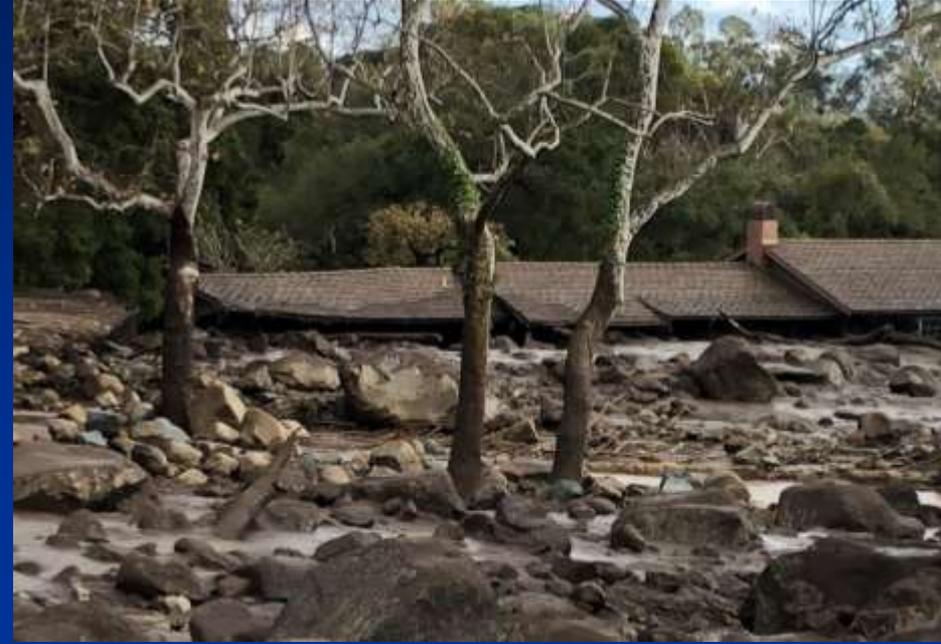
Past vs Present

- Completely filled with boulders/etc
- Debris volume and speed was reduced
- Max capacity was contained
- Overwhelmed and spilled downstream

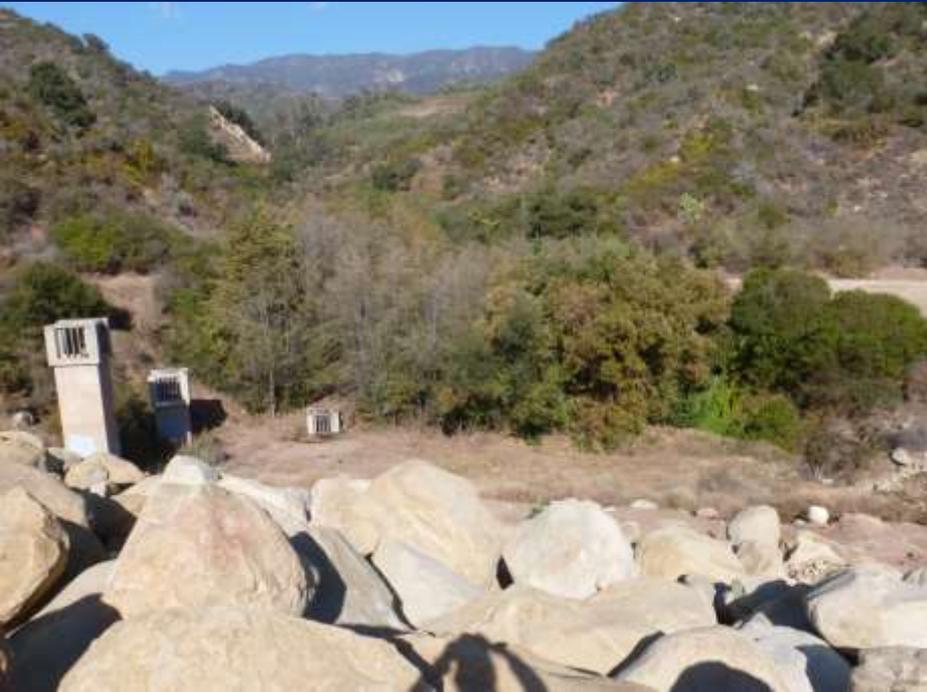
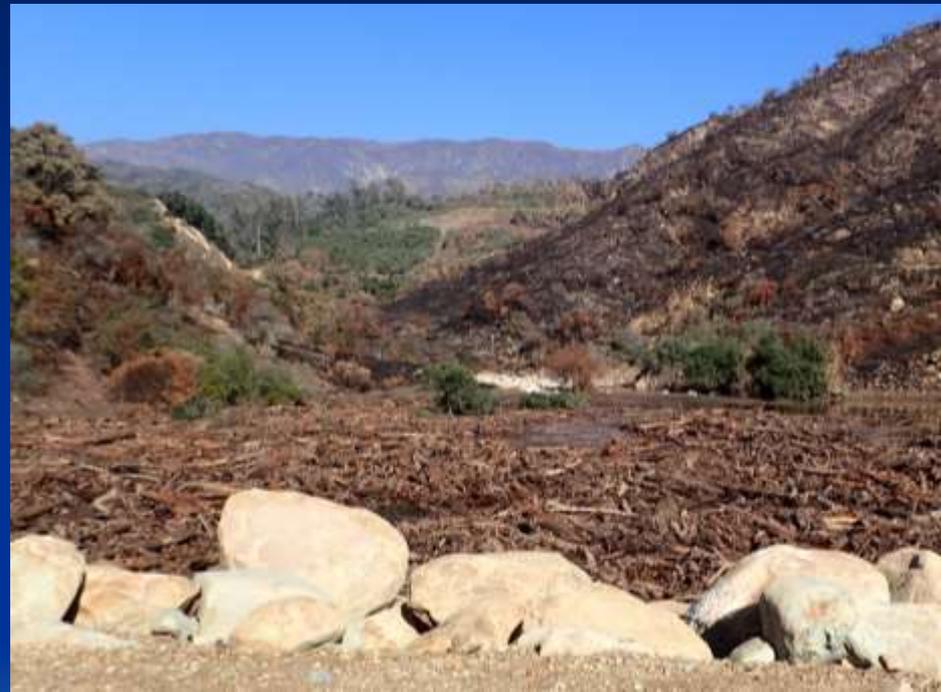
Santa Monica Basin

Earlier this month, above, the Santa Monica Debris Basin in Carpinteria still held a large quantity of boulders and other materials brought down from the Thomas Fire burn area for a strong storm on Jan. 9. County officials hope to have it completely cleared by March 15. (Tom Fayram photo)

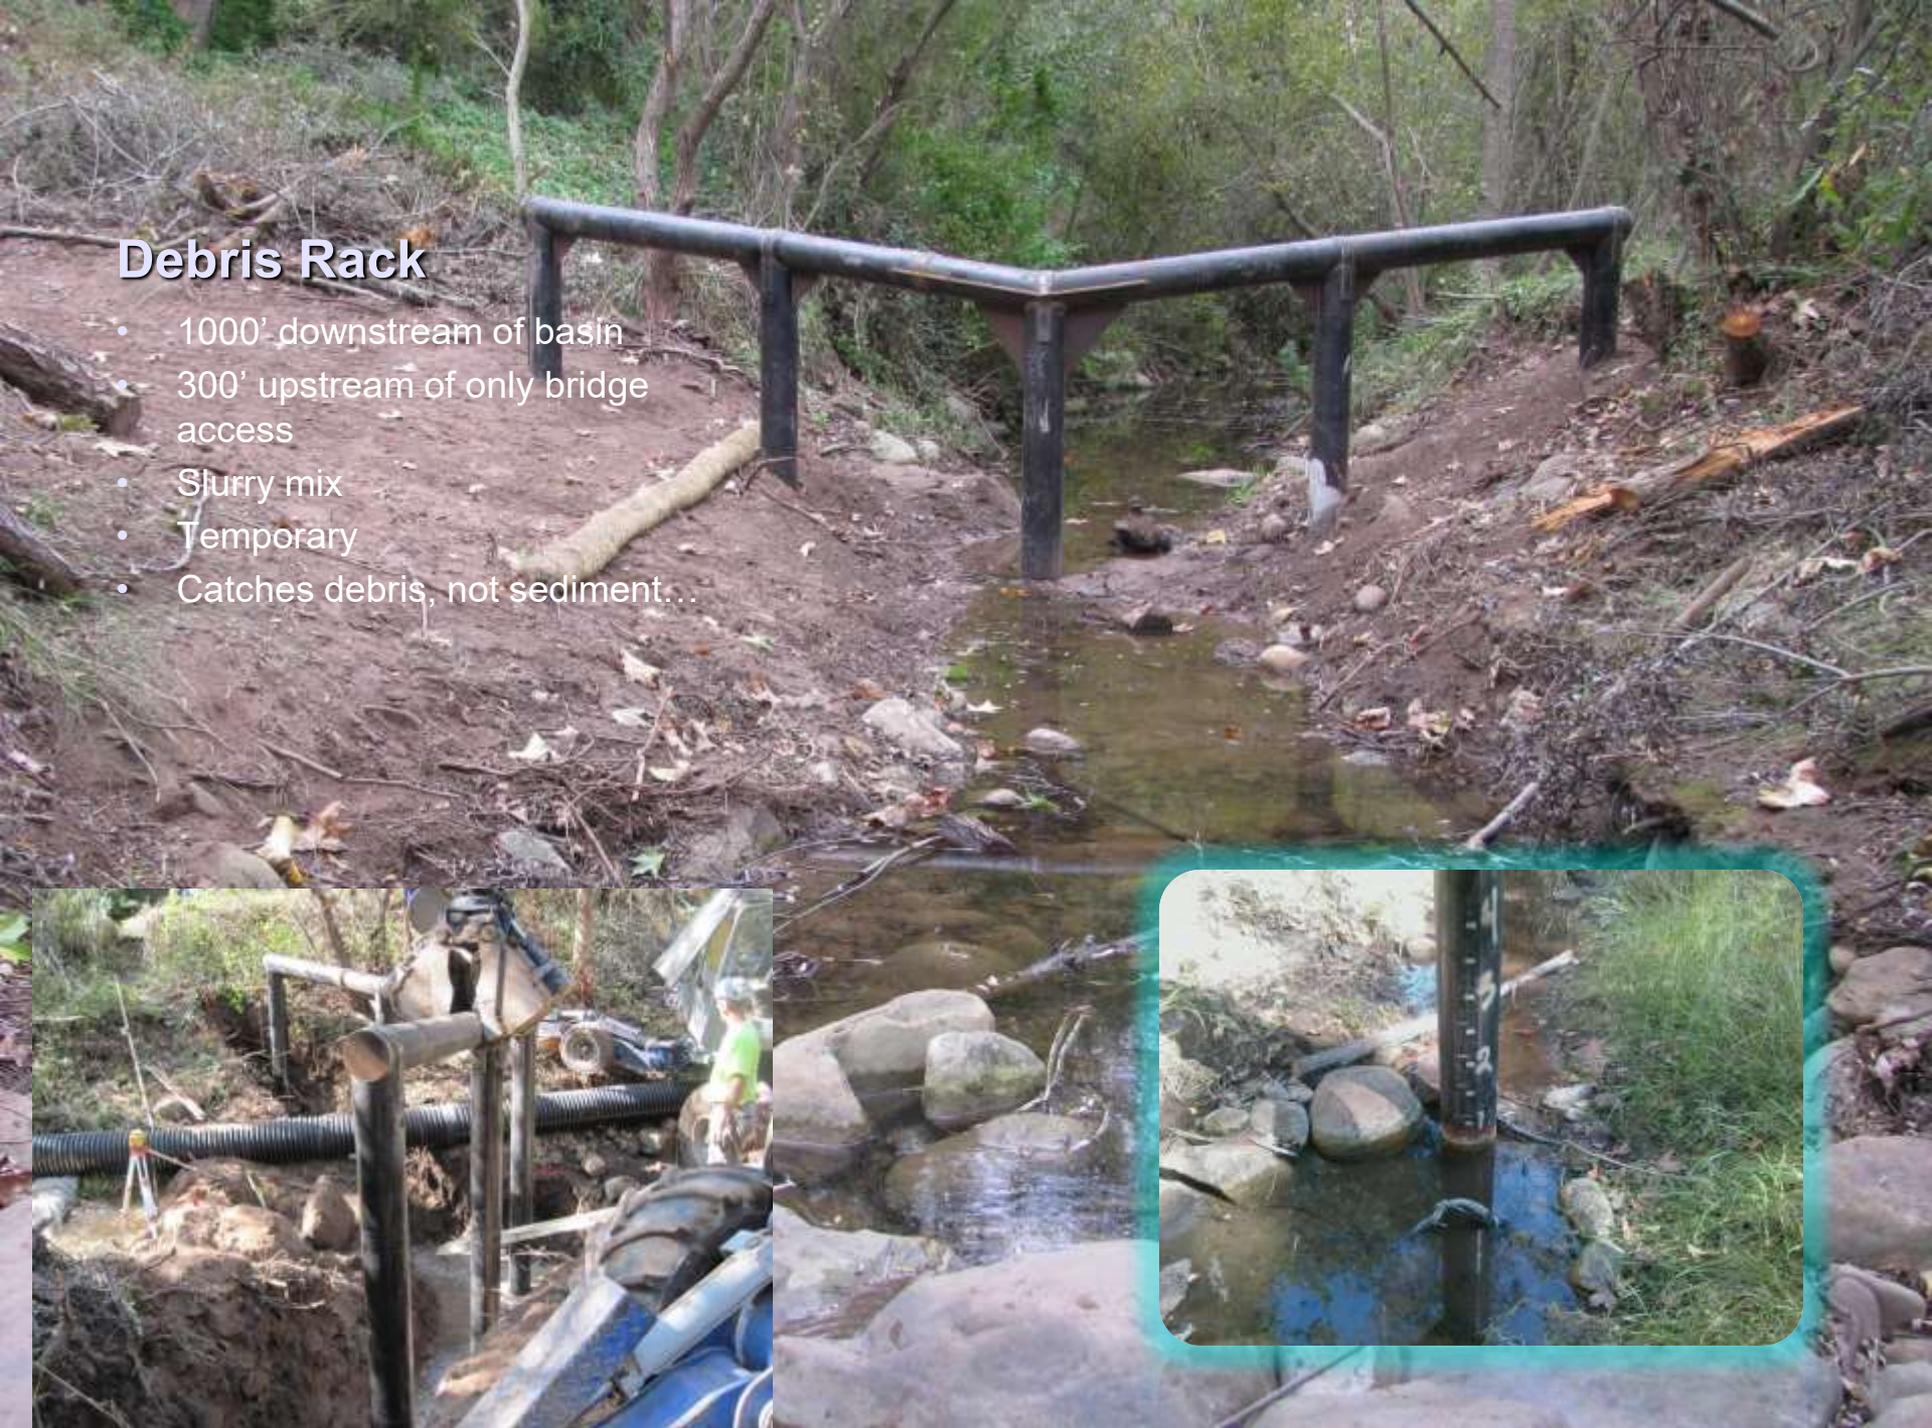
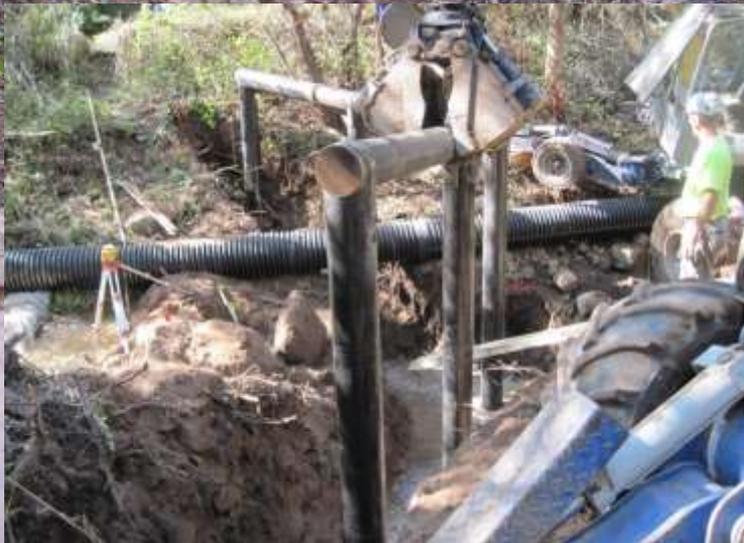
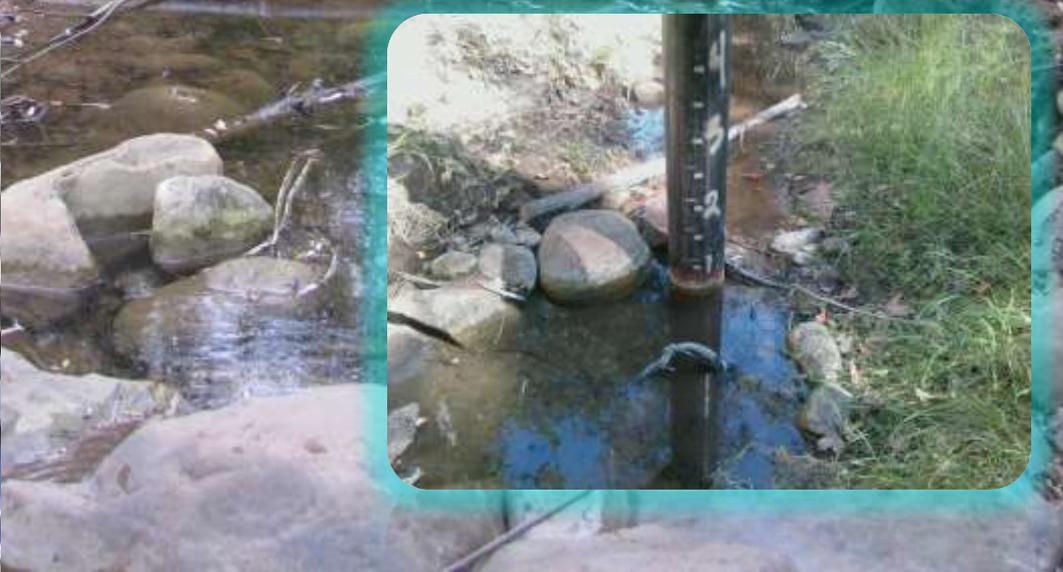
Debris Rack

- 1000' downstream of basin
- 300' upstream of only bridge access
- Slurry mix
- Temporary
- Catches debris, not sediment...

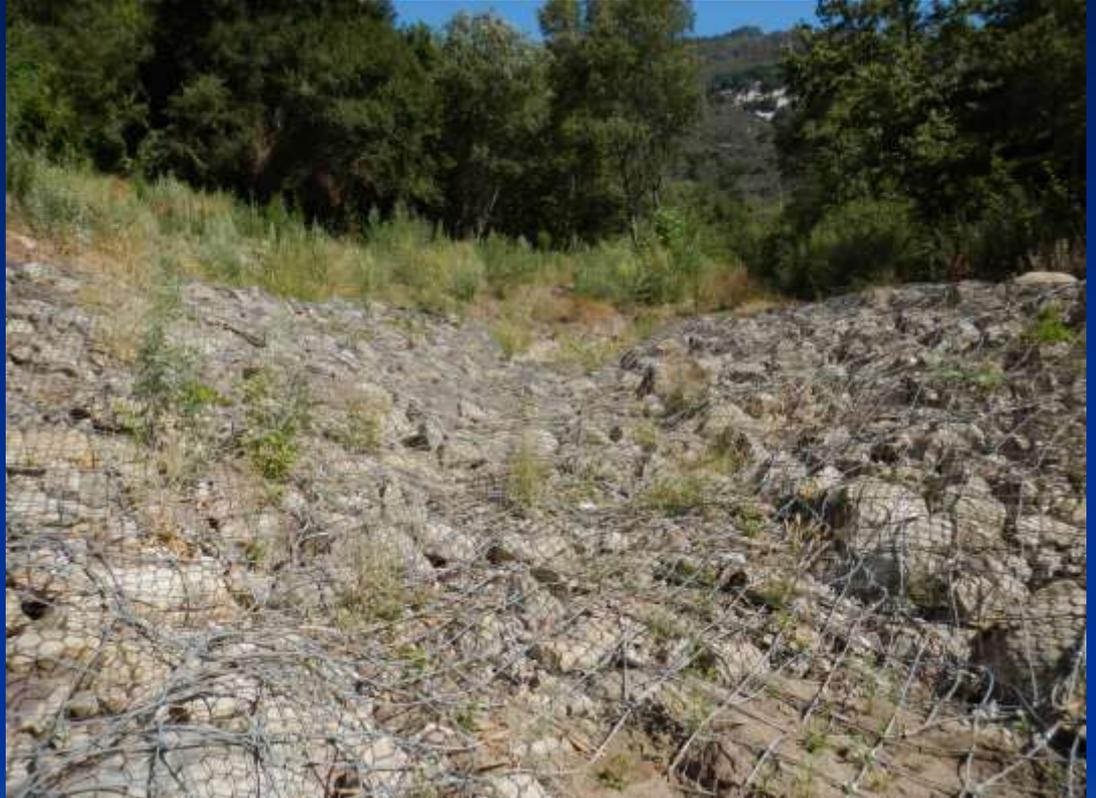
Phase 2

- New thought process
 - <1cy sediment moved year 1
 - Lets move some dirt!!
- D/S pool remains
 - Fish/turtles
- No overland flow upstream
 - No dewatering!
- Regulatory agencies wanted wire mesh covered in fear of animals/fish getting caught
