Alluvial Fans and Salmonid Habitat: The Forgotten and Challenging Landscape In-Between

A Concurrent Session at the 36th Annual Salmonid Restoration Conference held in Fortuna, California from April 11 – 14, 2018.

The Benefits of Restoring Alluvial Fan Processes after a Century of Neglect

Alluvial Fan Construction in the Pacific Northwest

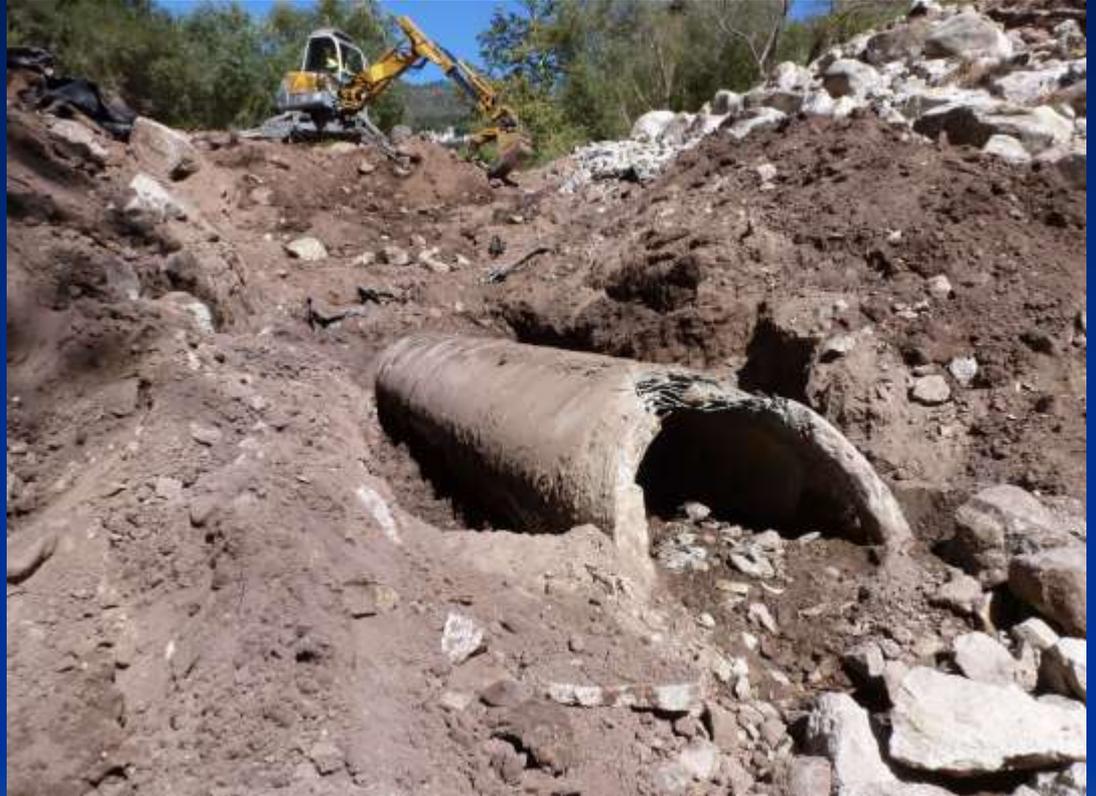
Phase 3 Objectives/Concerns

- Final Phase
 - Minimal movement previous phases
 - More sediment transport
 - Final channel would be to narrow
 - No further disturbance
 - Downstream pool full of sediment (tracked equipment access?)
 - No creek flow upstream (roughen channel...)

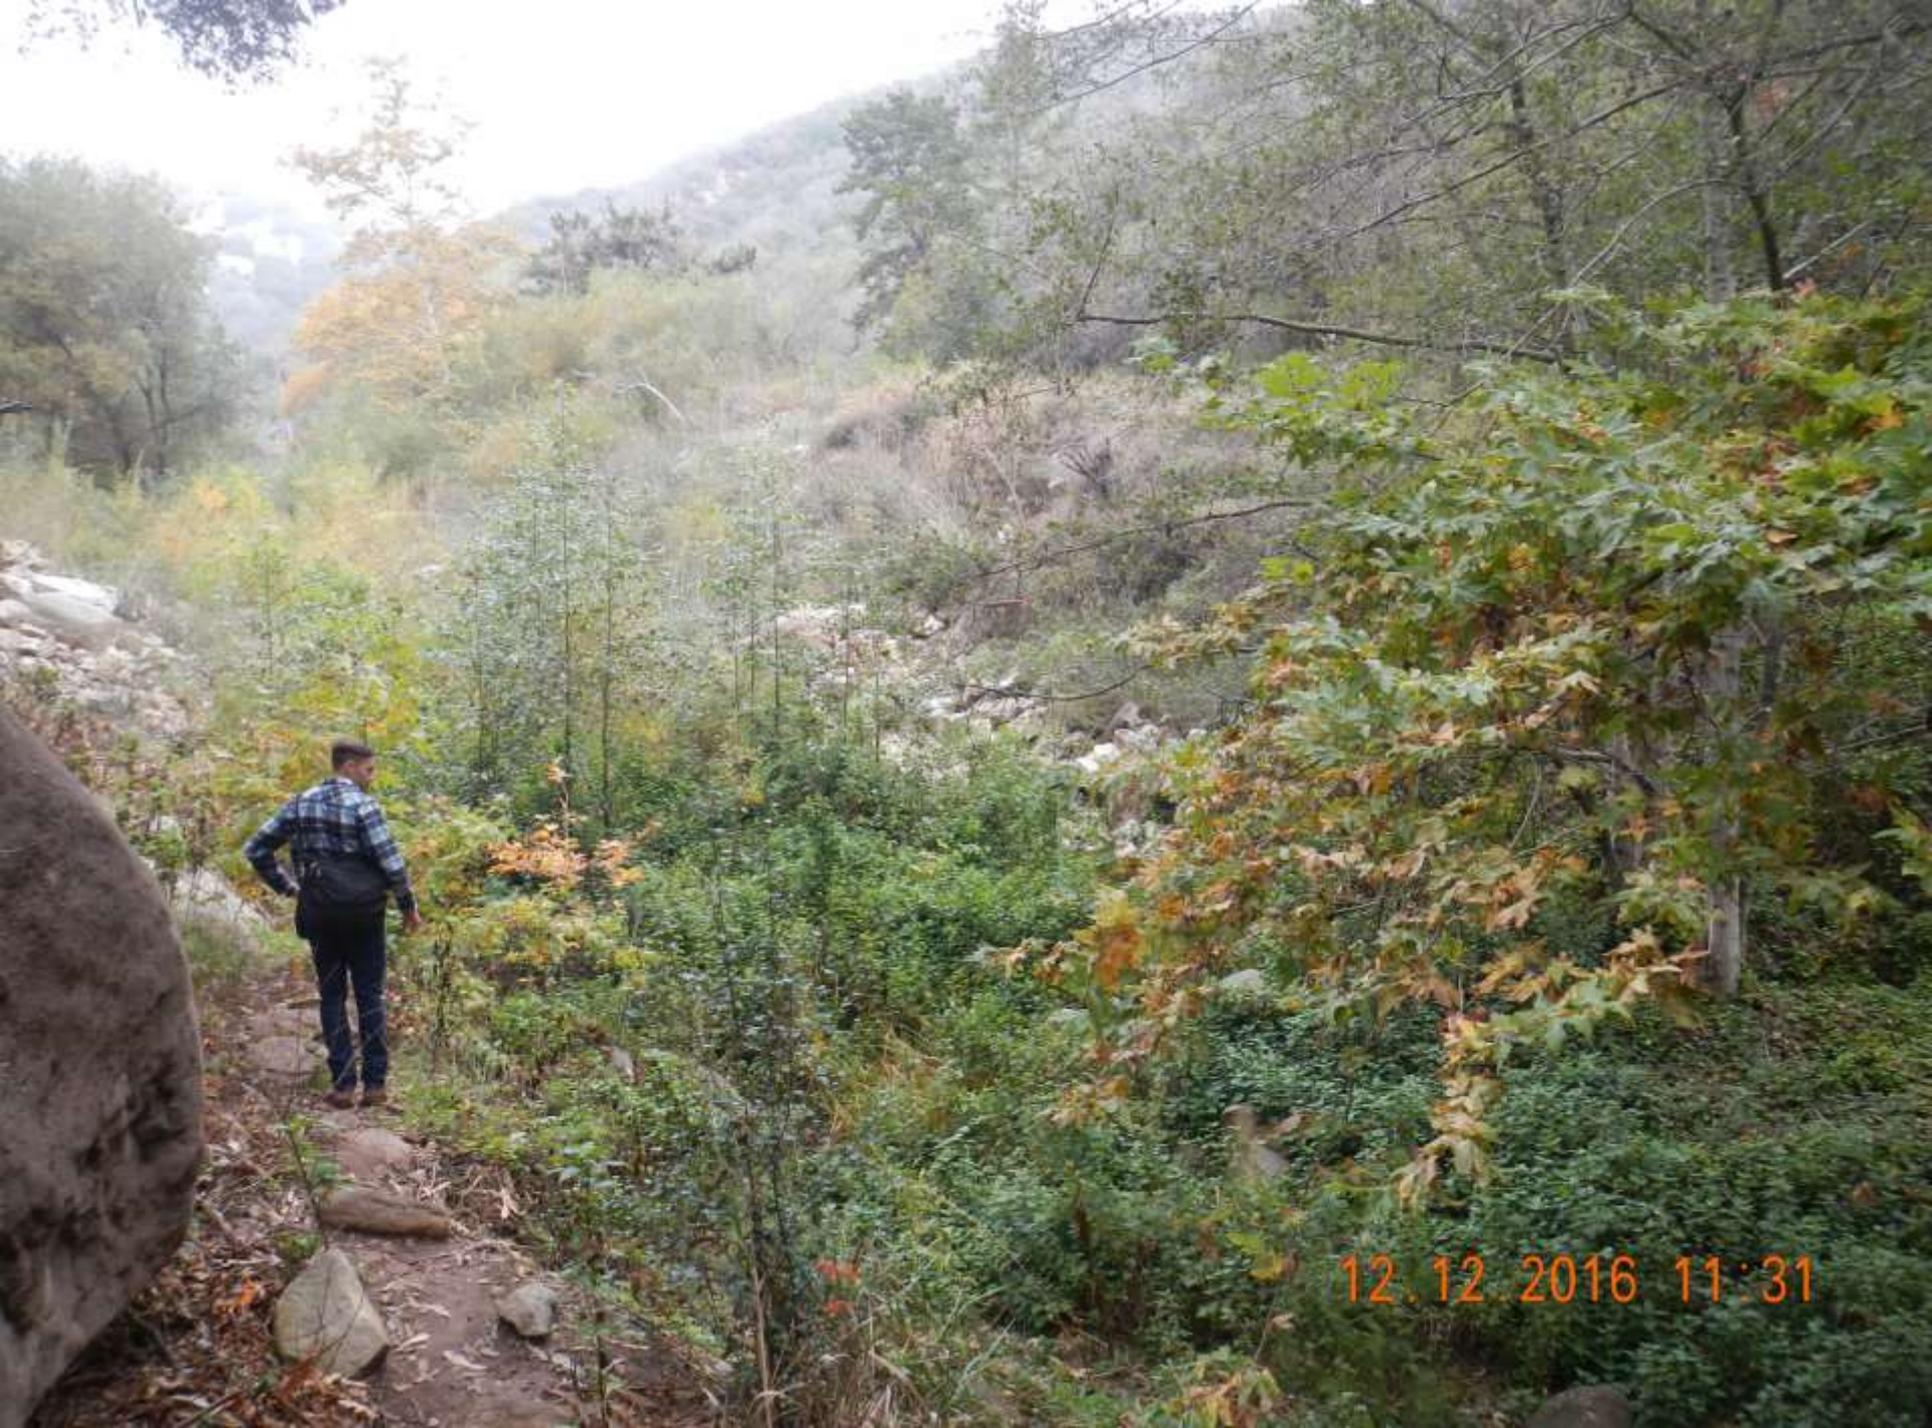
Project Complete

- Flanks broken up and left in place to protect steep slopes
- Rock placed throughout channel to establish new channel , slow and redirect flow
- 8% slope through site

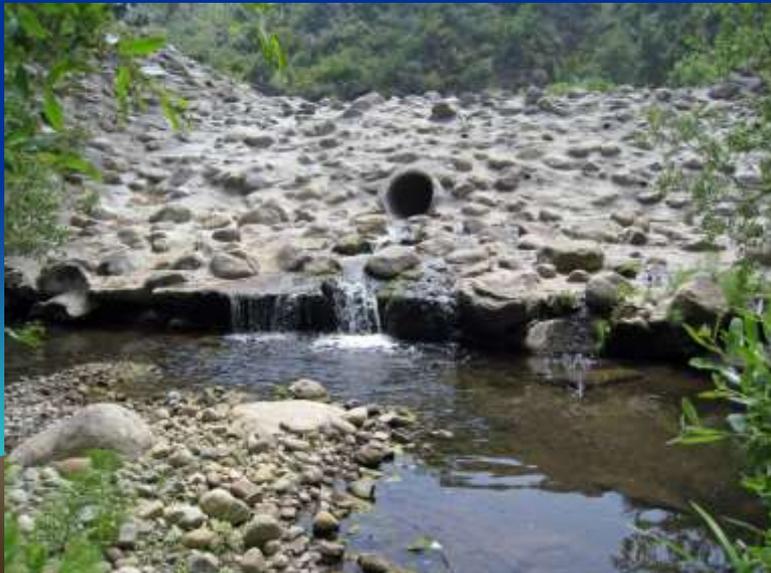
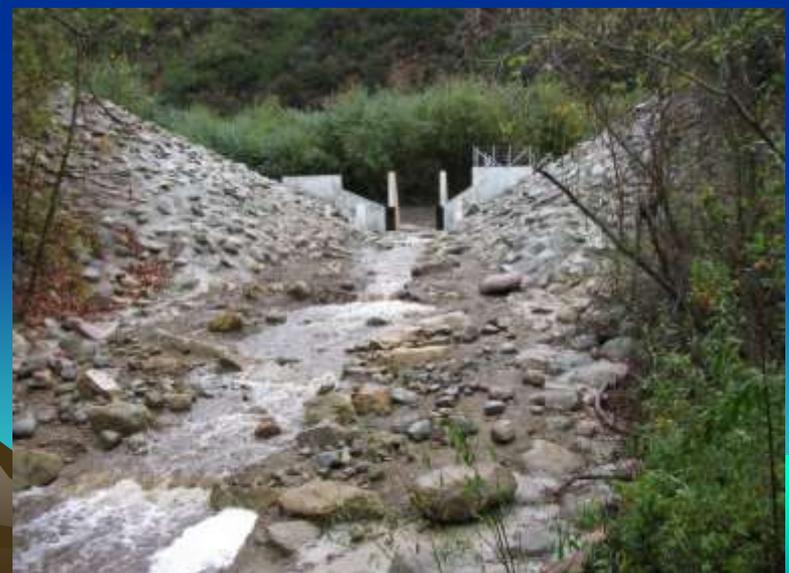
Gobernador Debris Basin

- District needed to maintain basin function while restoring fish passage and sediment transport
- Easy construction access, no sediment trapped in basin
- 3-3' deep resting pools with 1' max jump heights
- Embedded boulder structures with streambed material to maintain ~5% slope
- Longitudinal and transverse cutoff walls to ensure structure stability

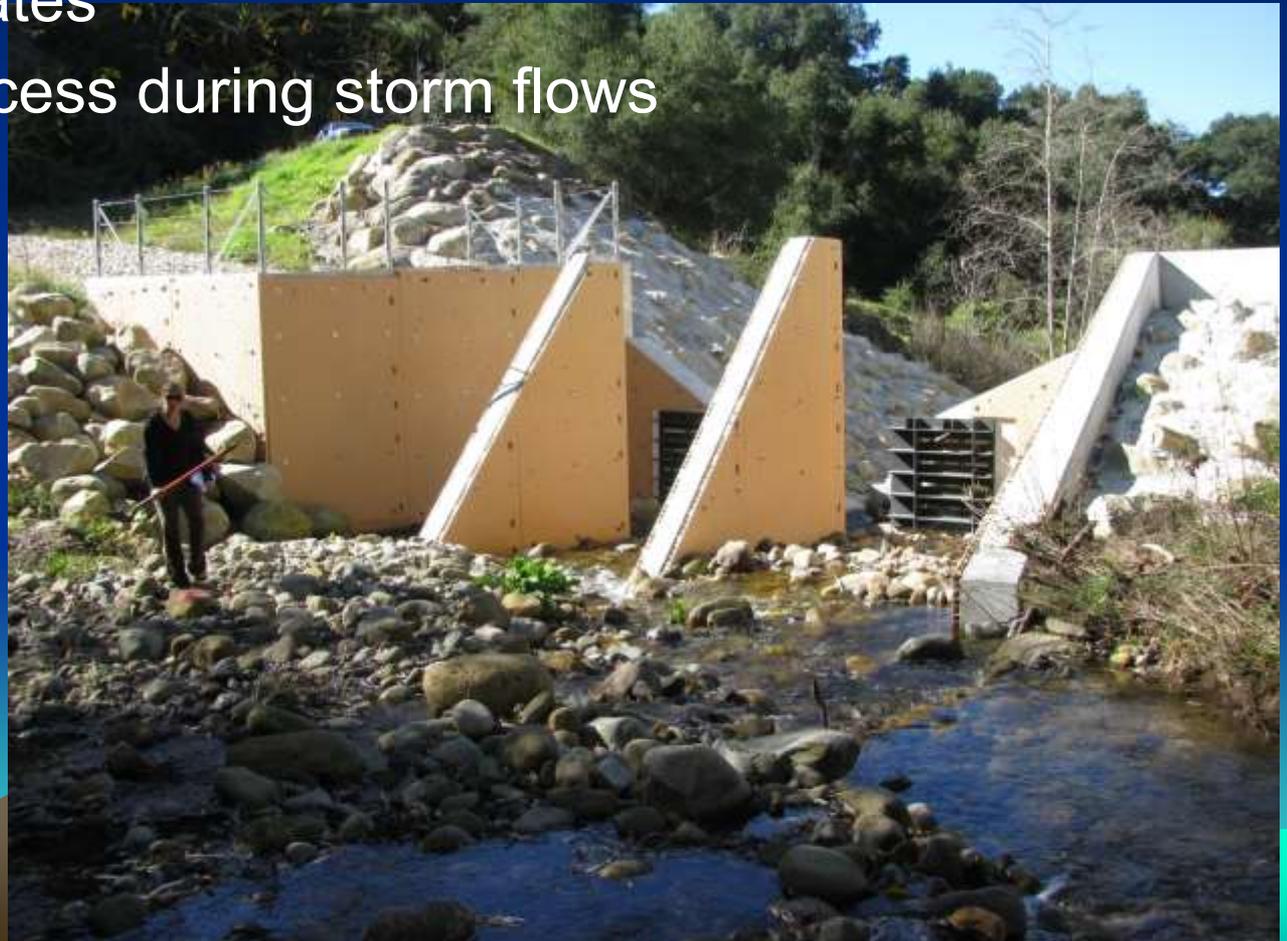
Inlet Structure

- Splitter walls to trap large debris
- Retractable gates
- Equipment access during storm flows

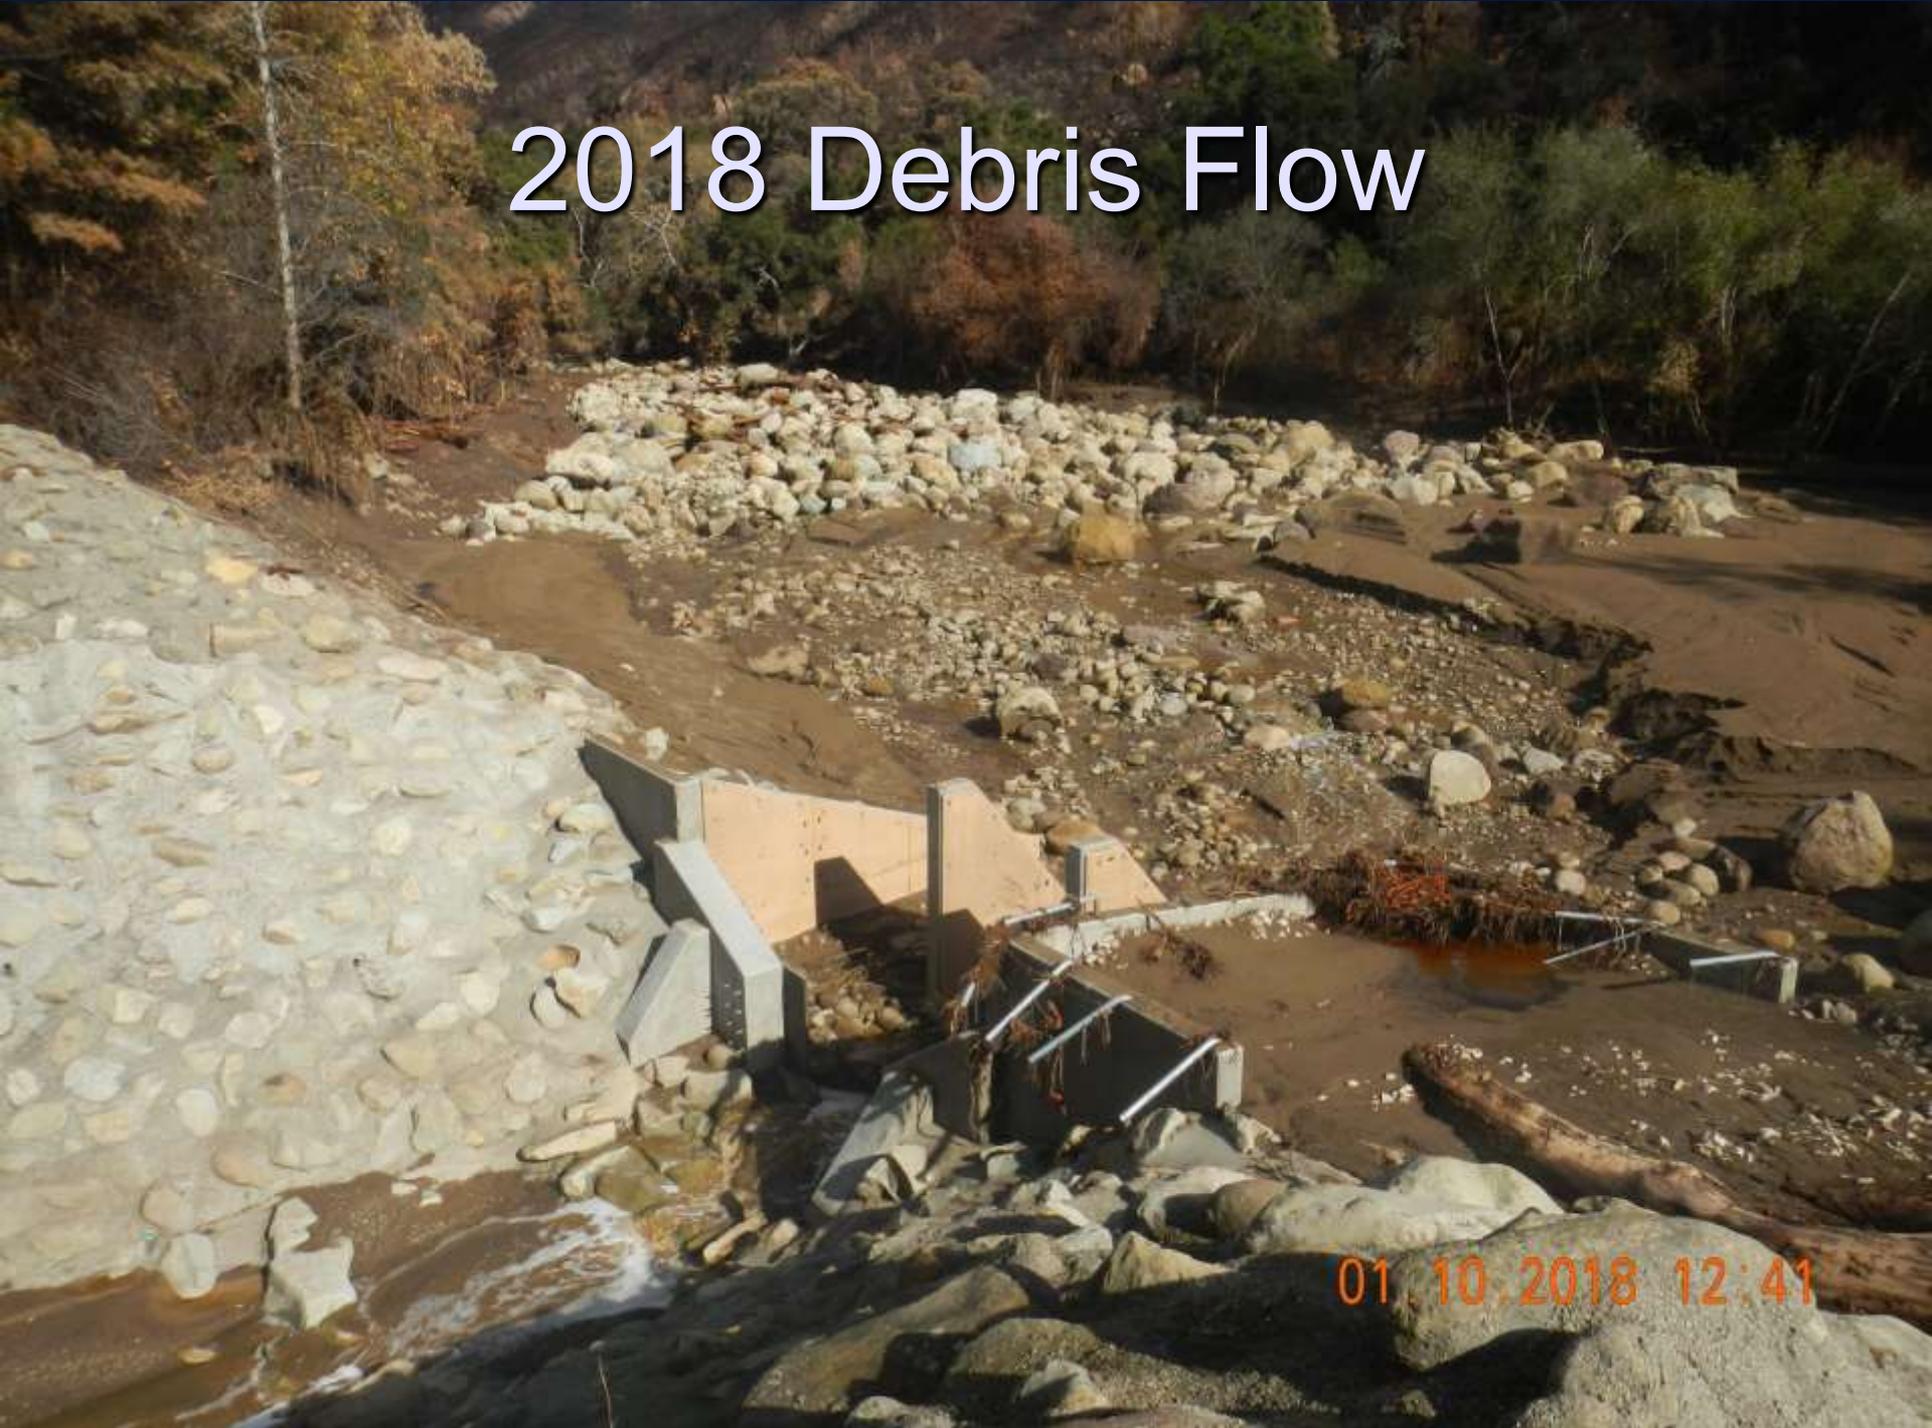
2018 Debris Flow

- Transverse cutoff wall visible
- Pools filled with sediment (typical of burned watershed)
- Overall good condition

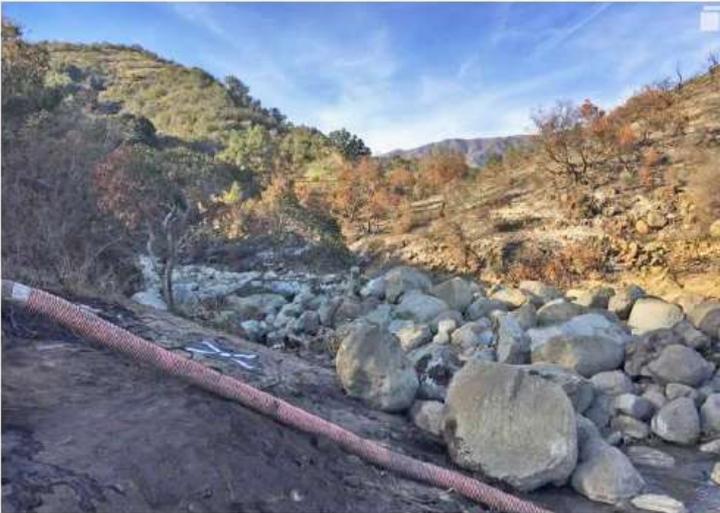
Earlier this month, above, the Santa Monica Debris Basin in Carpinteria still held a large quantity of boulders and other materials brought down from the Thomas Fire burn area for a strong storm on Jan. 9. County officials hope to have it completely cleared by March 15. (Tom Fayram photo)

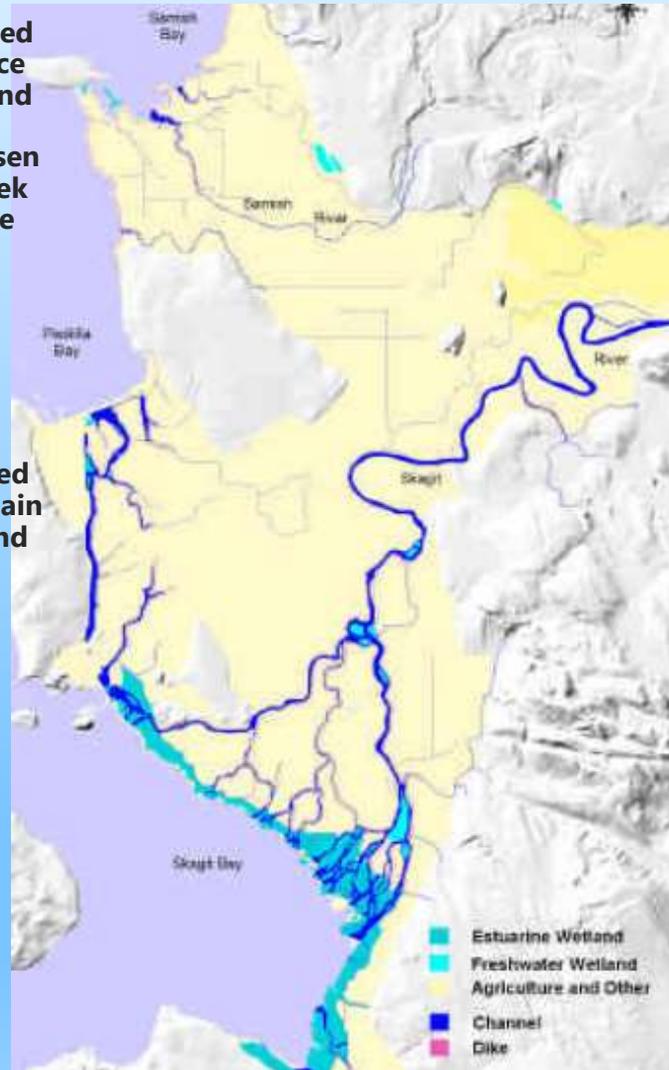
1945

17,730 Ha of Wetlands

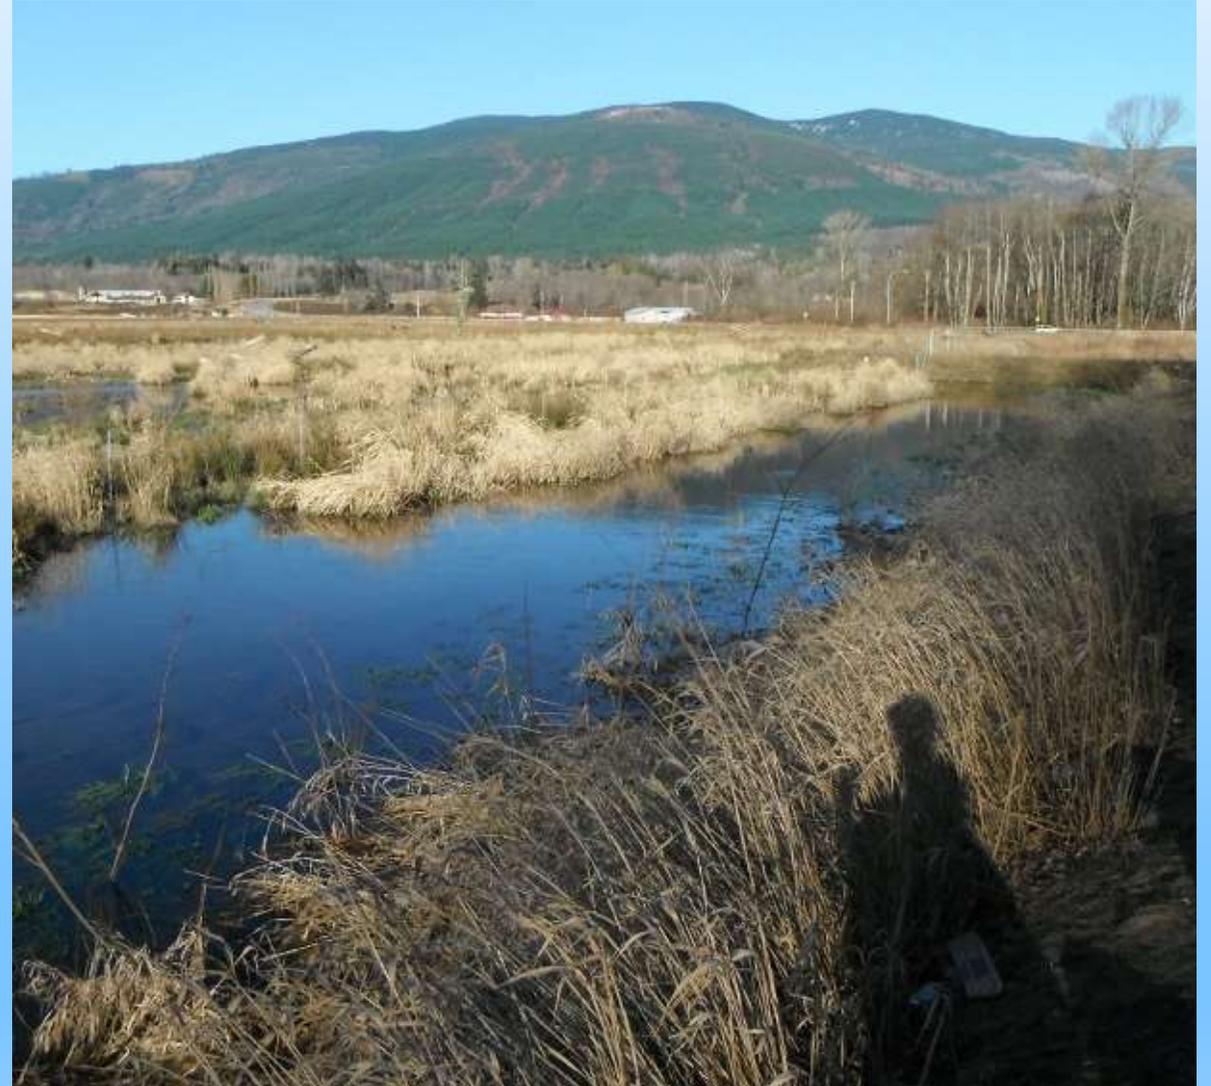
- Basin size = 20 km²
- Average Precipitation = 50 inches
- Relief = 4,000 feet
- Flood Flows:

Recurrence interval (years)	Flow (cfs)
100	698
50	644
25	578
10	495
5	413
2	314
1.25	256

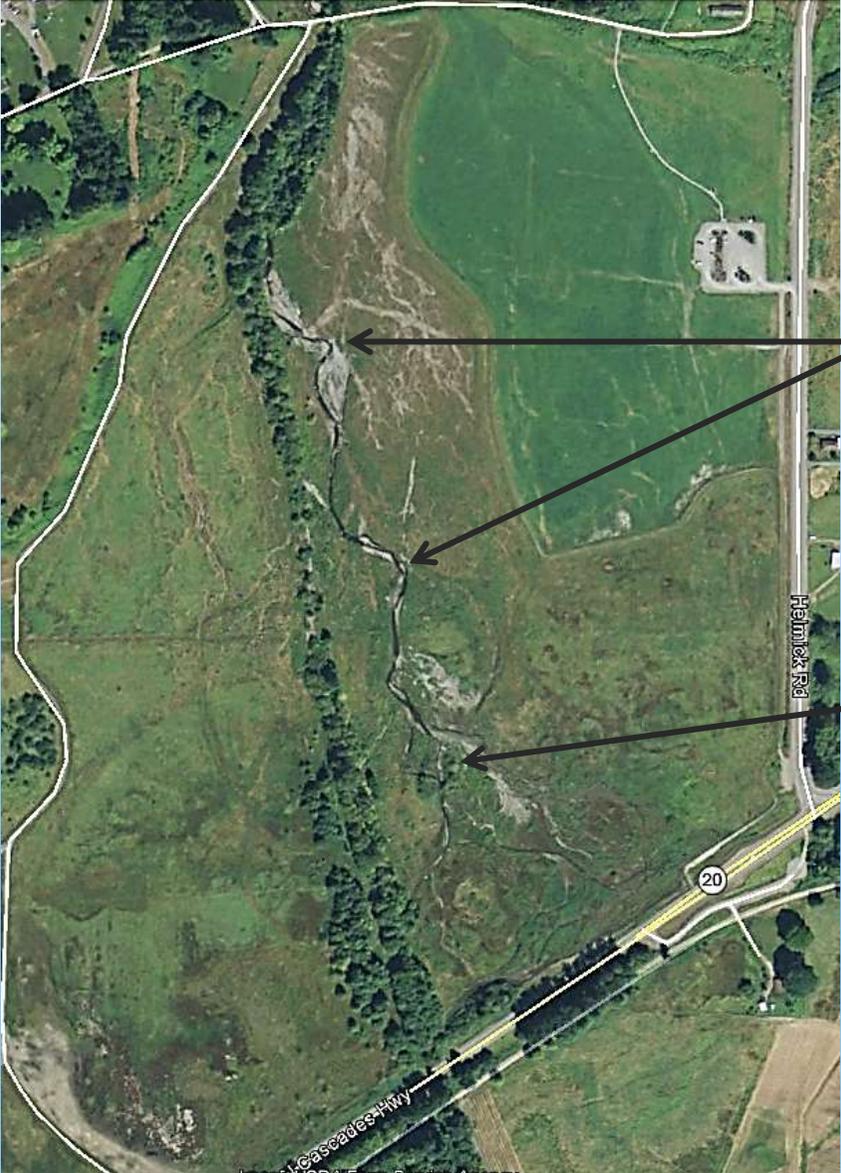
2009

Single channel

Multiple channels

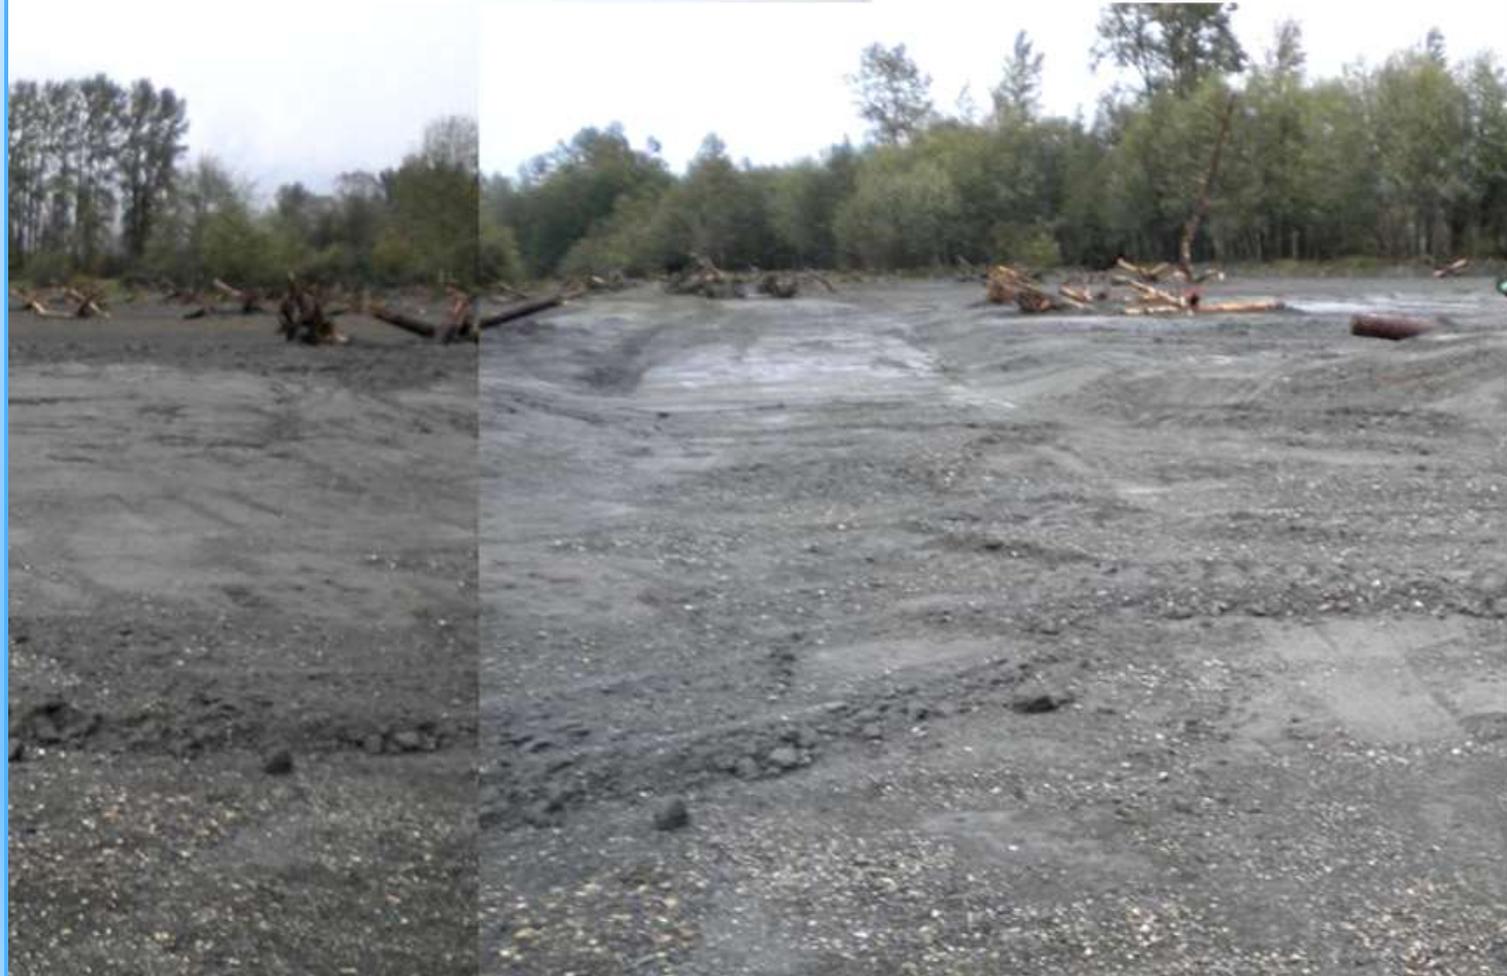
Post Construction (2009)

Geomorphic Change

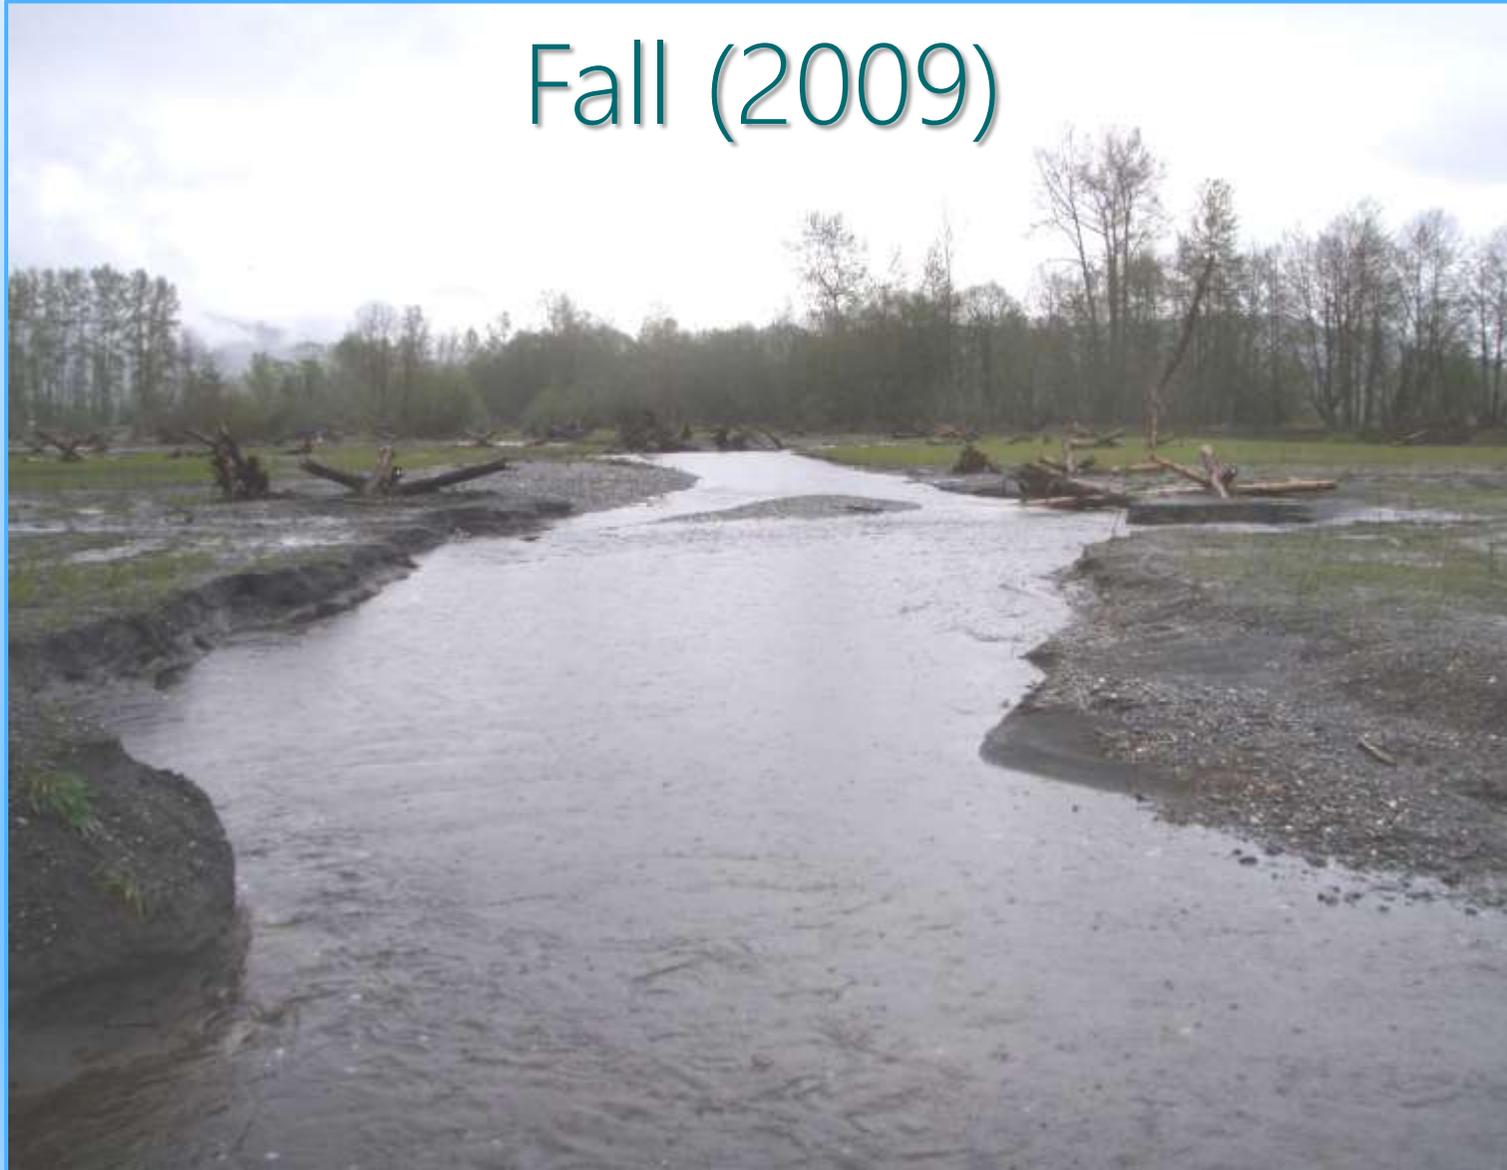
Fall (2009)

Geomorphic Change

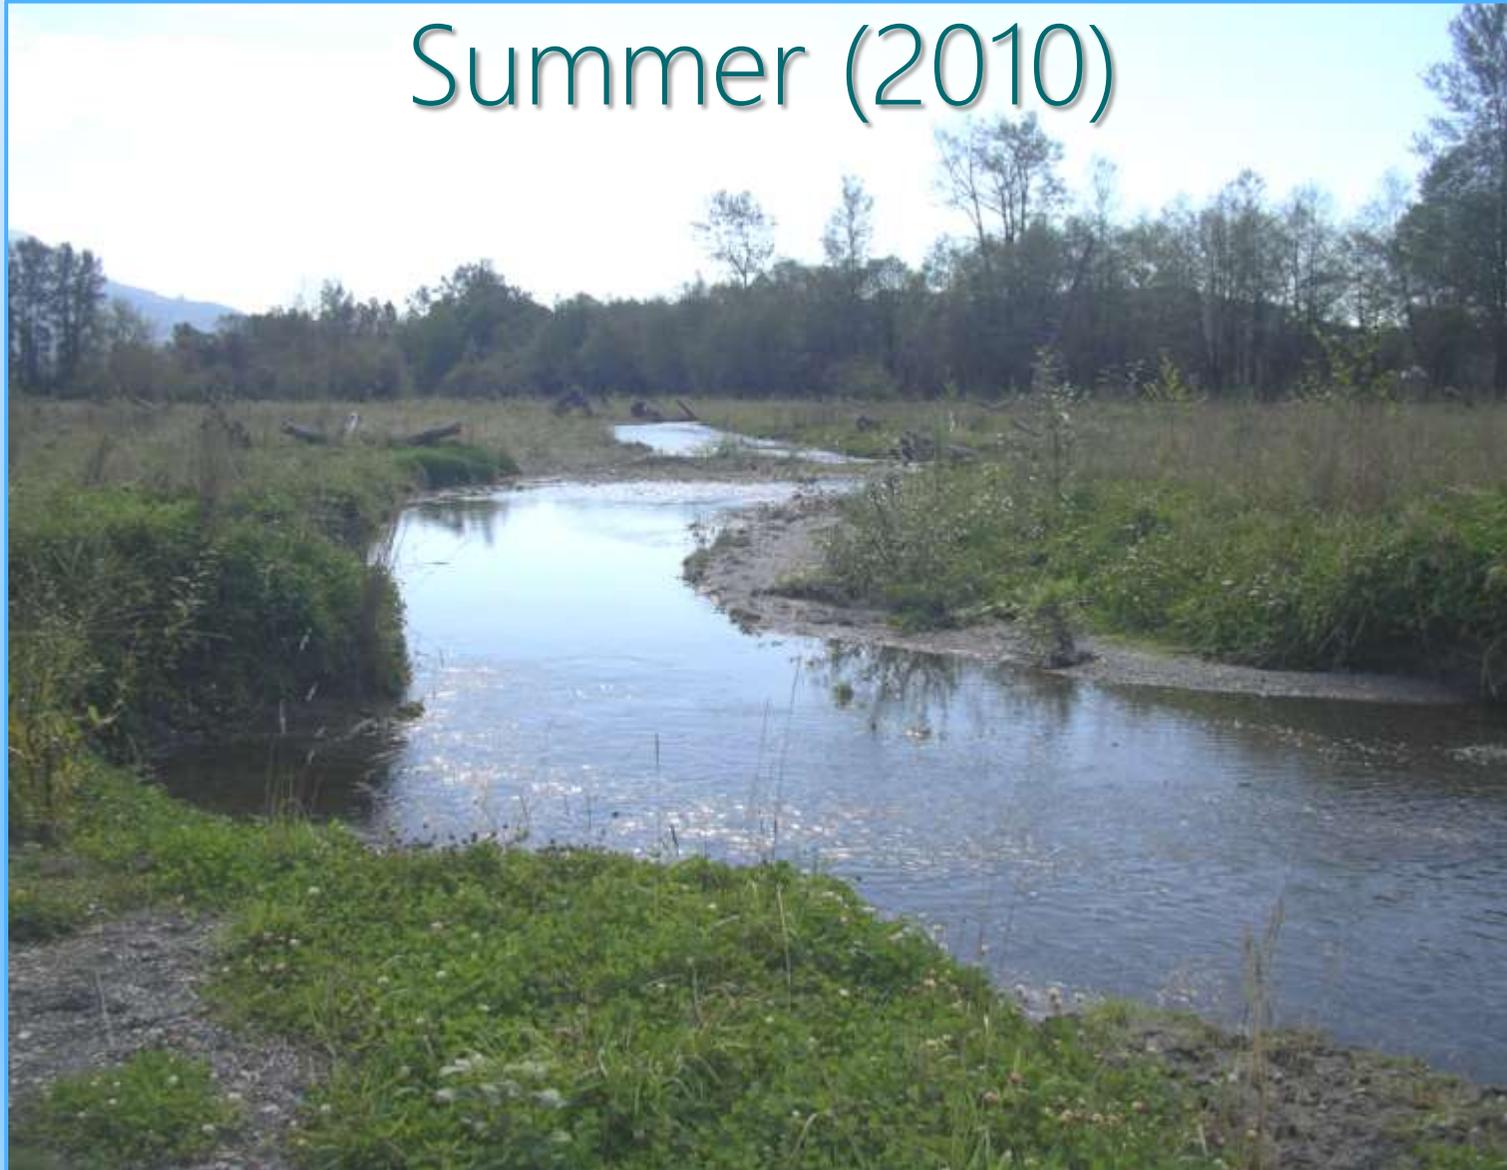
Summer (2010)

Geomorphic Change

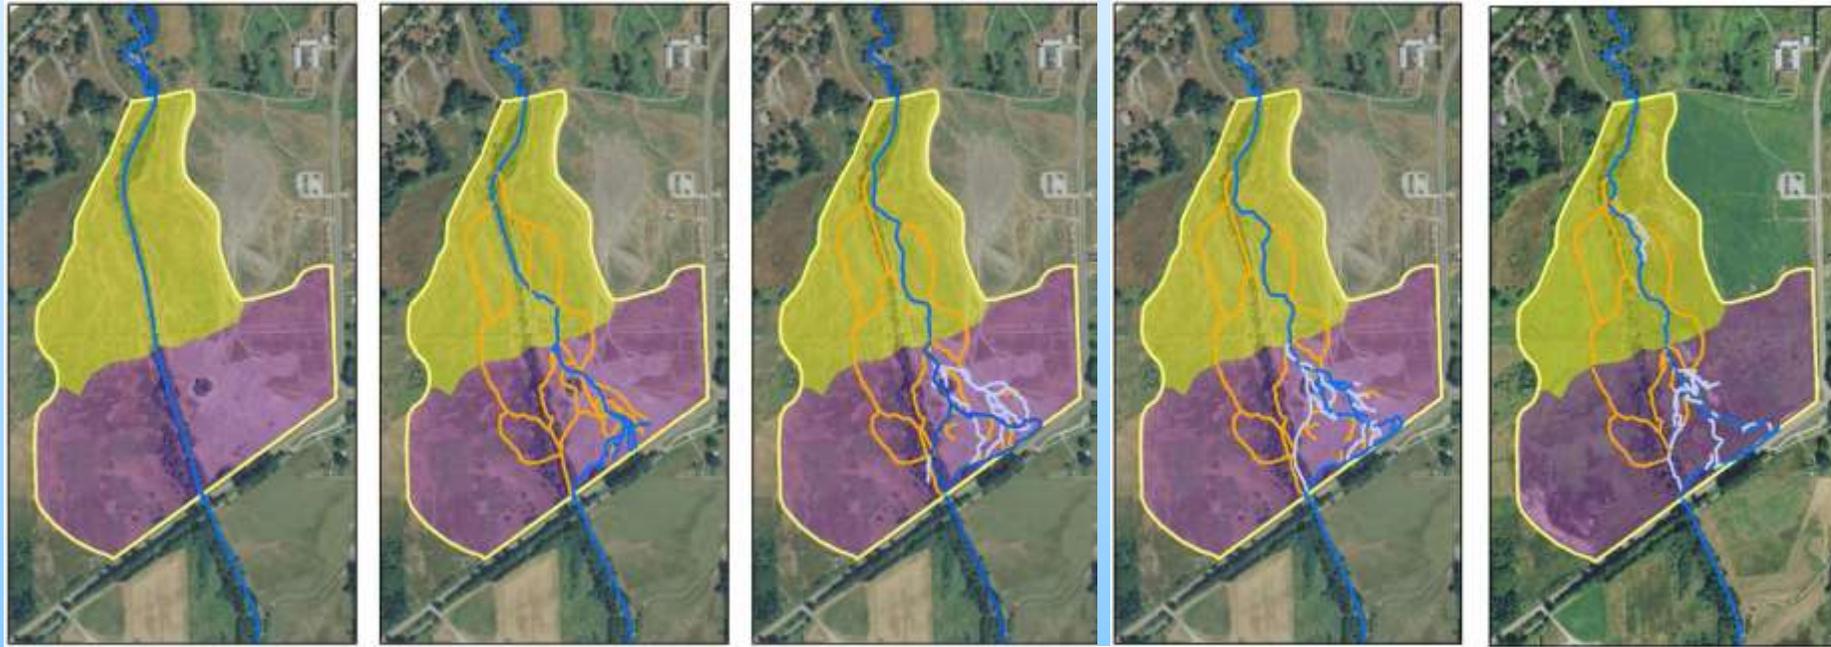
Geomorphic Change: Channel Length

Historic	2010	2011	2012	2013
Main Channel	3,450 feet	5,490 feet	5,890 feet	6,310 feet	4,740 feet
Side Channel	0 feet	0 feet	4,560 feet	3,440 feet	3,970 feet
Total	3,450 feet	5,490 feet	10,450 feet	9,750 feet	8,710 feet

Increase → 59% 71% 83% 37%
 59% 202% 183% 153%

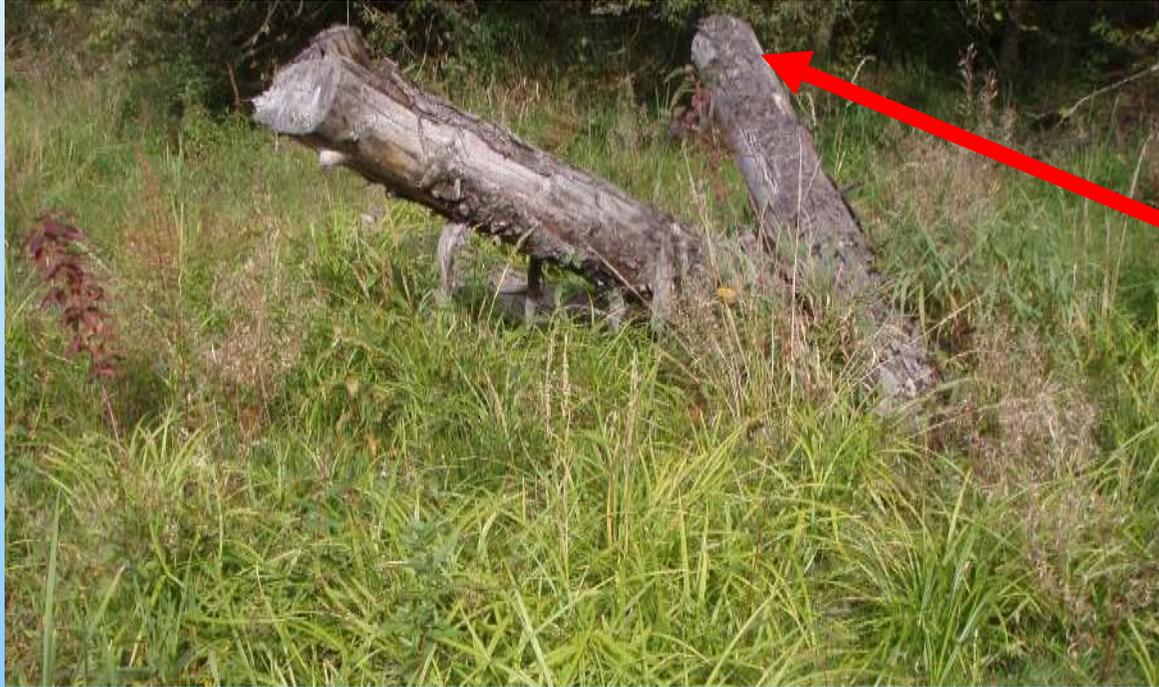
Typical floodplain roughening logs approx.
4 to 5 feet above grade

2 to 3 feet of deposition at
Floodplain roughening log (2014)

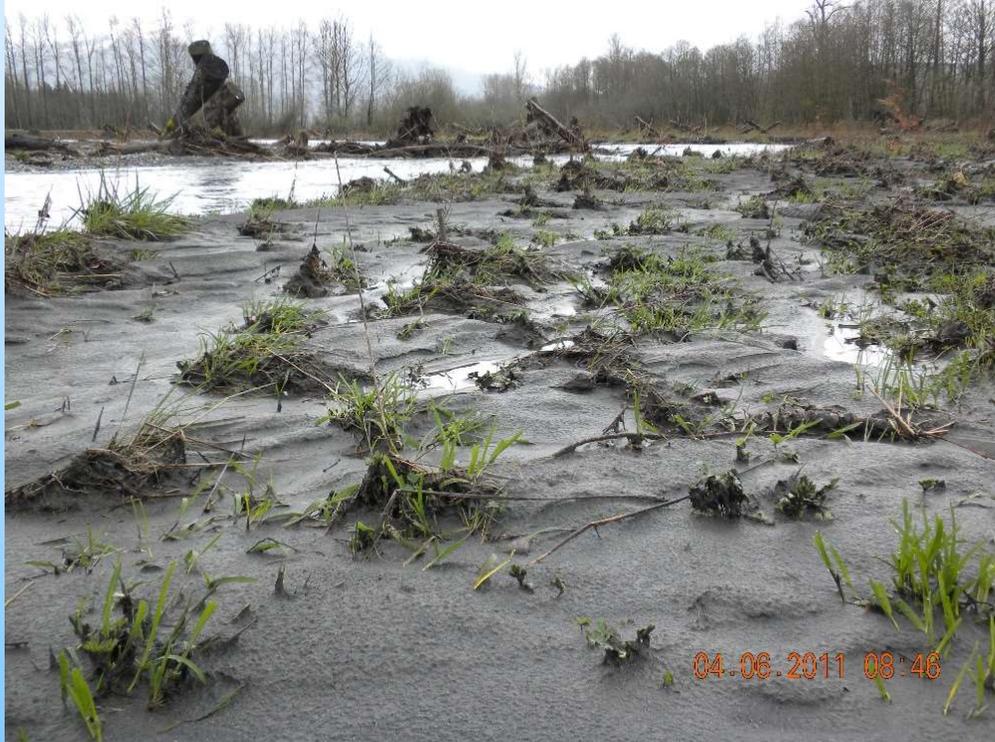
Vegetation in wetland buried in after the March 2011 Flood

0.8m (2.6 ft) cumulative deposition in wetland (measured in winter 2014)

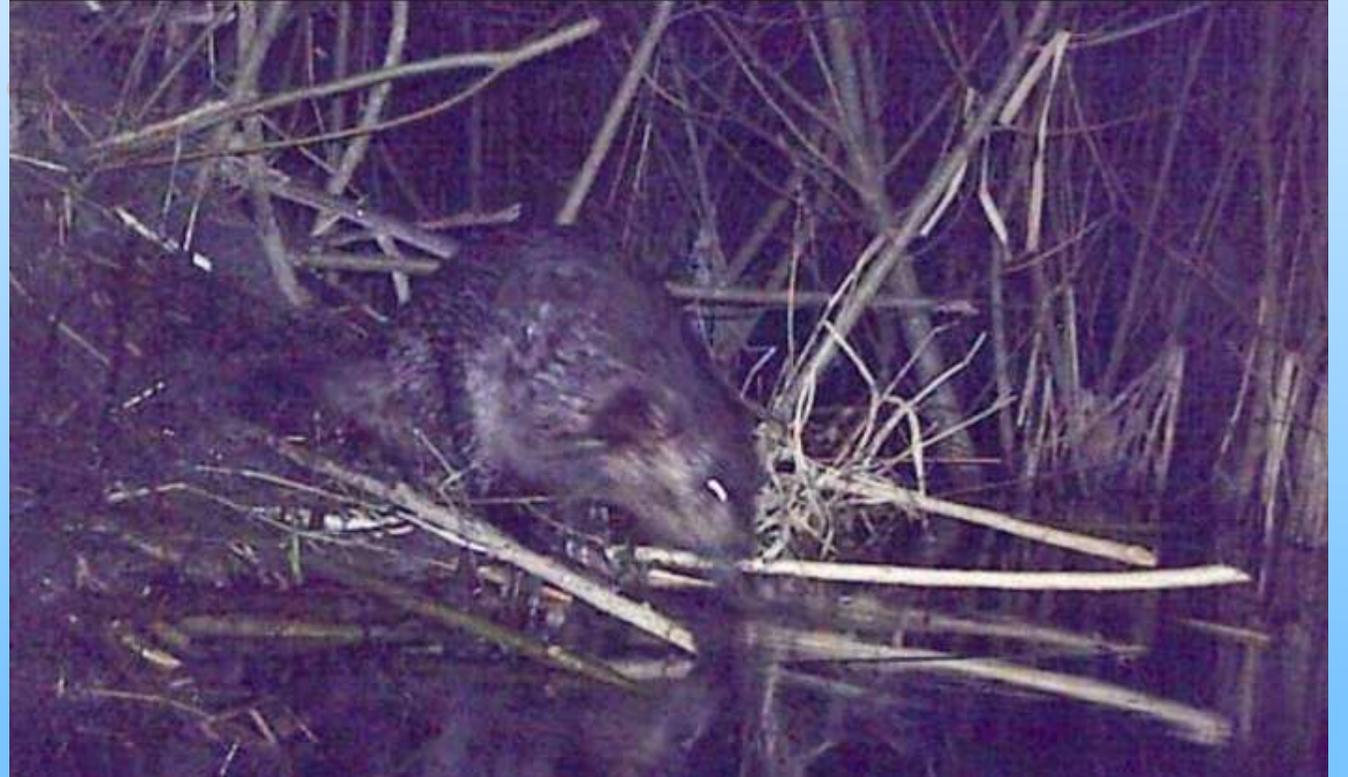
- Expect the unexpected:
 - Hydrology (loss of seeding)
 - Beaver

Date	# Dams	Inundated Area (m ²)
7/3/2013	2	601
9/19/2013	6	1,920
9/24/2013	6	3,124
10/22/2013	13	7,686

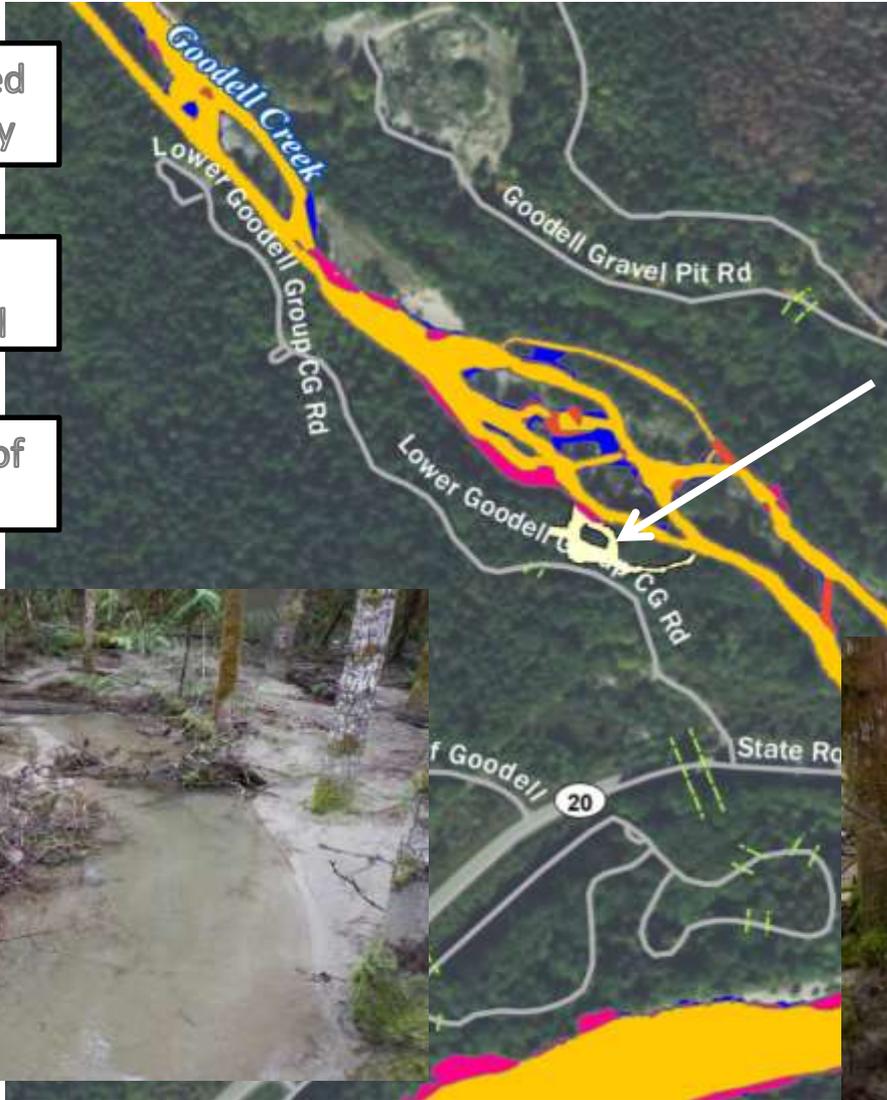
GIS delineation of
habitat types

Slough

Relic channels with defined
inlet and outlet

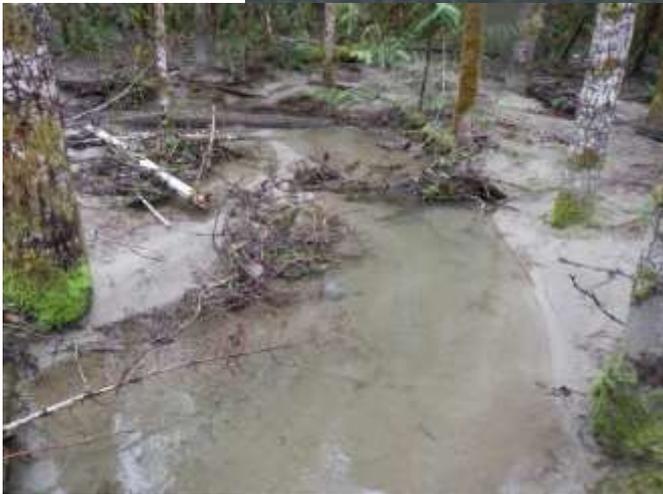
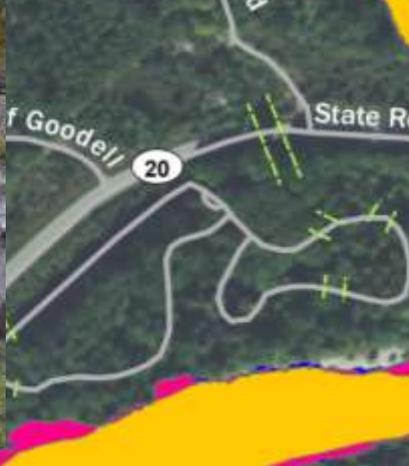
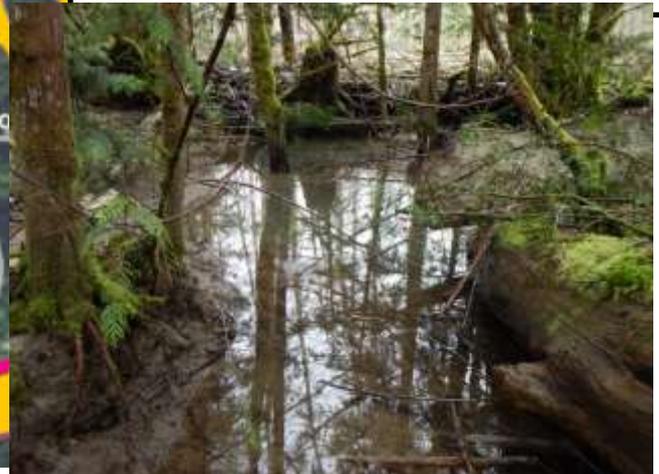
1 to 3 ft deep
and
near zero velocity

Describing Tributary Habitat

Lidar DEM refined
with topo survey
