Alluvial Fans and Salmonid Habitat: The Forgotten and Challenging Landscape In-Between

A Concurrent Session at the 36th Annual Salmonid Restoration Conference held in Fortuna, California from April 11 – 14, 2018.

The Benefits of Restoring Alluvial Fan Processes after a Century of Neglect

Alluvial Fan Construction in the Pacific Northwest

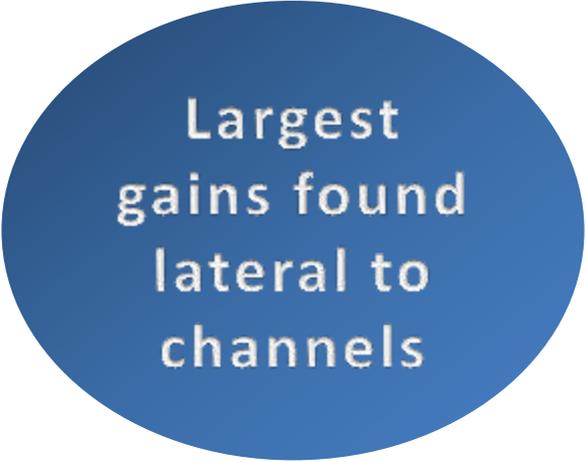
Parr capacity – spring “frequent flood” (715 cfs)

Habitat type	Density (m ⁻²)	Current area (m ²)	Restored area (m ²)
Mid-channel	0.000	32,861	34,676
Edge	0.055	4,282	5,984
Diffuse flow	0.021	1,365	5,149
Wetted margin	0.021	6,340	10,515
Slough	0.086	1,394	3,175
Floodplain	0.086	0	4,102
Total	NA	46,242	63,601

Largest gains found lateral to channels

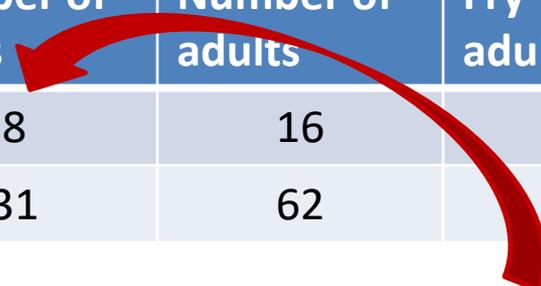
Combining redd density and egg-to-fry survival to estimate fry abundance

Alluvial fan condition	Number of redds	Number of adults	Fry adult ⁻¹	Fry abundance
Current plane-bed form	8	16	341	5,456
Restored pool-riffle complexity	31	62	435	26,970

Actual redd counts → average 6 per year

Alluvial fan condition	Number of redds	Number of adults	Fry adult ⁻¹	Fry abundance
Current plane-bed form	8	16	341	5,456
Restored pool-riffle complexity	31	62	435	26,970
