Effectiveness Monitoring of Instream Restoration Projects - Lessons Learned and Where Do We Go From Here

A Workshop at the 36th Annual Salmonid Restoration Conference held in Fortuna, California from April 11 – 14, 2018.

(Slide 5) The Pudding Creek BACI Experiment: A Paired Watershed Approach to Effectiveness Monitoring
Elizabeth Mackey, Trout Unlimited

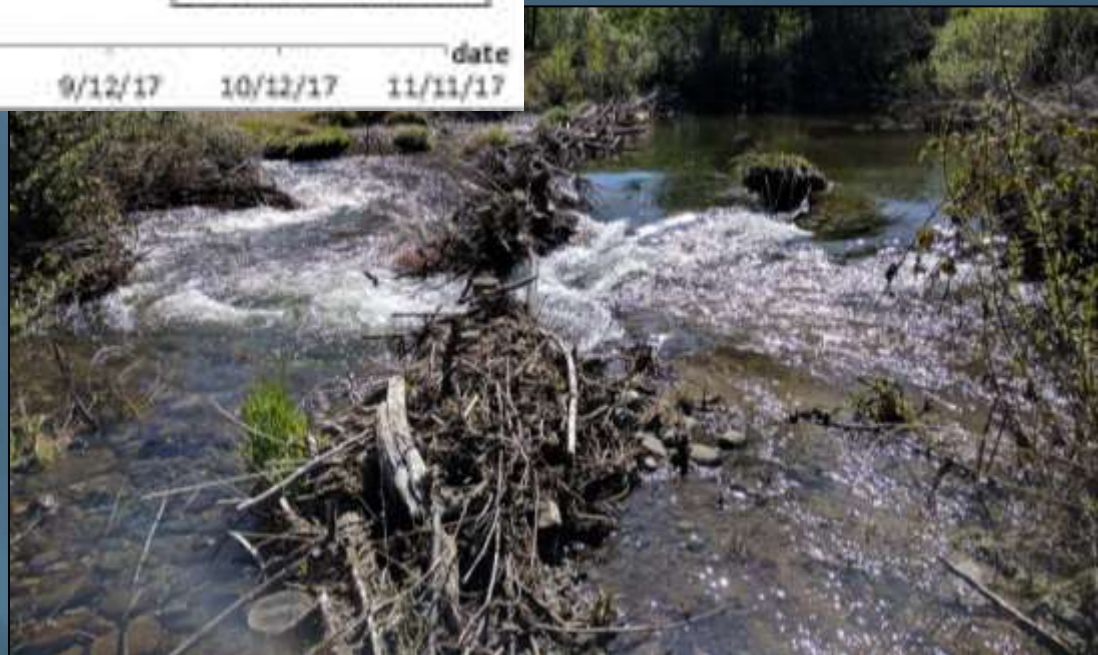
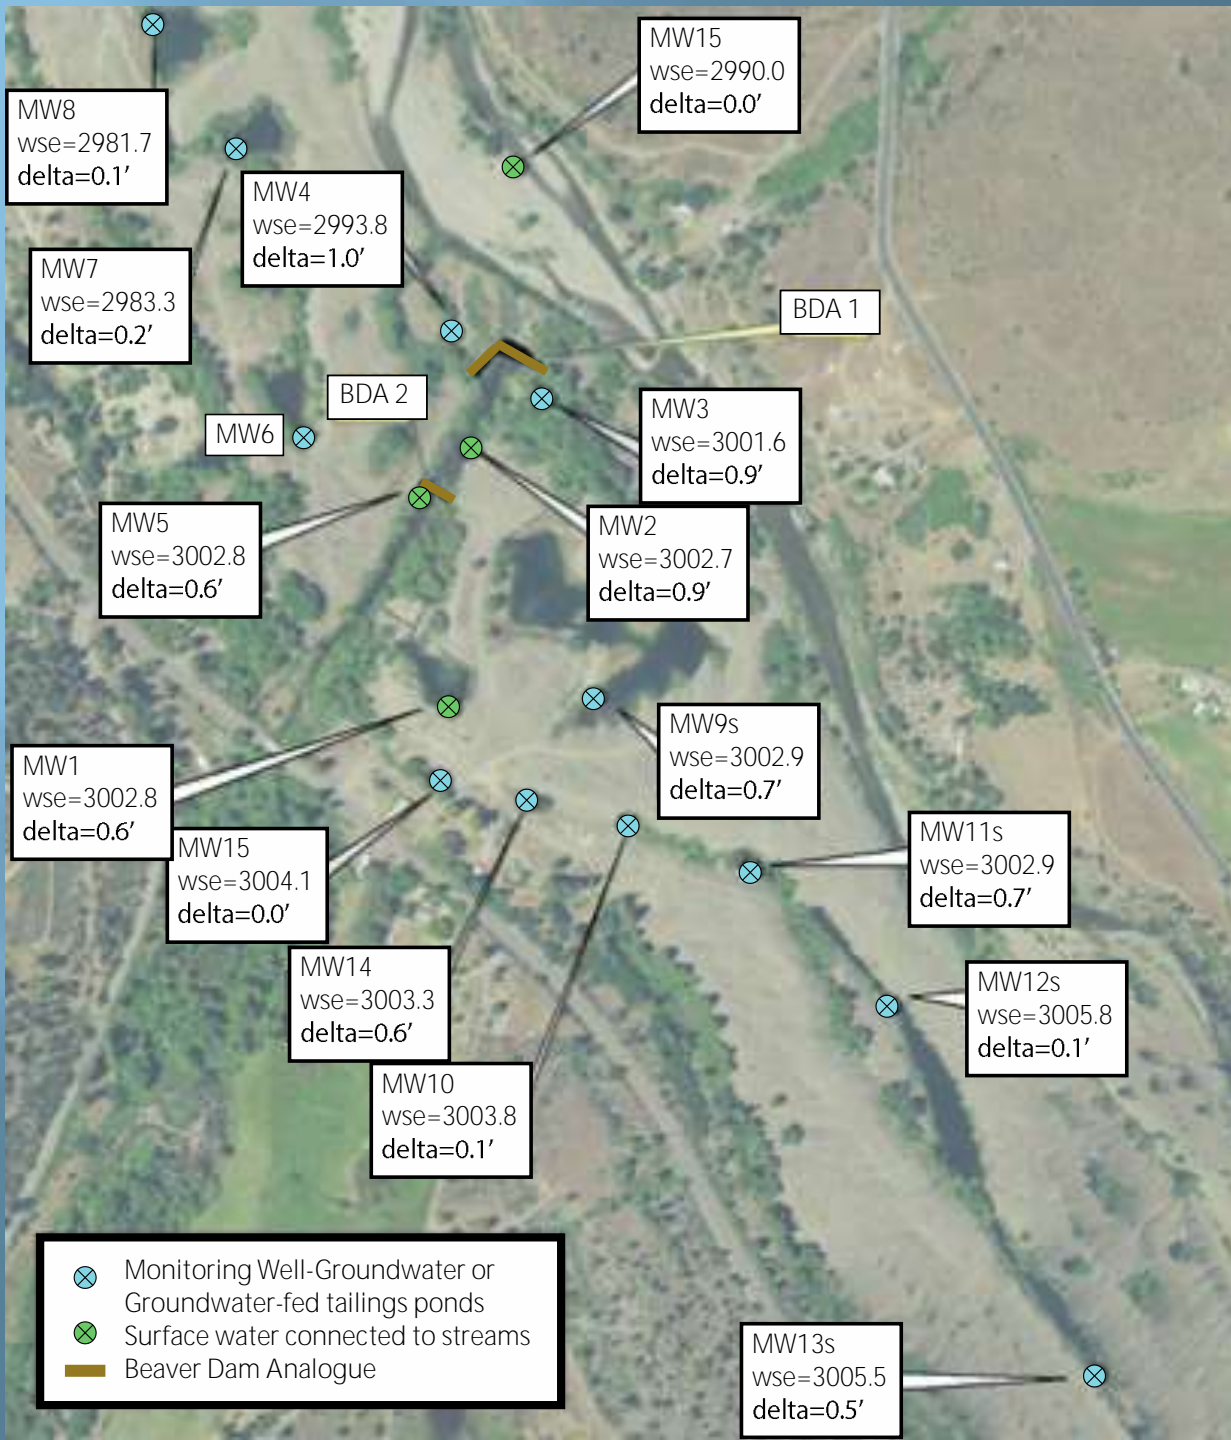
Water Surface Elevation
at Sugar Creek BDA
Pond 1, 2017 (above)

A breach in Sugar
Creek BDA 1 in 2017
(right)

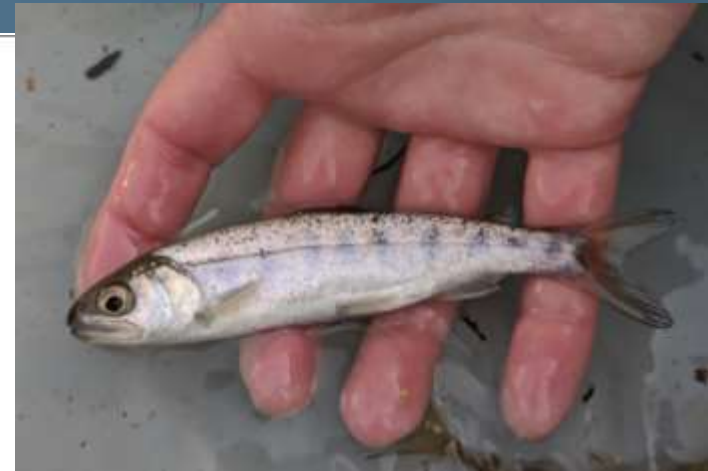
Diurnal movement
of coho to and from
the off-channel
pond (left)

Seasonal movement
of coho in relation
to flow (below)

Growth rate of juvenile coho salmon at restoration site (Sugar Ck) and control site (French Ck) in relative to growth rates in other ponds and tributaries in the Klamath River basin.
