Klamath Dam Removal - Lessons Learned as a River is Reborn

A Concurrent Session at the 42nd Annual Salmonid Restoration Conference
Santa Cruz, California, April 29 - May 2, 2025

- **Planning, Implementation, and Lessons Learned for the Removal of the Four-Dam Complex of the Lower Klamath Project**
Mort McMillen, *Executive Vice-President, McMillen Inc.*.....Slide 4

Planning, Implementation, and Lessons Learned for the Removal of the Four-Dam Complex of the Lower Klamath Project

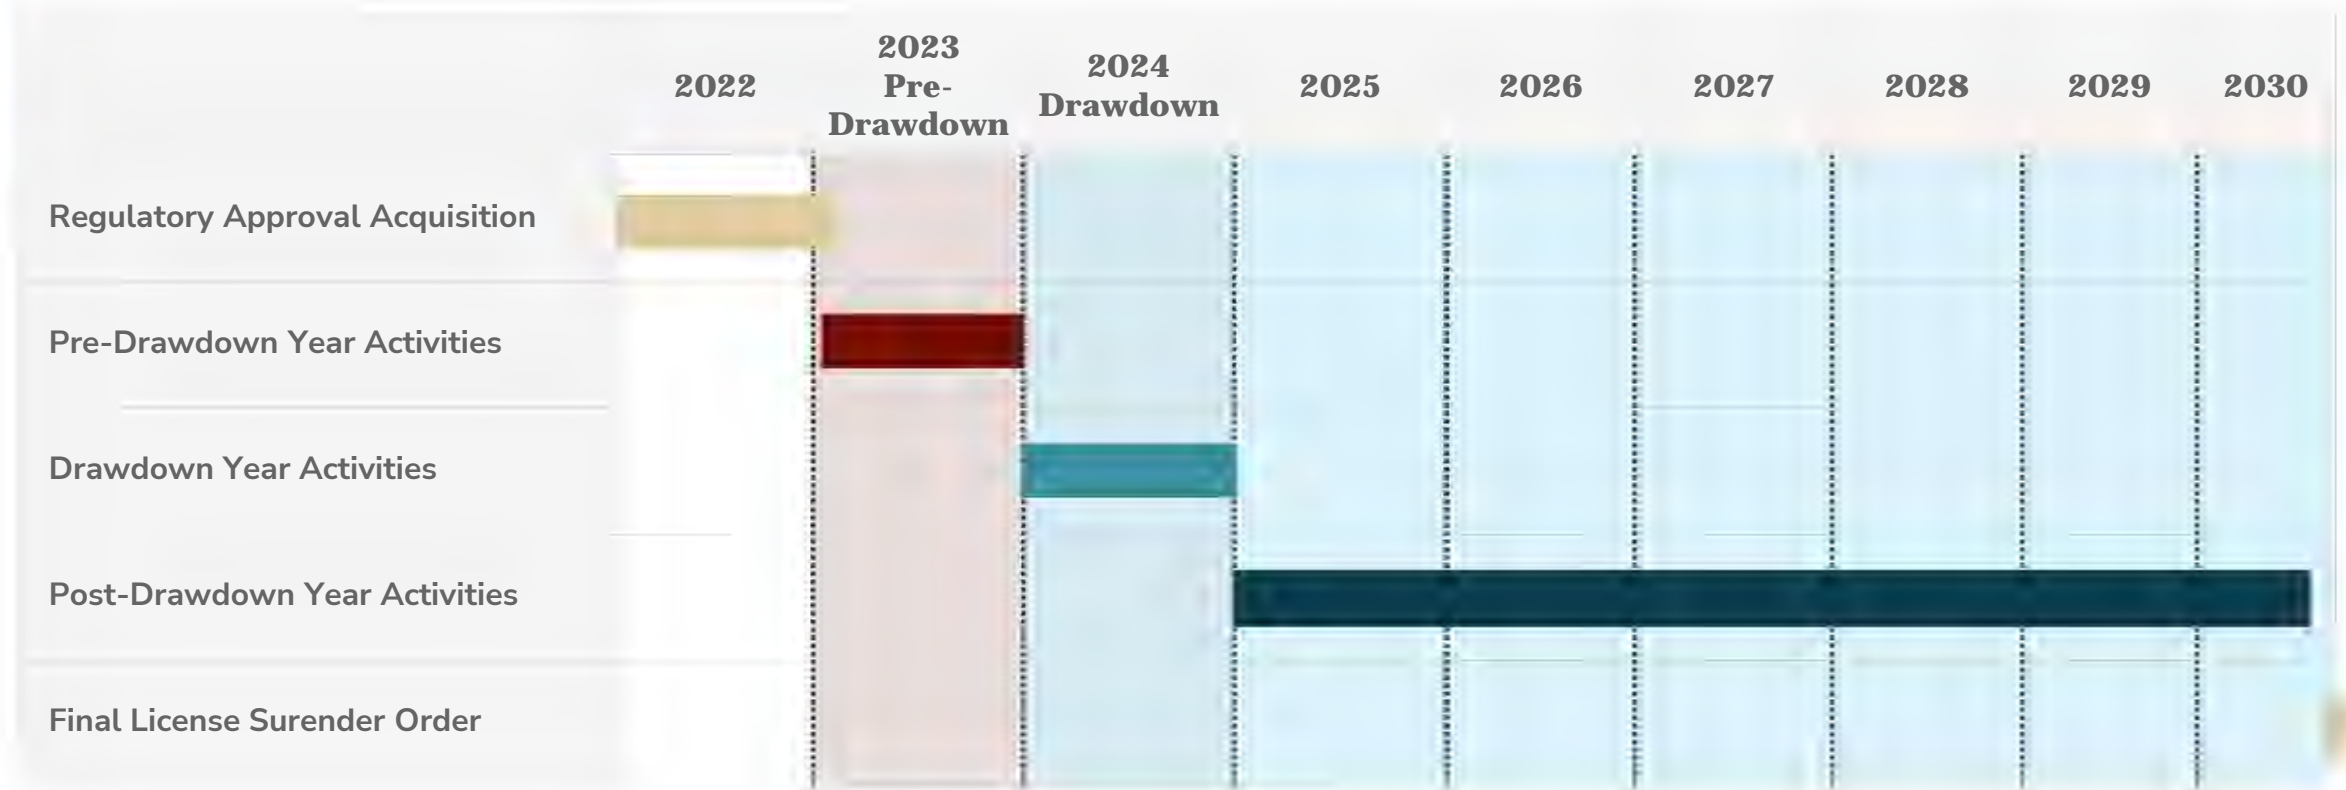
Dam Removal Project Timeline

Pre-Drawdown Year:

- Dam/tunnel modifications
- Road/bridge improvements
- CoY Waterline Replacement
- Fall Creek Hatchery Construction
- Water Quality/Quantity Monitoring
- Copco No. 2 Dam Removal

Drawdown Year:

- Dam and infrastructure removal
- Initial reservoir restoration

Post-Drawdown Years:

- Site Restoration
- Monitoring/Adaptive Management

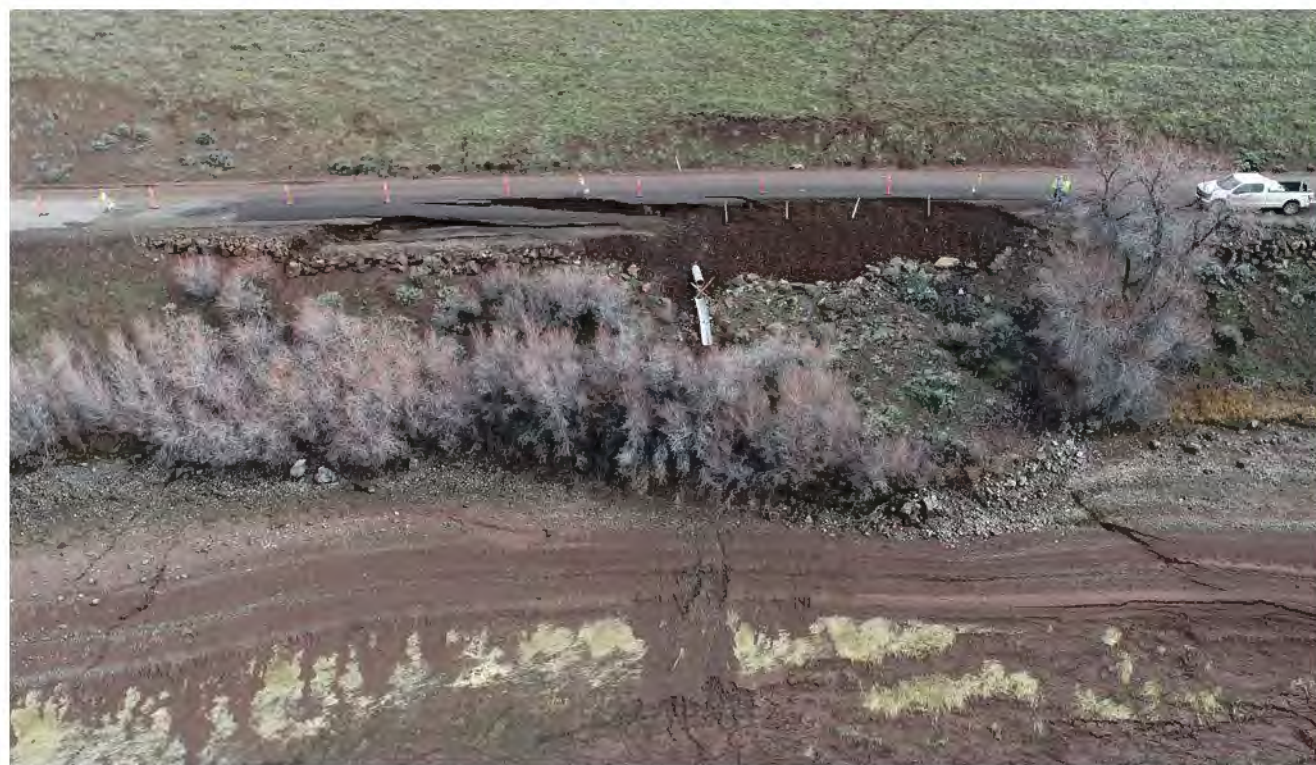
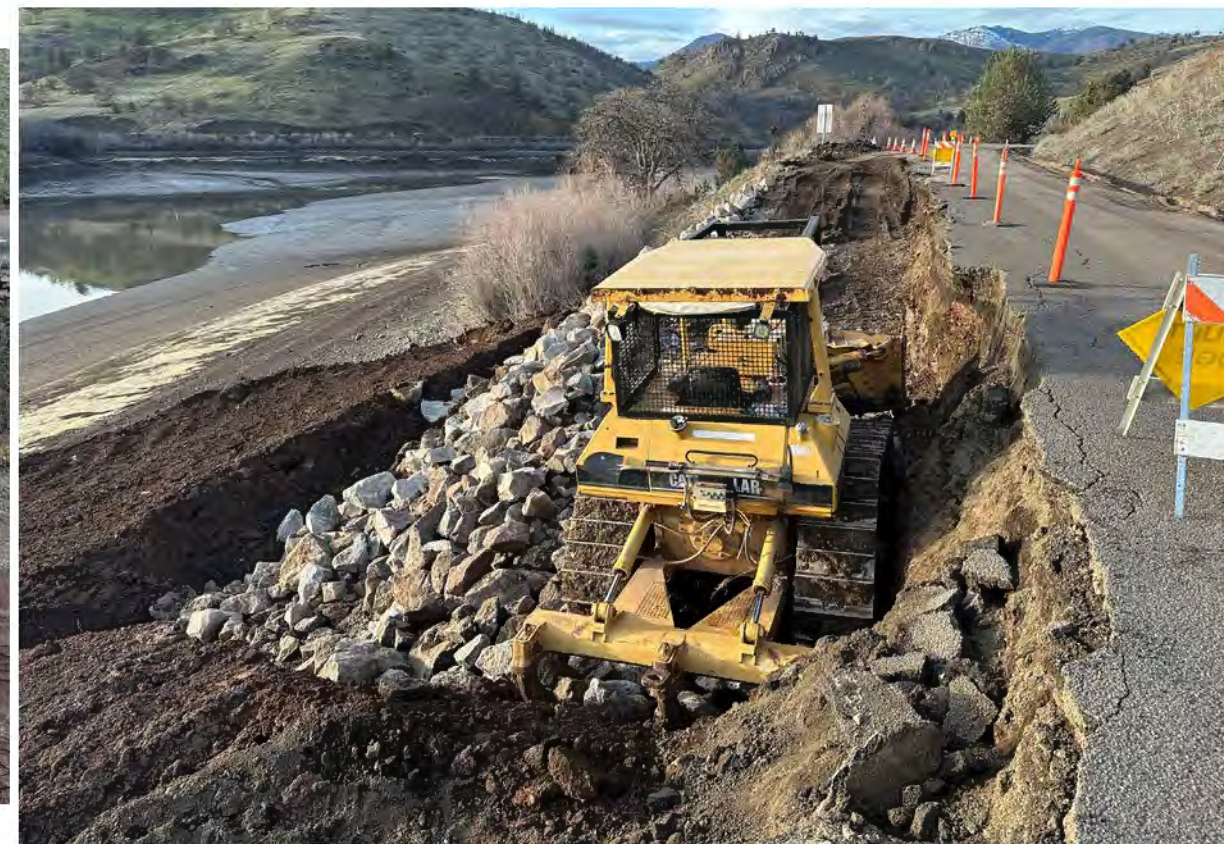
Iron Gate Reservoir Slope Stability Monitoring

- JC Boyle Dam embankment stability during reservoir drawdown and dam removal
- Scour Hole slope stability during construction
- Copco Lake Reservoir Rim Slope Stability during Reservoir Cycling
- Copco No. 1 Dam stability during blasting and removal
- Iron Gate reservoir rim slope stability during drawdown
- Iron Gate Dam embankment stability during drawdown
- Iron Gate Tunnel condition during reservoir drawdown

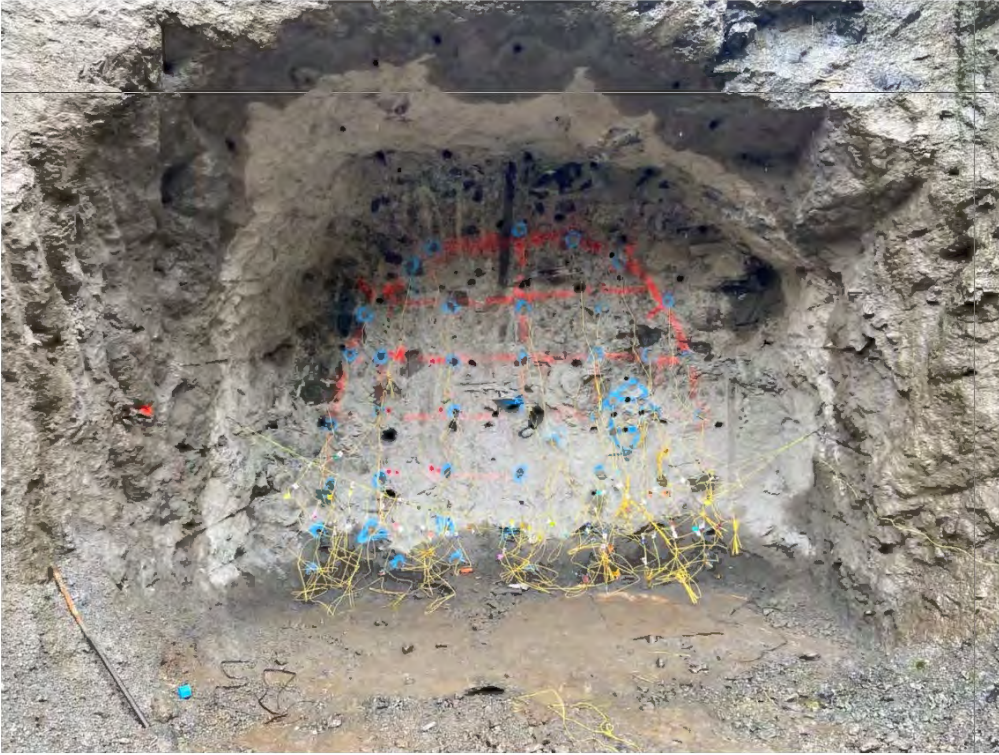
Copco No. 1 Adit Blasting

Issue: Steel rails placed in the original dam concrete placement caused the blast to vary depending on the number and location of the rails. This resulted in a delay in advancing the adit construction as well as high fly rock debris in the first two blasts.

Picture shows at least 7 pieces of rail at random angles that kept the shot from breaking to full depth.

Lesson Learned: Blasting schedule should be developed to accommodate multiple test blasts and “dialing-in” of blasting program to accommodate site specific conditions. Data from the field blasting was required in order to determine the appropriate powder factor to shear off steel rails and reach the full blast depth but stay below a safe threshold for vibration. More fly rock guarding was required than anticipated.

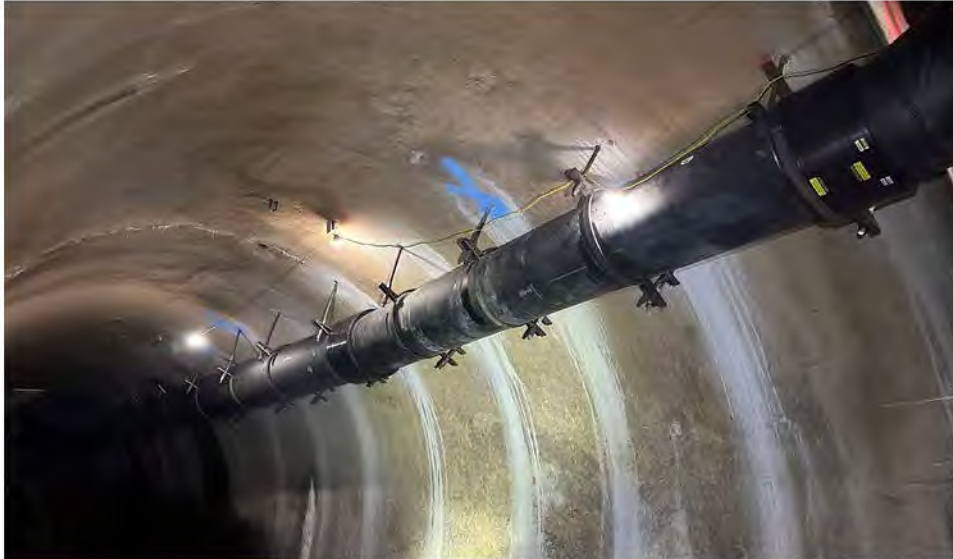
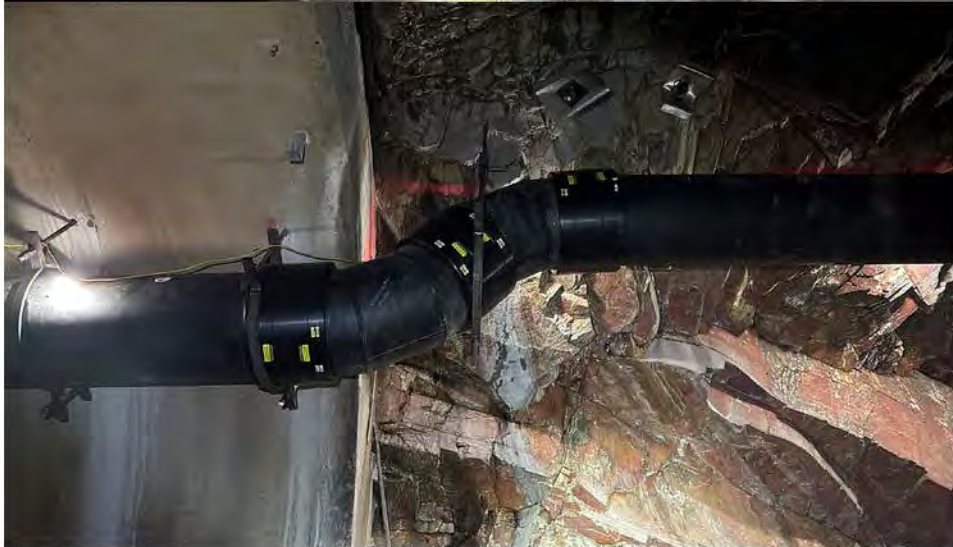
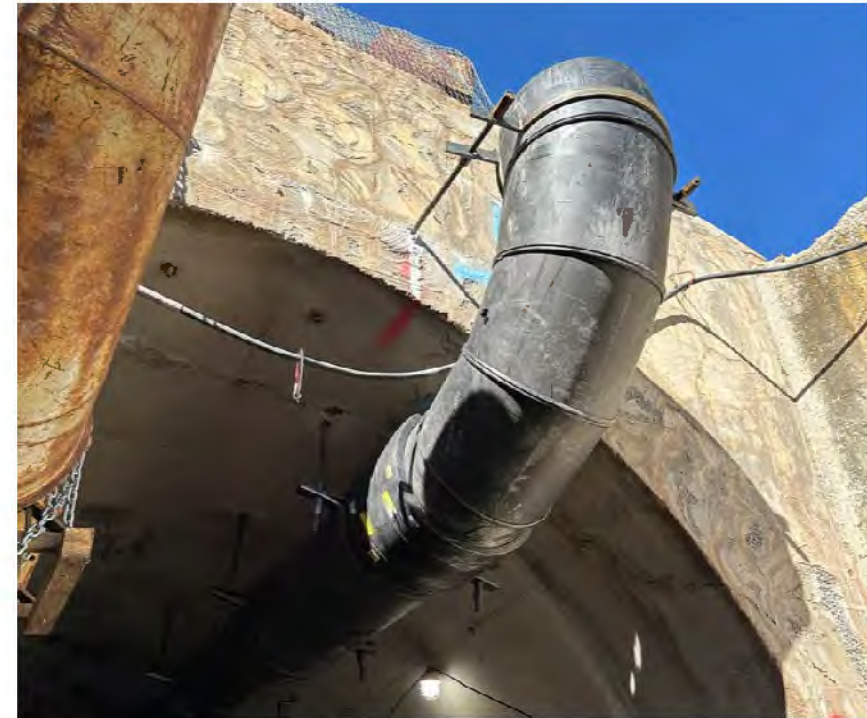
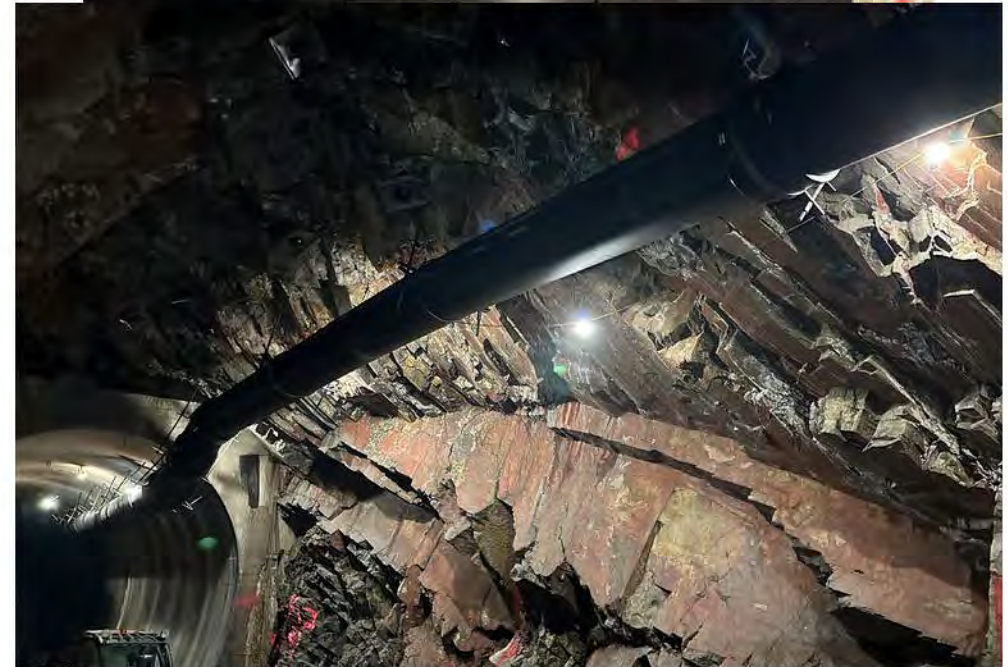
Iron Gate Diversion Tunnel Cavitation/Venting

Issue: During the initial opening of the existing diversion tunnel gate, significant cavitation noise was observed. Soon after, the newly installed vent pipe in the outlet tunnel failed. This caused significant concern about the level of damage occurring in the tunnel due to cavitation and potential lack of aeration.

Lesson Learned: Though the aeration issue was identified and evaluated in the design, cavitation subsequently occurred and resulted in significant damage to the newly installed vent pipe. Several different options for increasing the air flow to the downstream side of the gate were evaluated, and a design approach used which utilized the easiest access to install the pipe. In hindsight, new vent lines should have been routed down the inside face of the tower to supply the gate where damage due to flowing water would be eliminated.

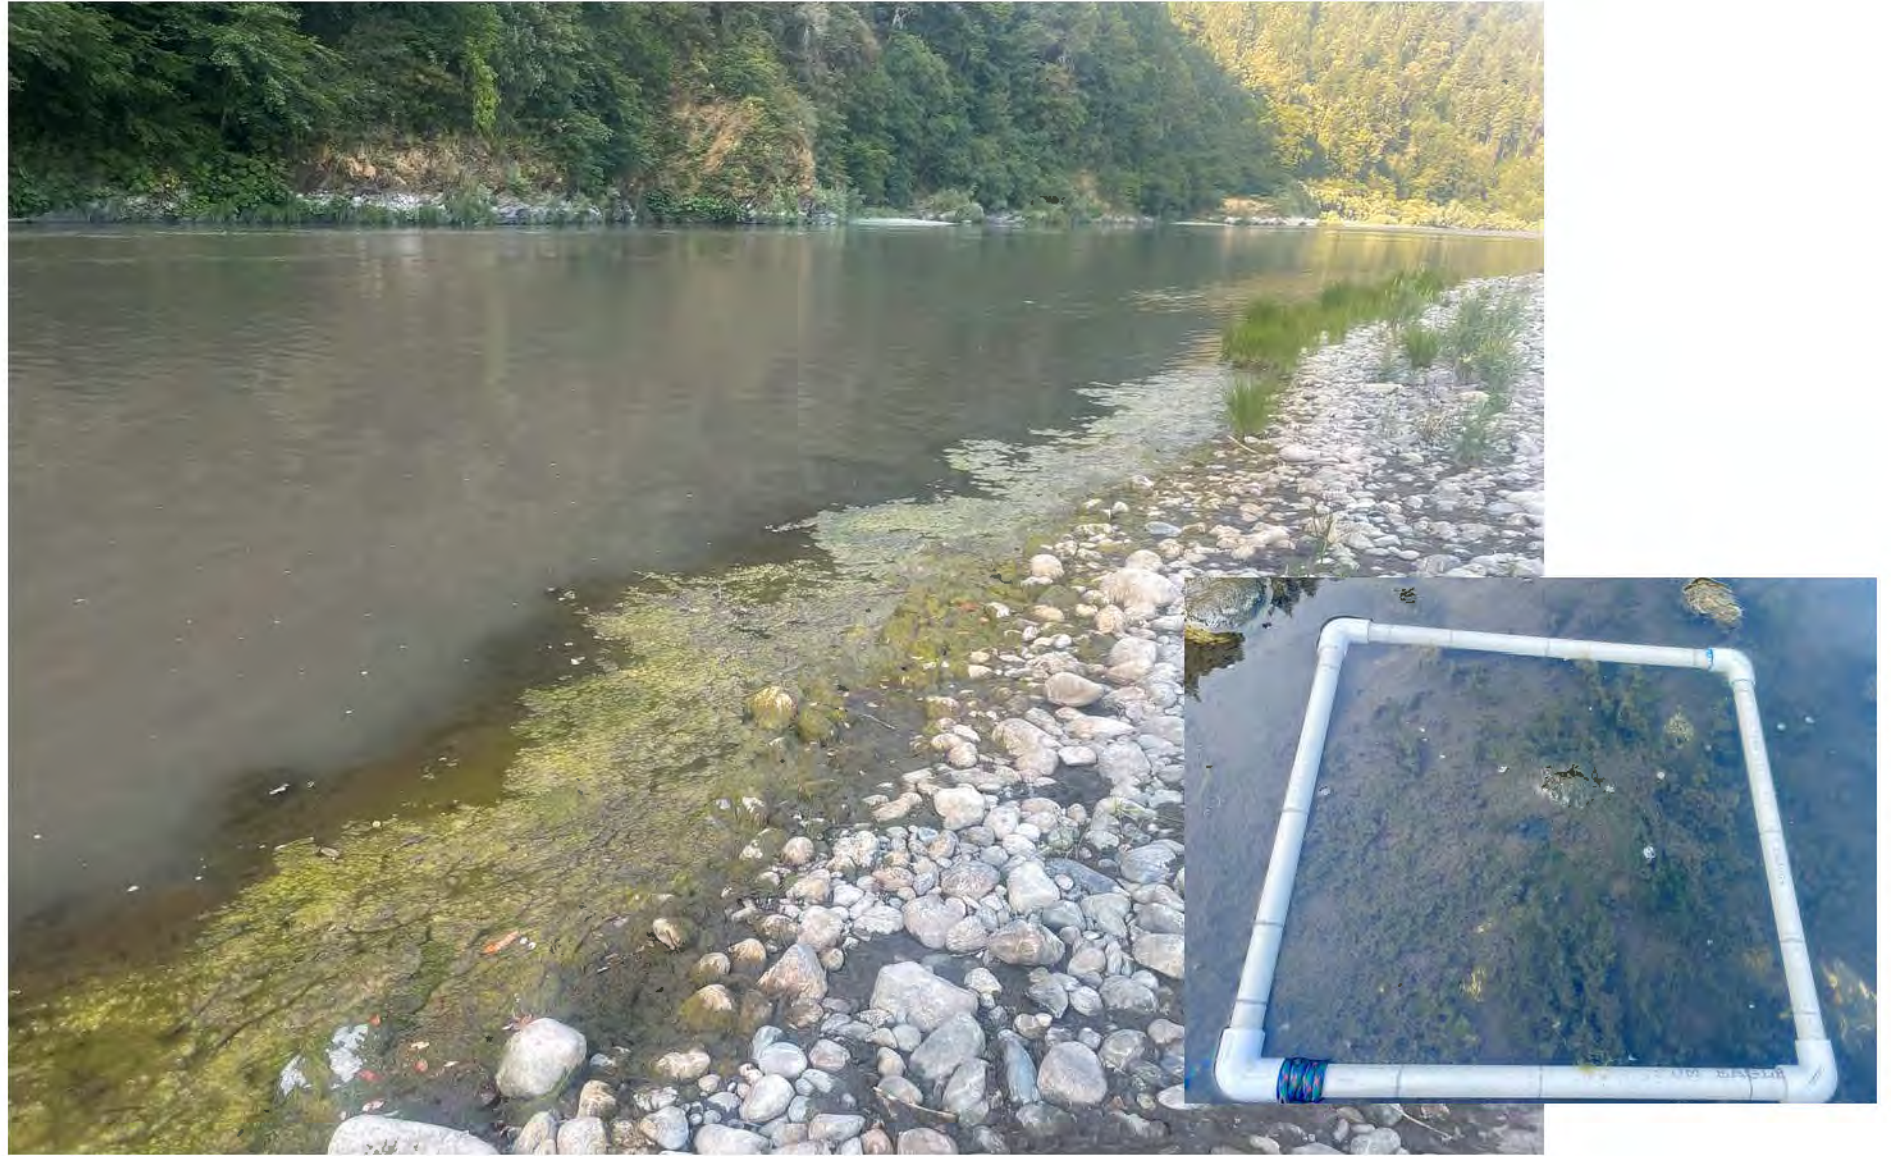
Algae are more sensitive to light than macrophytes.
