## **Welcome attendees of the Lower Mattole River Tour for the 2023 Salmonid Restoration Conference**

## **A Brief History of Cooperative Restoration Actions in the Mattole River Estuary 1990 – 2016**

## Lower Bear Creek at Lighthouse Road Realignment and Restoration Project

## McGinnis Creek Habitat Enhancement Project – Mattole Salmon Group

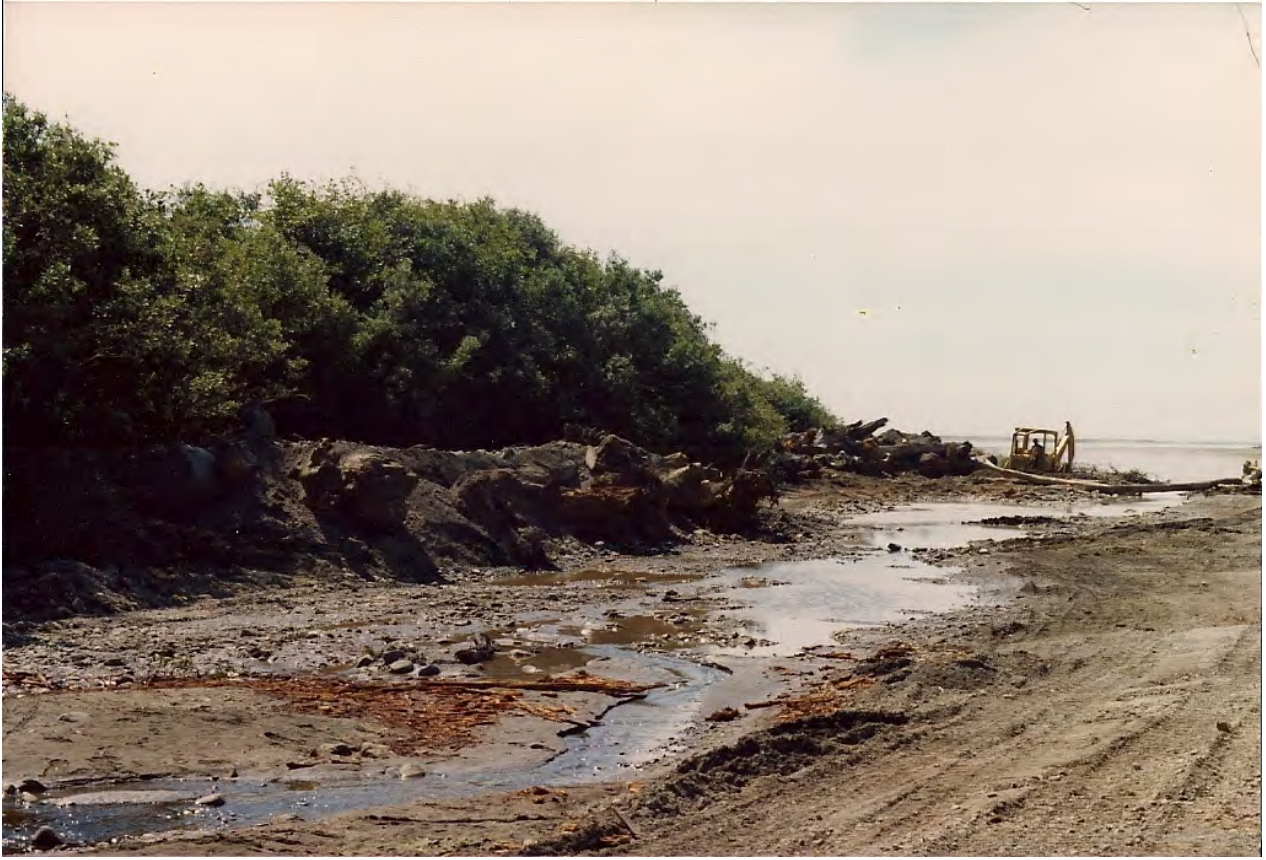
1991 Revetment structures south bank

In 1990, MSG built two log revetment structures on the south bank of the Estuary and, in 1991, another six along the north bank. These structures provided scour and habitat complexity in the hostile aquatic environment. The South Bank structures were still in place as late as 2010 (photo) and most of the North Bank structures are in place today. Along with structure installation, MSG conducted riparian plantings from 1986 through 1994.

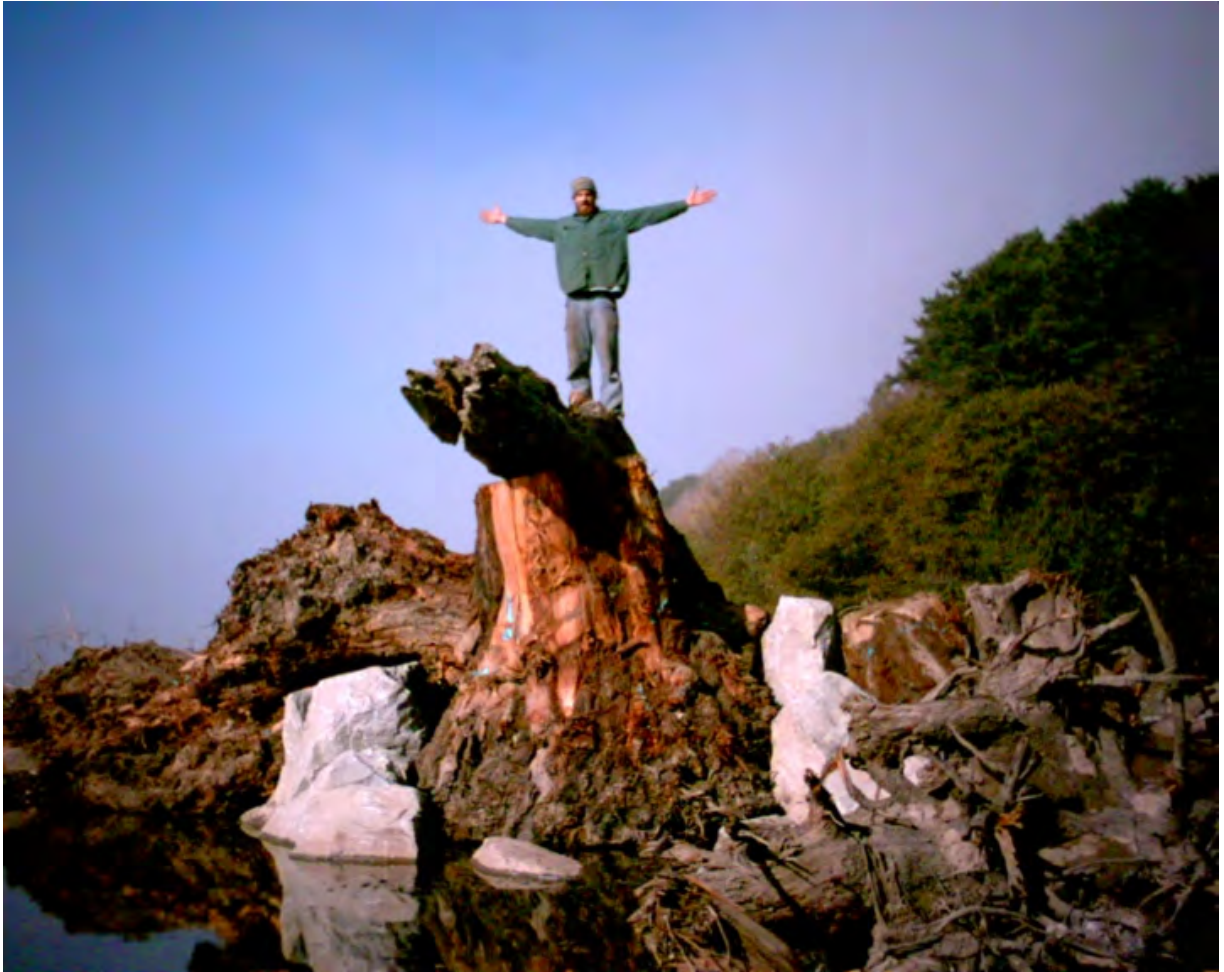
“Woodzilla” as built, 2002

The first massive structure was a wood and rock assemblage called “Woodzilla” at the mouth of Collins Creek – a source of cold water. When the river channel migrated away from the structure to the center of the floodplain, this structure functioned in the Collins delta, sometimes in the water, sometimes high and dry.

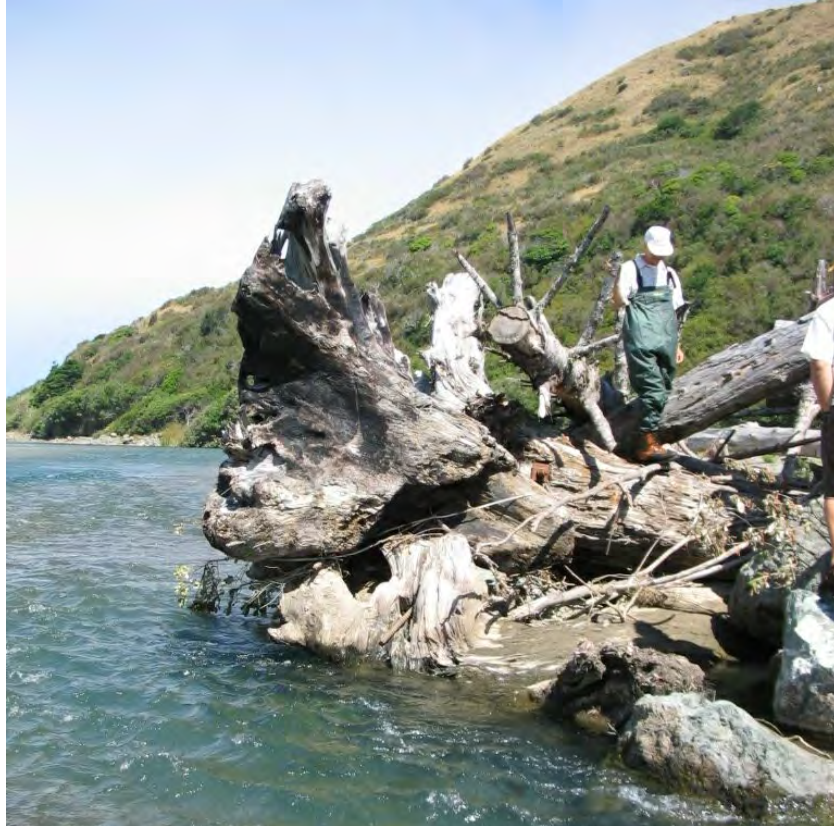
Gary Flossi (CDFW) on field tour of structure #3 built in 2003

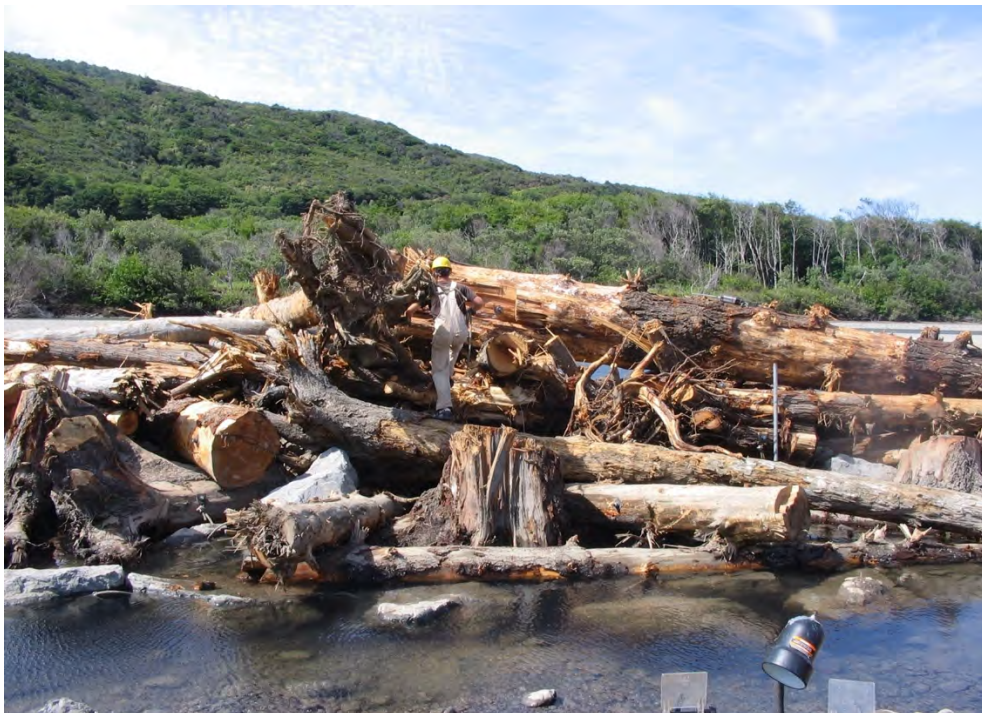
2007 structure as built

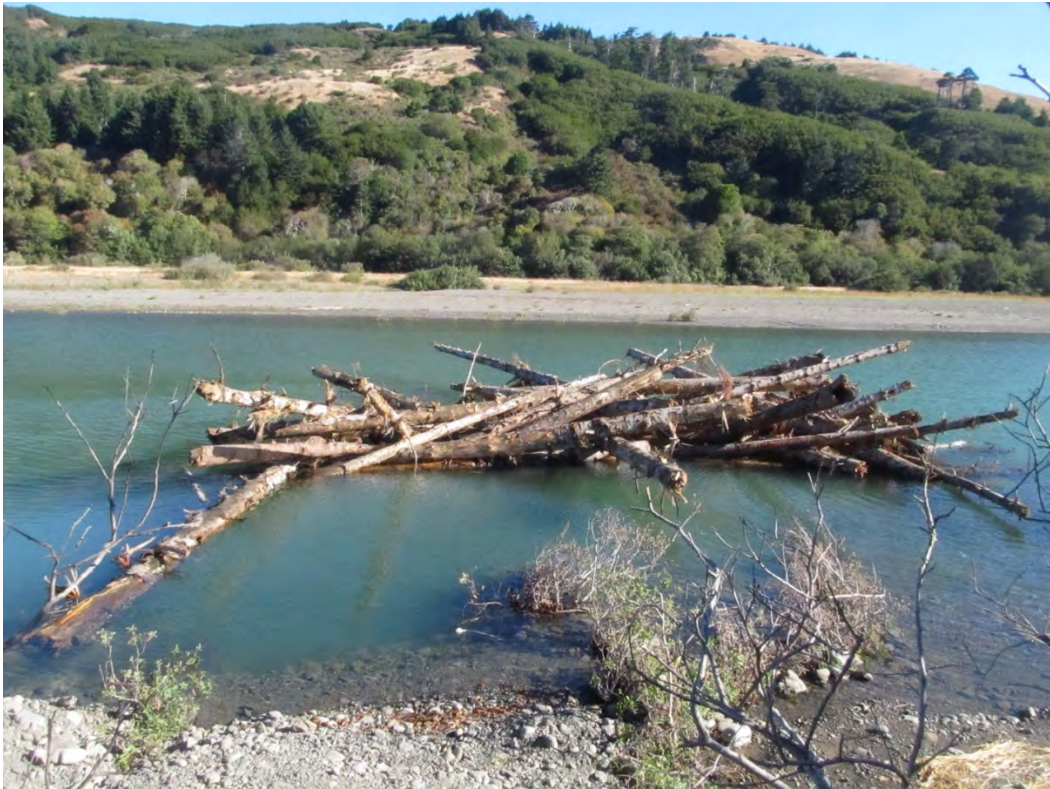
As built - 7<sup>th</sup> LWD structure completed, August 2011

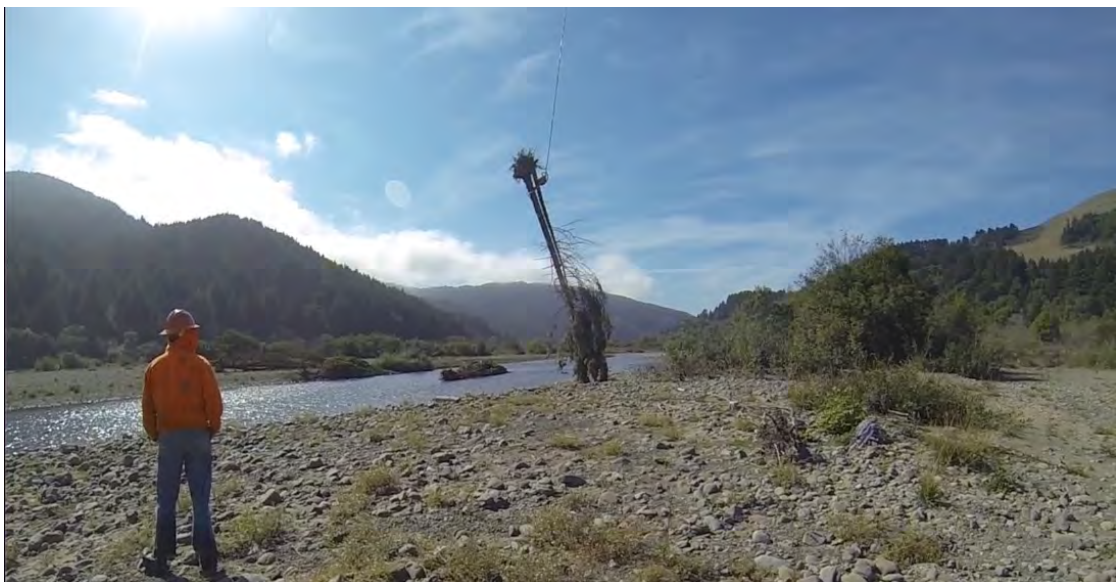
Heliwood 2013

Beginning in about 2012, MSG pioneered the use of the helicopter transport of whole, large trees into the wetted channel. The project had mutual benefit of removing Douglas-fir which was encroaching into historic grasslands for use in the river. These trees were excavated from sidehill rangeland and carefully placed in the lower 2 miles of the river.

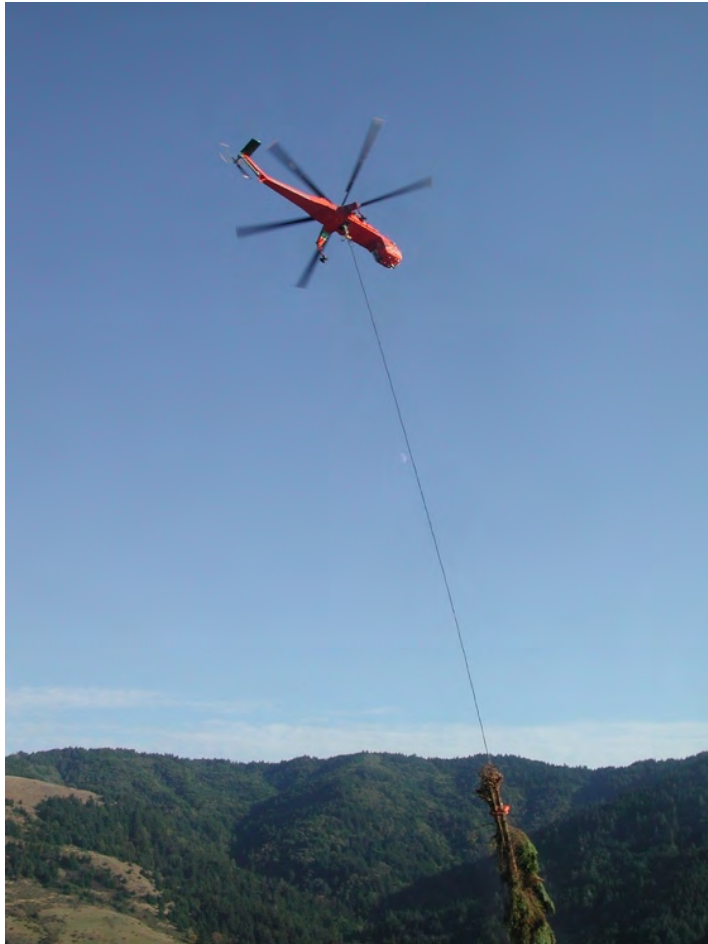
The Mattole Salmon Group, working with a BLM chartered Estuary Technical Advisory Committee, pursued the use of a helicopter for wood placement of whole trees in the estuary. With seven large wood structures downstream in the estuary, whole trees might hang up and or create their own jams and island building structures. The idea is to give the river the materials it needs to build structures and let the rivers dynamics do the work.

The first placement of 100 whole trees took place between September and November 2013. A helicopter lowered the trees to conserve as much branch and root wad complexity as possible. All areas disturbed in the process of tree removal were planted and restored to deep rooted perennial grasses and clovers. A monitoring program was set up in which each trees has an individual identifying scannable tag. These tags are scanned and each tree's location is mapped. Locations and movement of the trees are tracked.

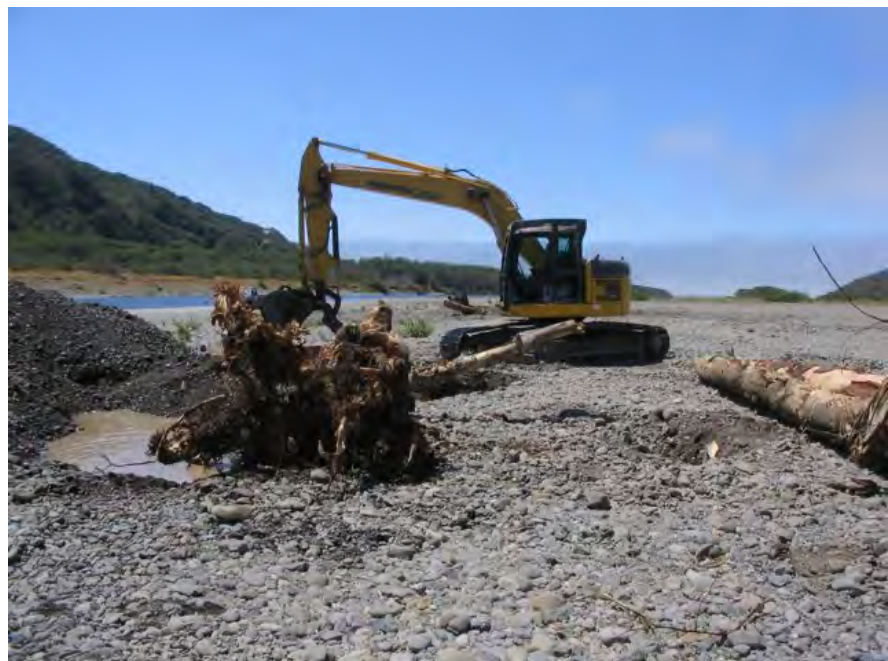
Apex jams in construction 2014

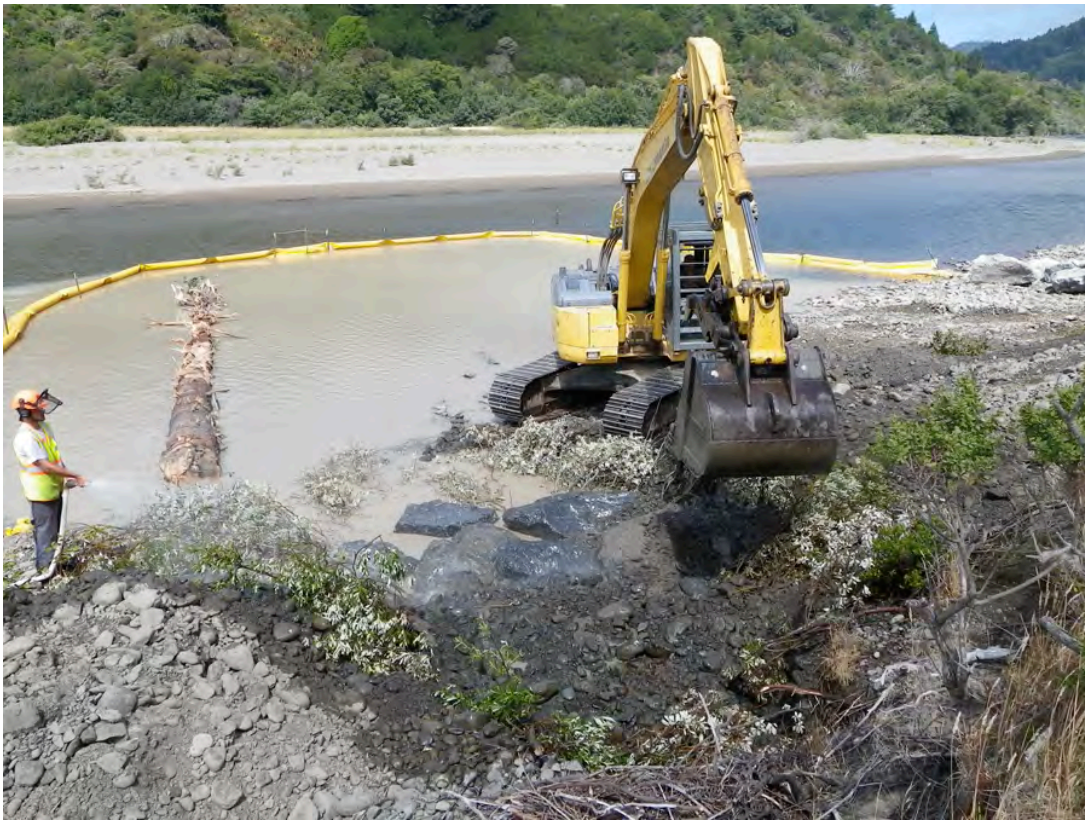
Construction in progress of the 7<sup>th</sup> LWD structure, August 2011

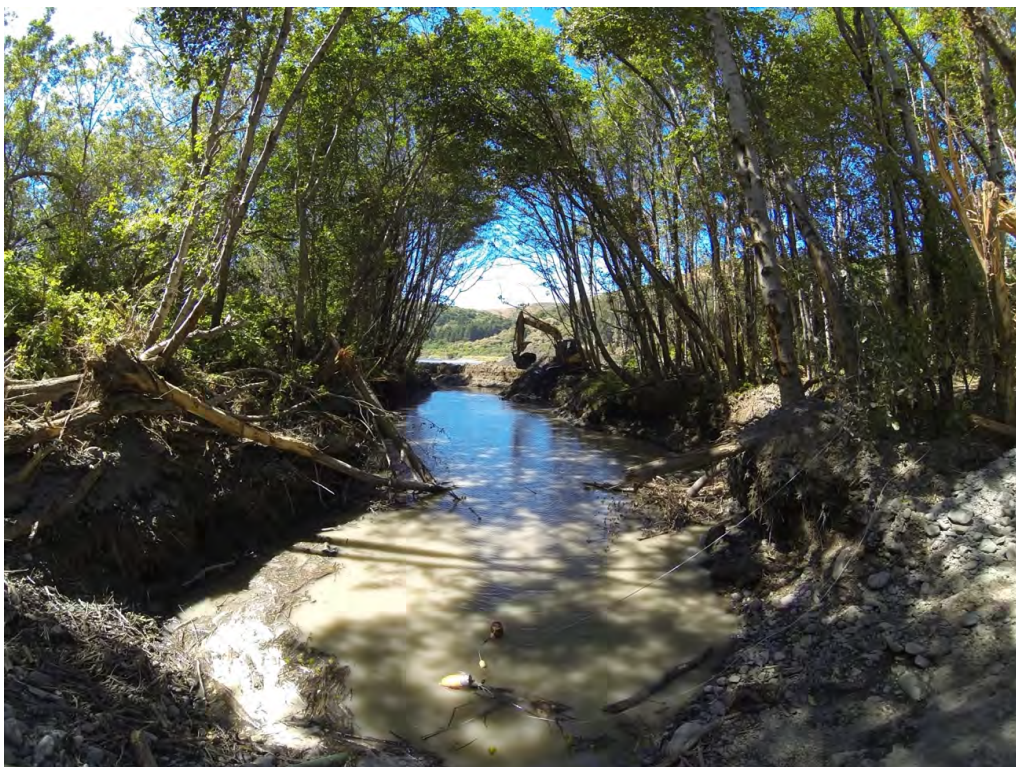
Slough excavation #1 in 2014

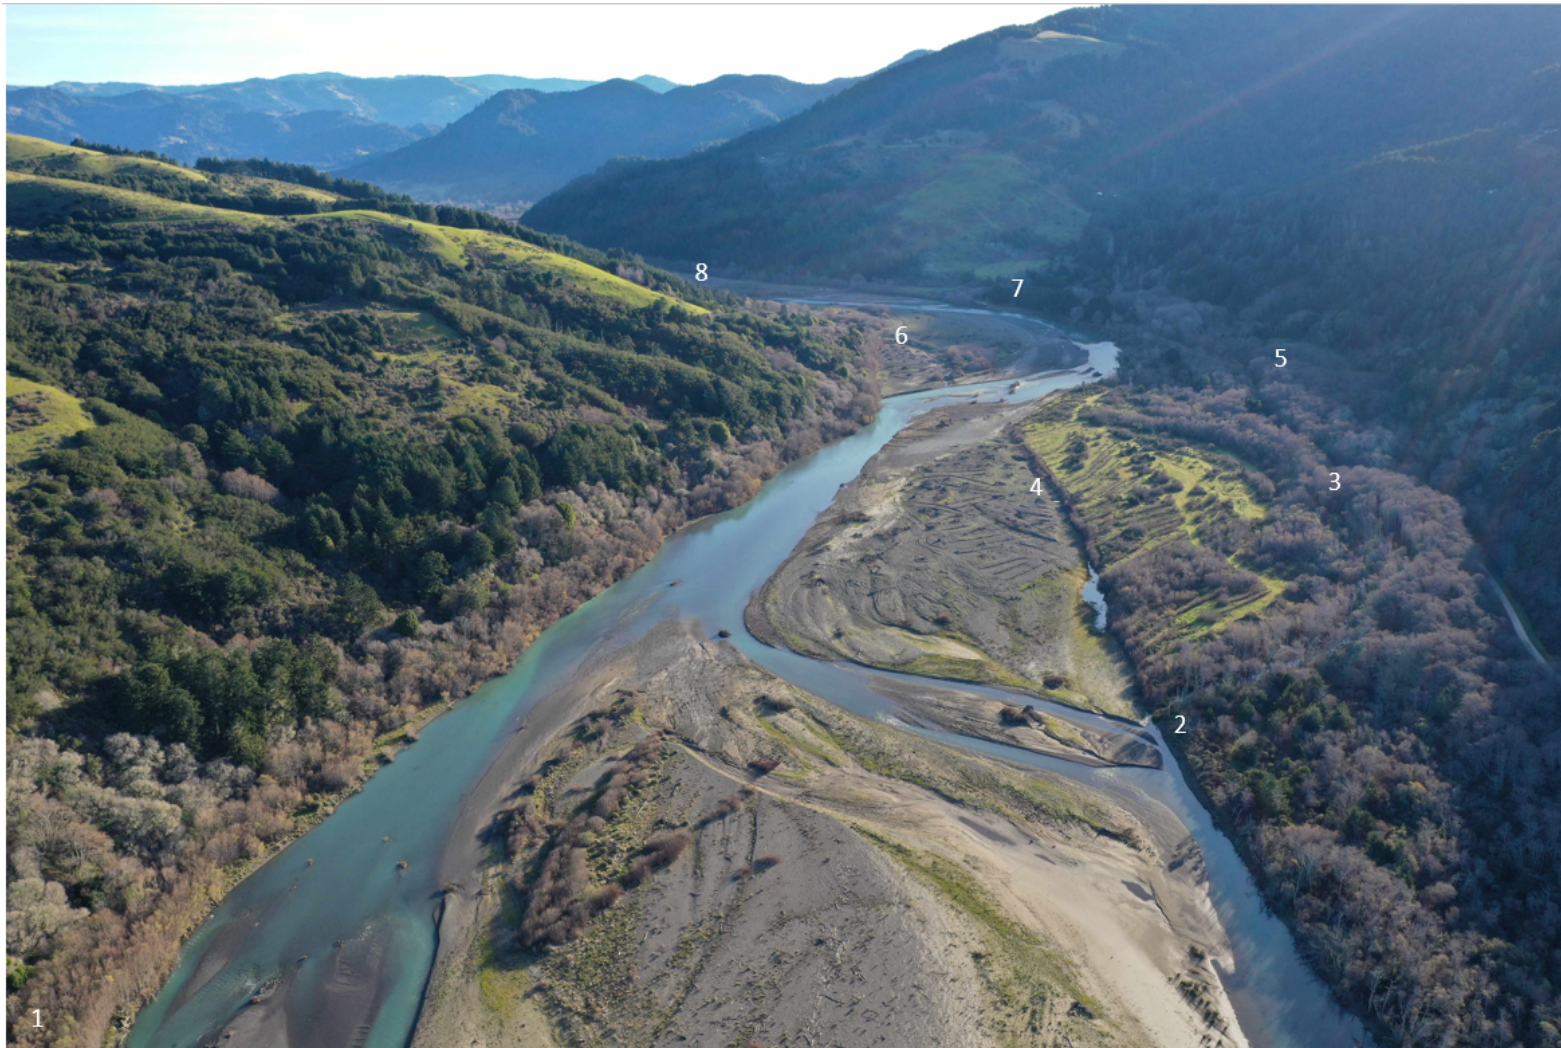
Photo by Hugh McGee, April 2023, looking east and upstream from near upper tidal extent of the Mattole estuary

1. Mouth of Collins Gulch
2. Mouth of excavated slough
3. Upstream end of slough, and Dogleg Pool
4. South terrace and floodplain, planted 2014-2020
5. Bear Creek channel realignment
6. North Bank, 2021 planting and wood
7. Lighthouse Rd emergency repair, Stansberry Ck mouth immediately upstream
8. Monadnock, planting and wood 2018-2021

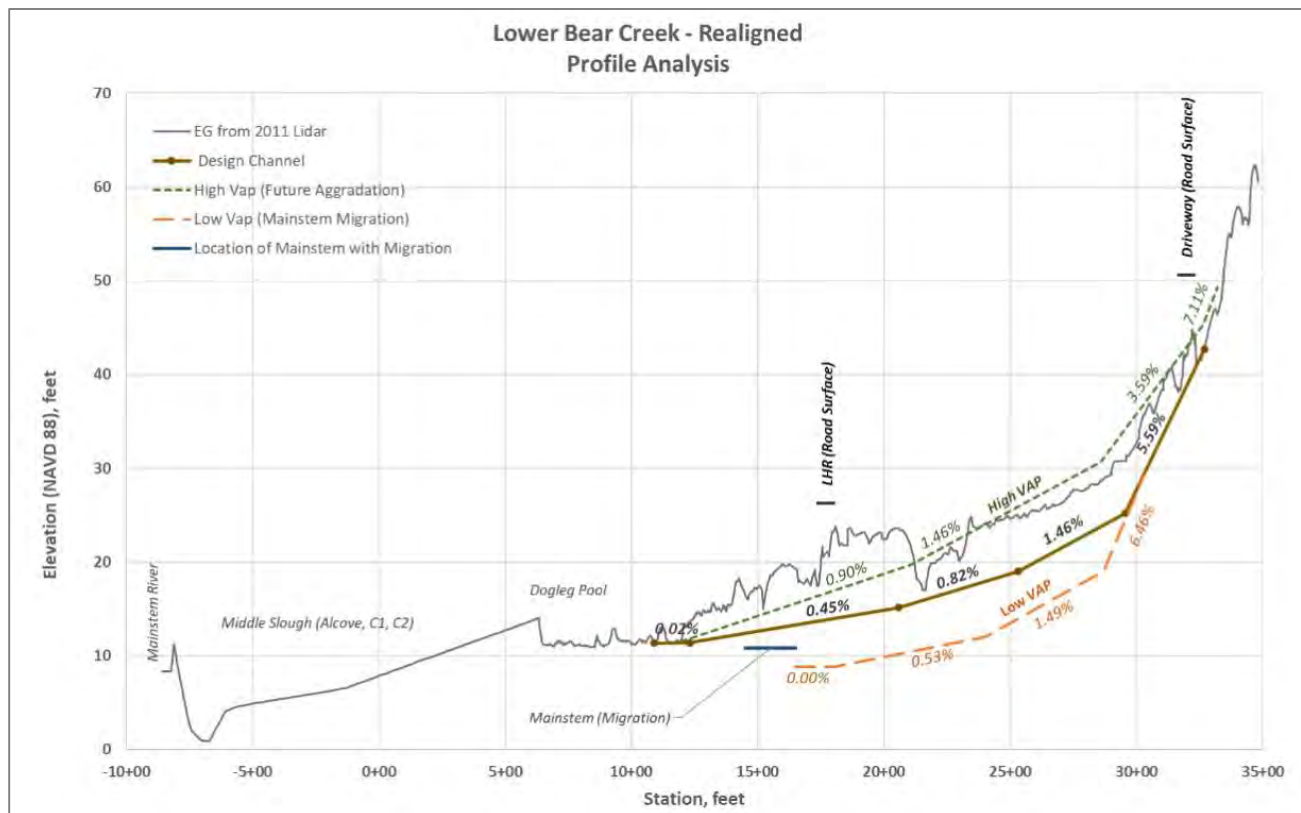
Vertical adjustment potential (VAP) profiles and existing ground (EG). The vertical adjustment potential of the channel is represented by the High VAP (Aggradation) and the Low VAP (scour from lateral mainstem river migration).

- Enhance salmonid habitat by including alcoves, backwater channels, and large wood cover structures in the LBC slough channel downstream of the alluvial fan.
- Design the realigned upper delivery channel based on an upstream natural reference reach.
- Establish the service life of the project based on aggradation extending from the head of the Dogleg Pool to the apex of the alluvial fan (referred to as the fully aggraded condition).

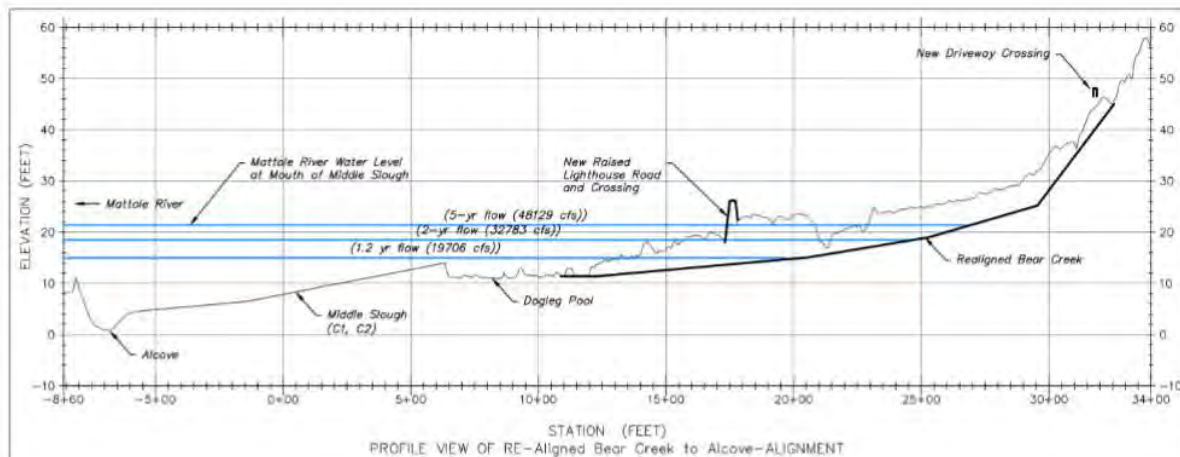
Water level in the Lower Mattole River projected on the realigned Lower Bear Creek profile.

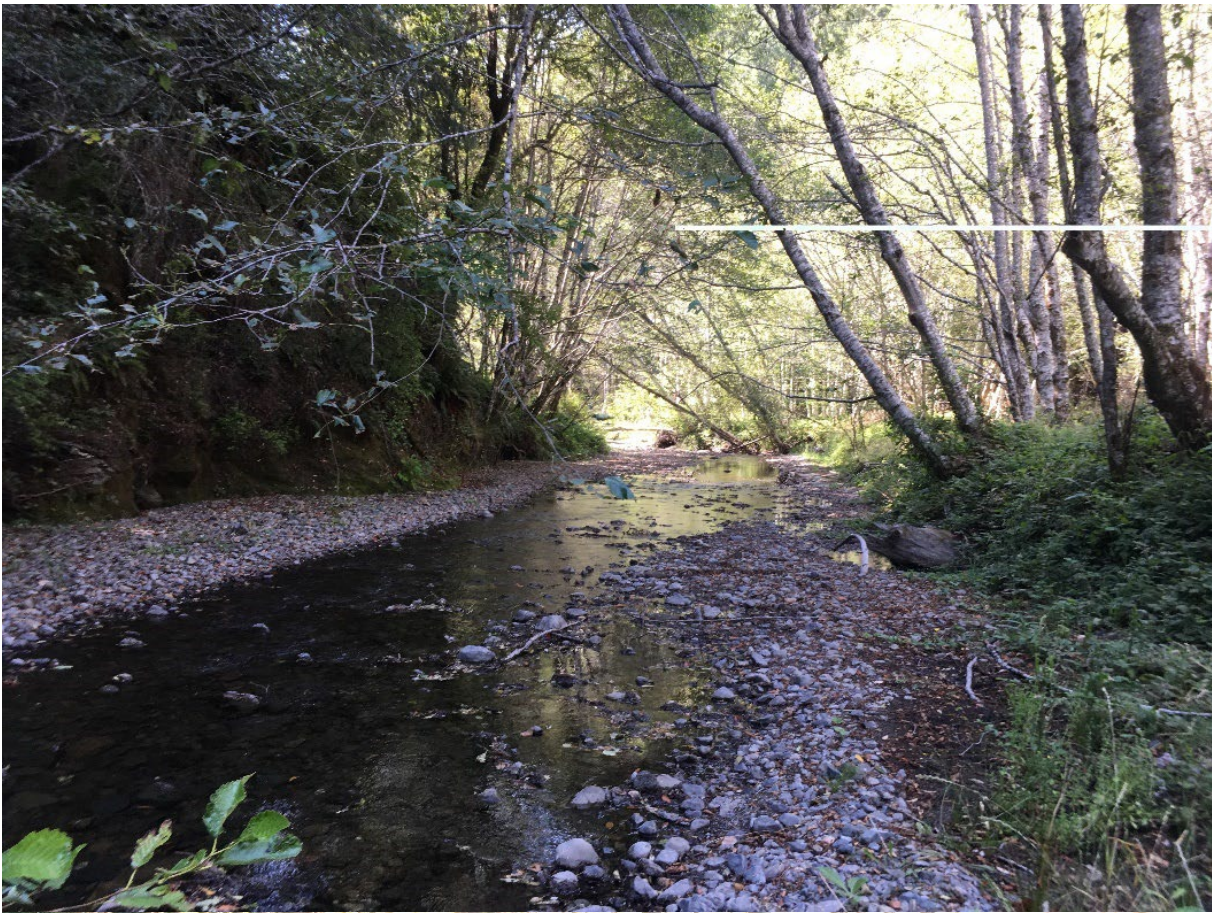
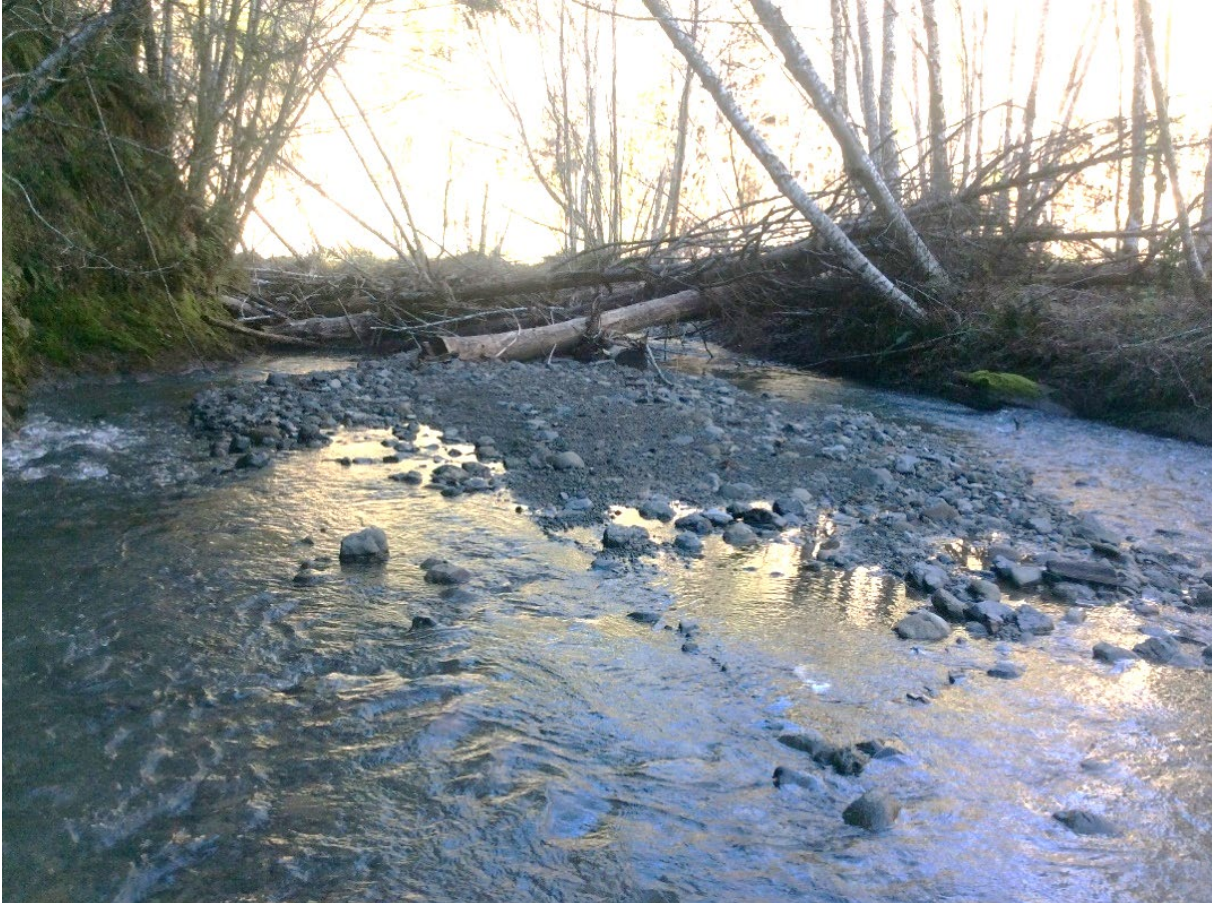
Site #8 Pre-project 2018 above, post-project 2022 below

Pre and post-project habitat surveys and snorkel surveys (sampling every other qualifying pool) were conducted in the treatment reach, and in the 1500m reach immediately upstream. Post-project data showed modest increases in pool depth relative to the control reach, and much more substantial increase in the amount of pool cover, which nearly tripled in the treatment reach. Perhaps the most notable result was the increase in the number of *O. mykiss* parr observed in the treatment reach relative to the control reach post-project, likely due to the much more complex habitat and cover created by the wood placement. These results also highlight the variability of instream habitat conditions year-to-year, and the importance of a control reach in evaluating the impact of instream projects.

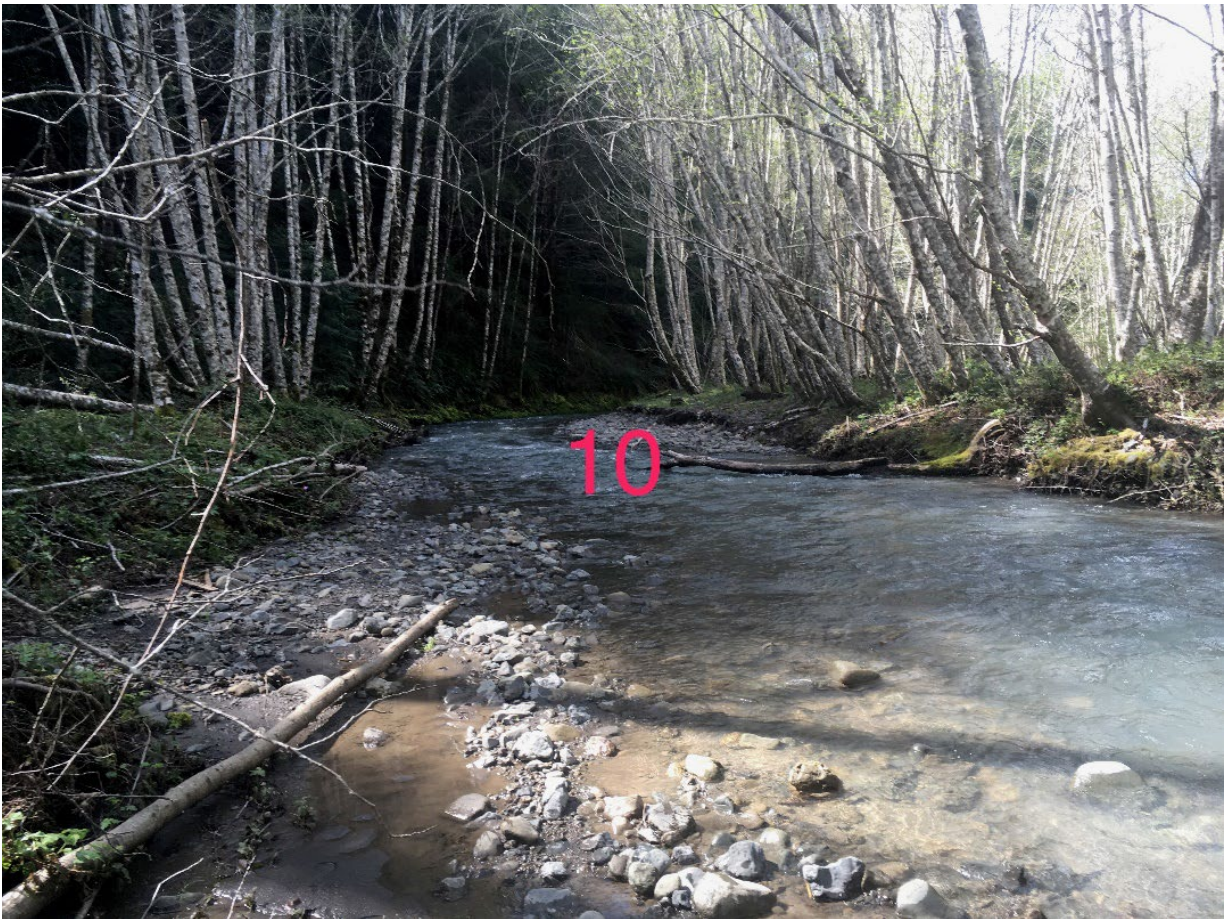
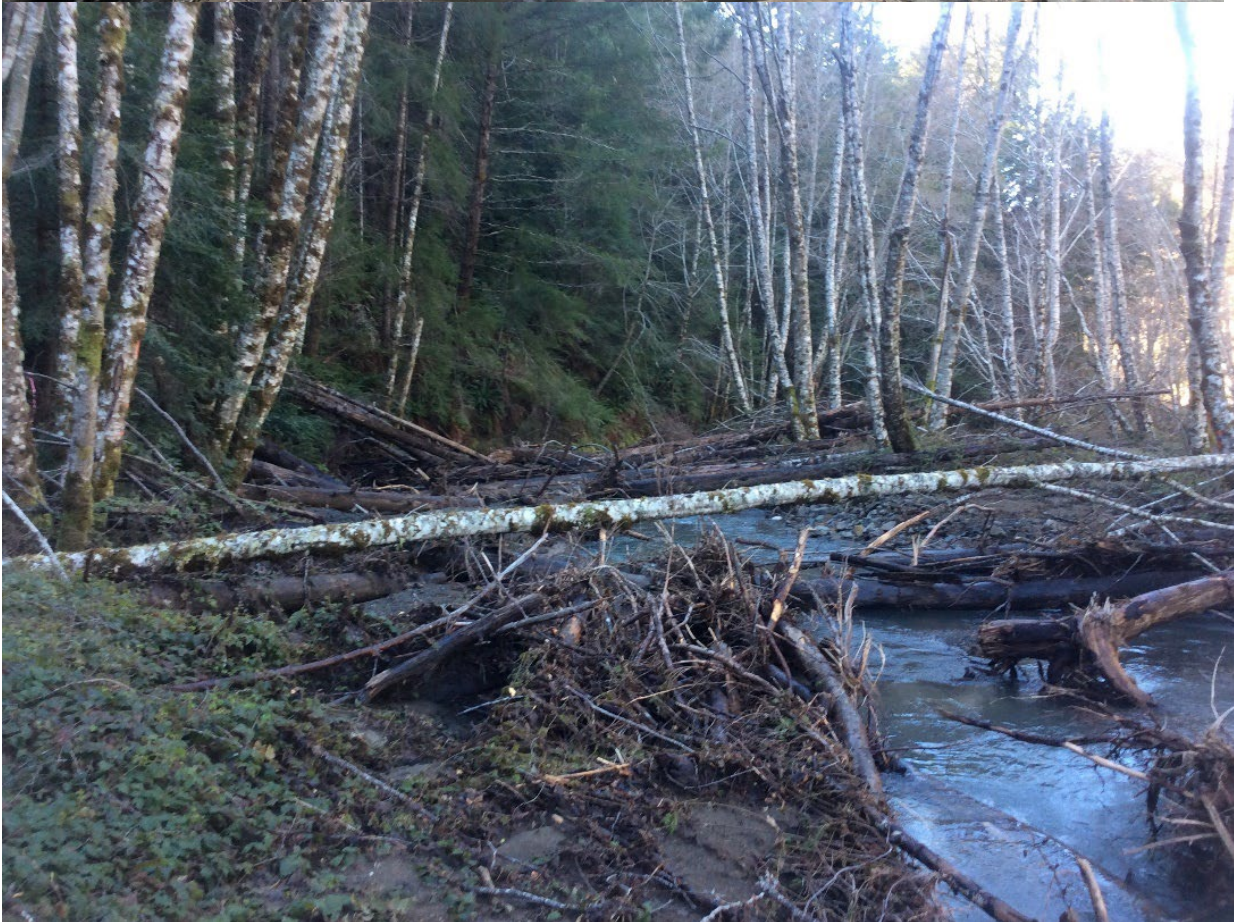
Site #10 Pre-project 2018 above, post-project 2022 below
