Fish Passage and Other Intriguing Talks

A Concurrent Session at the 41st Annual Salmonid Restoration Conference
Santa Rosa, California, March 26-29, 2024

Aquatic Organism Passage (AOP) and Culvert Asset Management in North America

Sulphur Creek Fish Passage Restoration Project

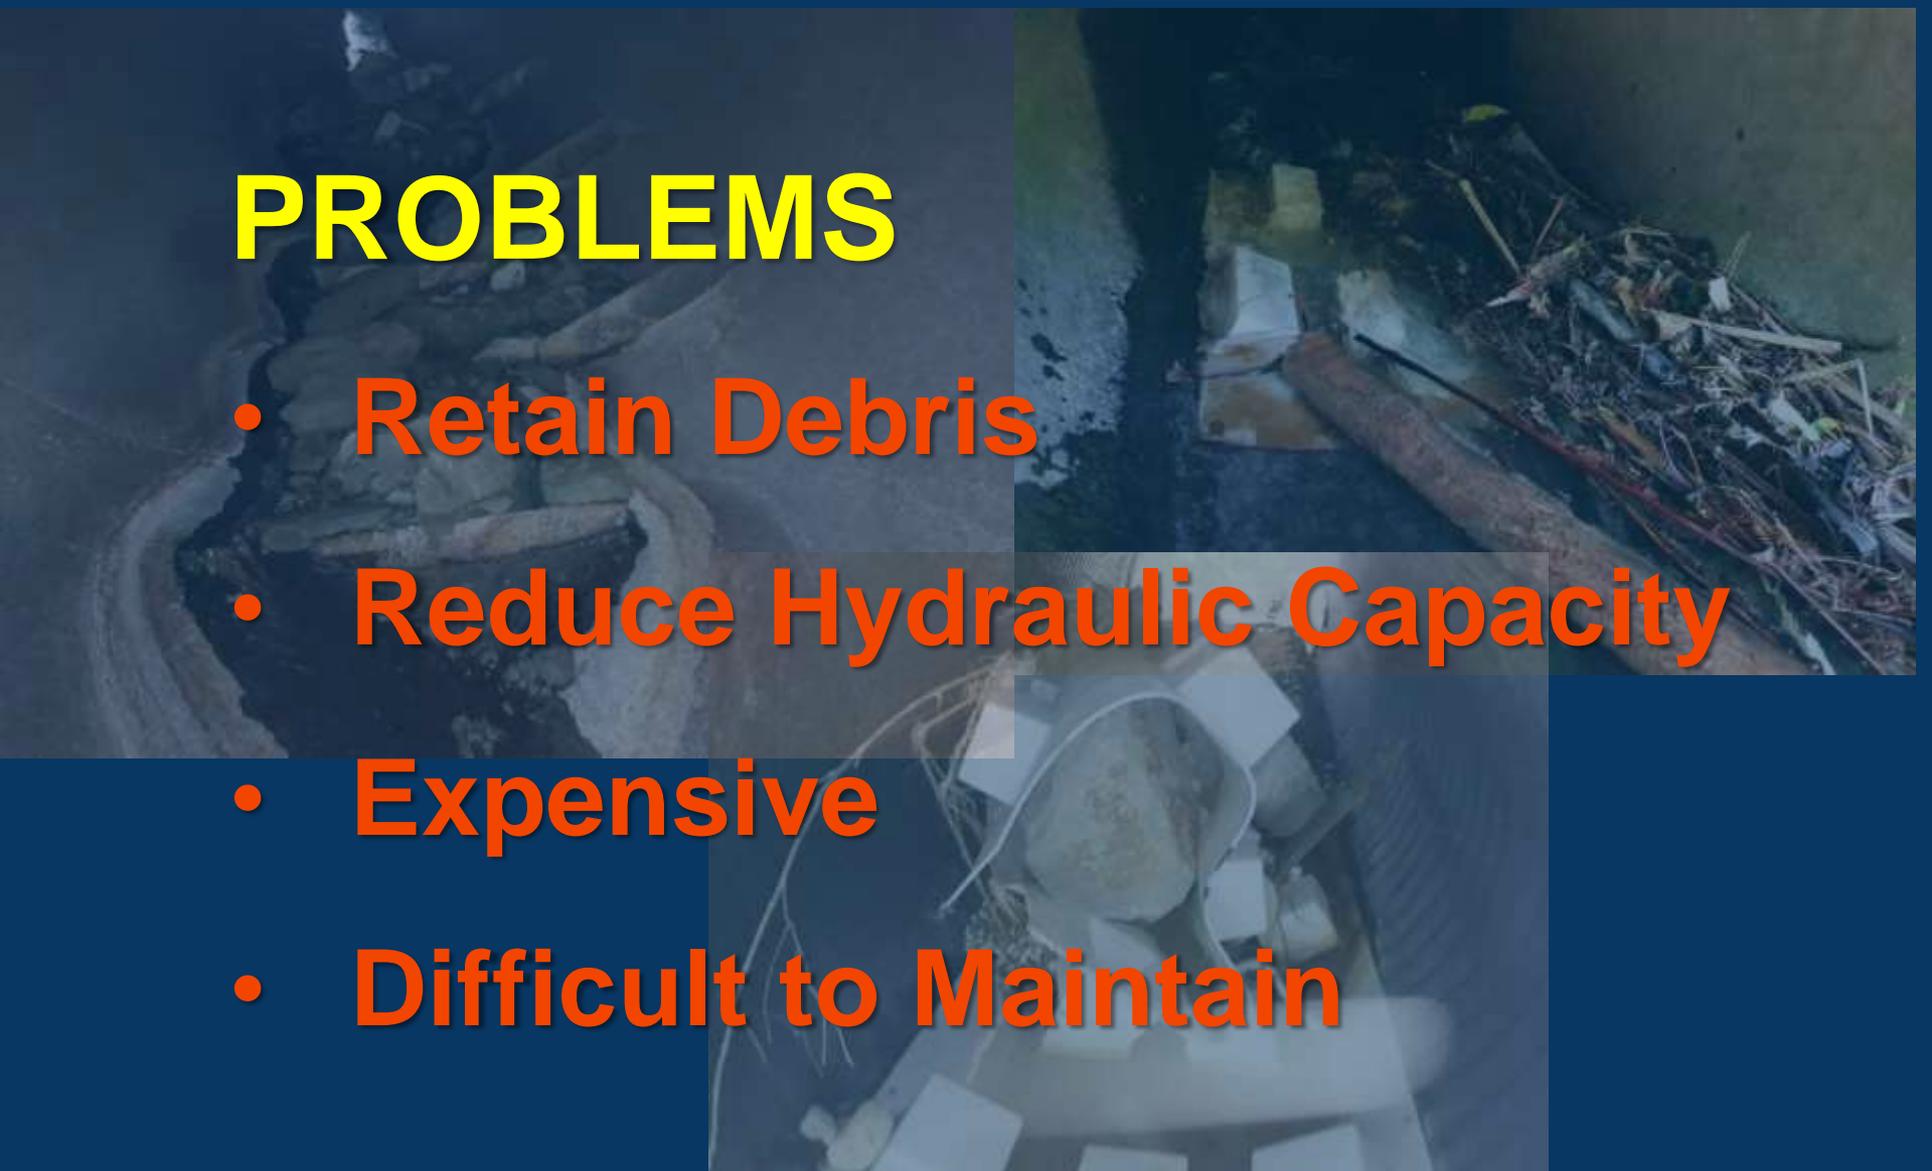
Solid Baffles

PROBLEMS

- Retain Debris
- Reduce Hydraulic Capacity
- Expensive
- Difficult to Maintain

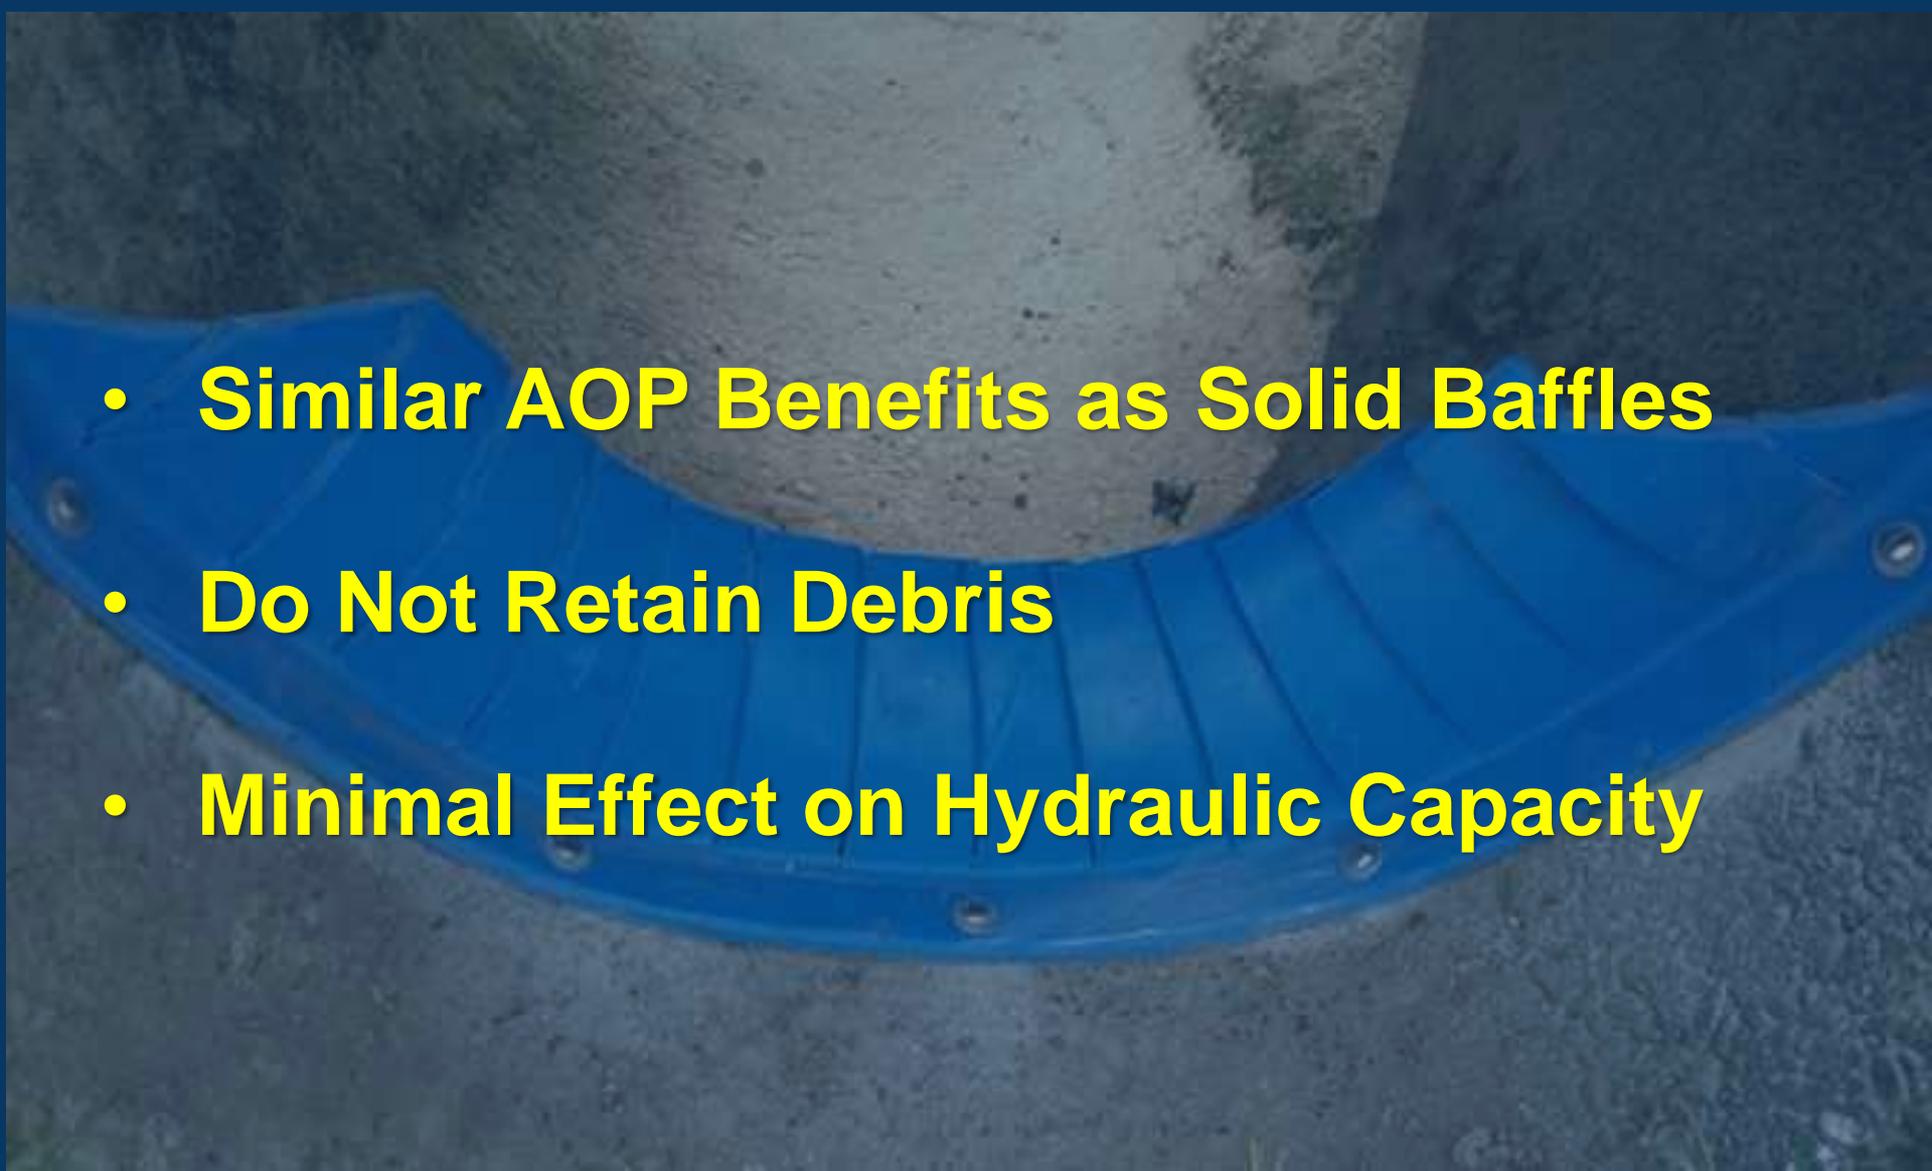
Flexible Baffles

- **Similar AOP Benefits as Solid Baffles**
 - **Do Not Retain Debris**
 - **Minimal Effect on Hydraulic Capacity**
-

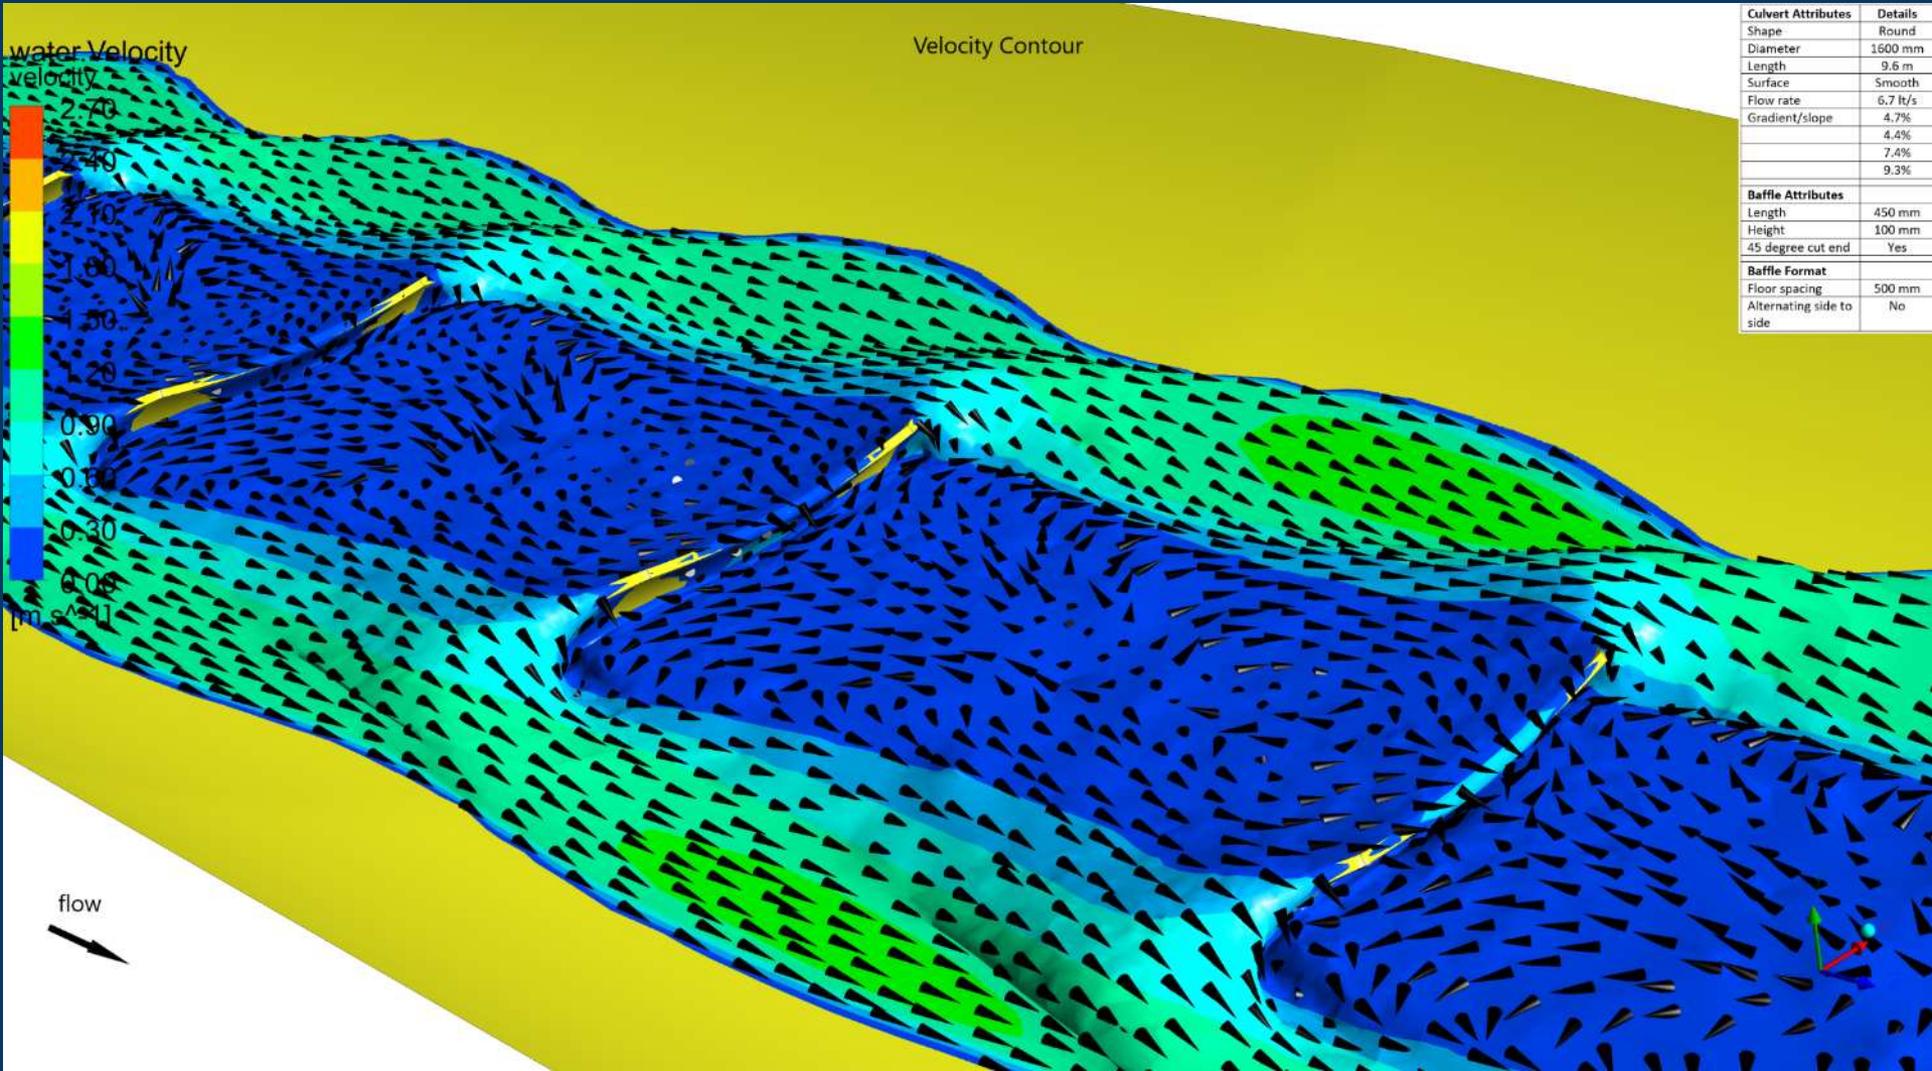
CFD Modeling

| Culvert Attributes | | Details | |
| Diameter | | 1600 mm | |
| Length | | 9.6 m | |
| Gradient/slope | | 4.7% | |
| Length | | 450 mm | |
| Height | | 100 mm | |
| Floor spacing | | 500 mm | |

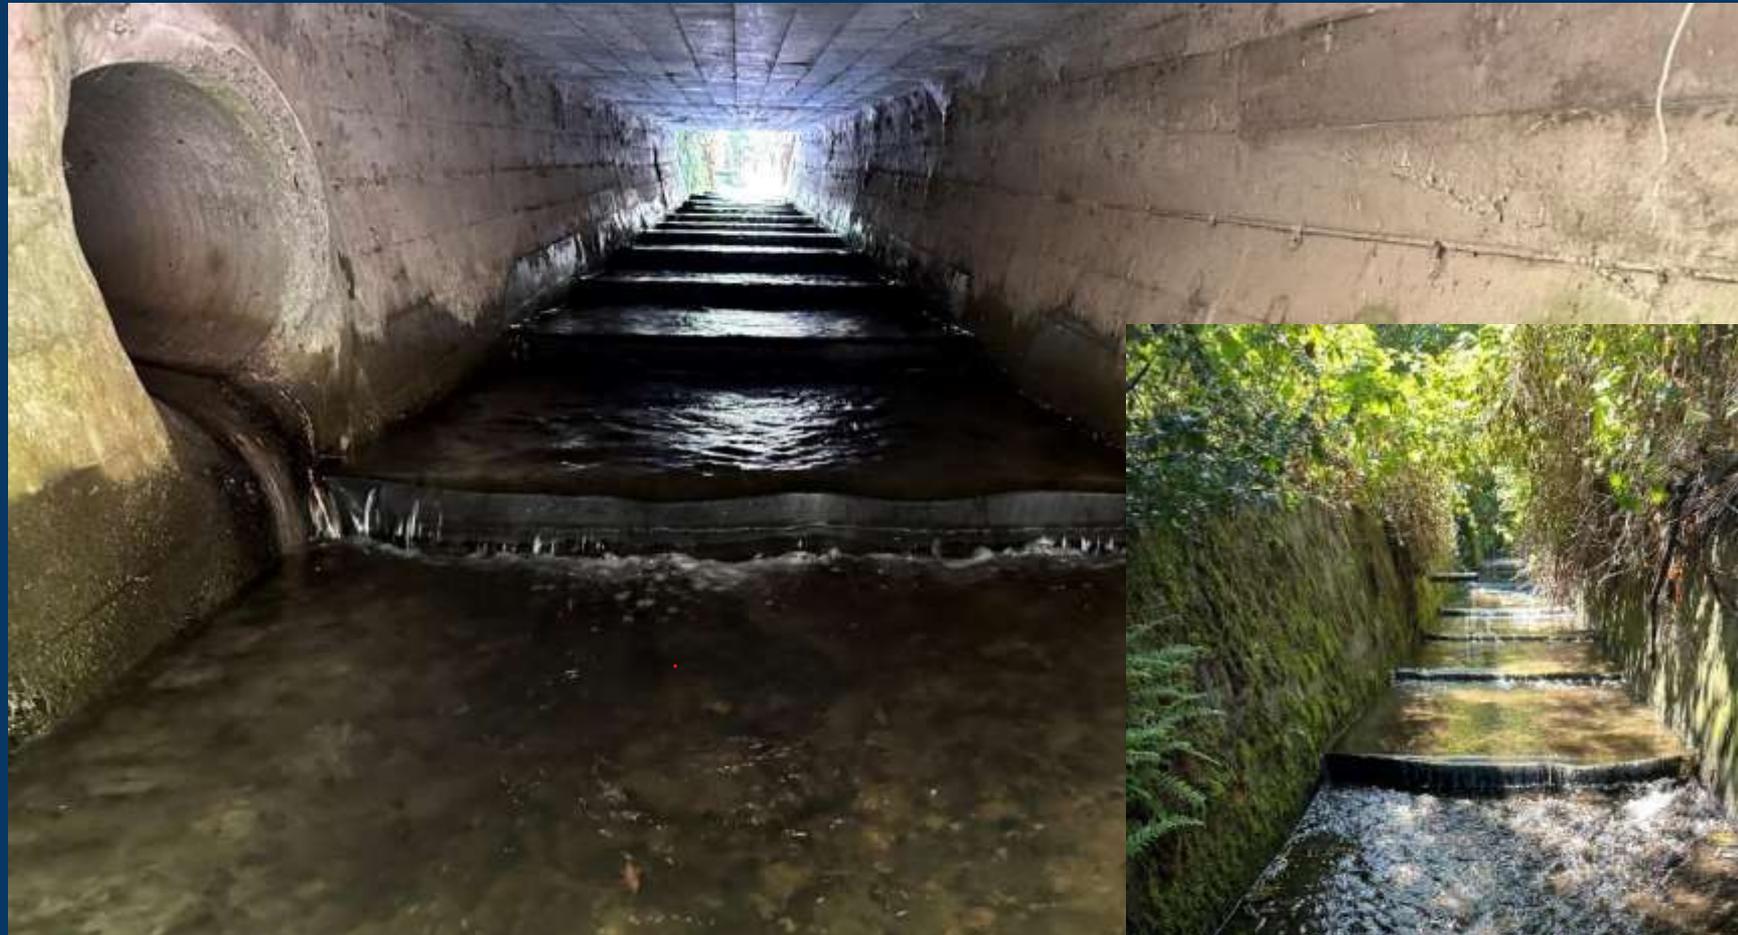
- Sixty x 2M Flexi Baffles Every 3M
- Installed by City of Surrey's Salmon Habitat Restoration Program (SHaRP)

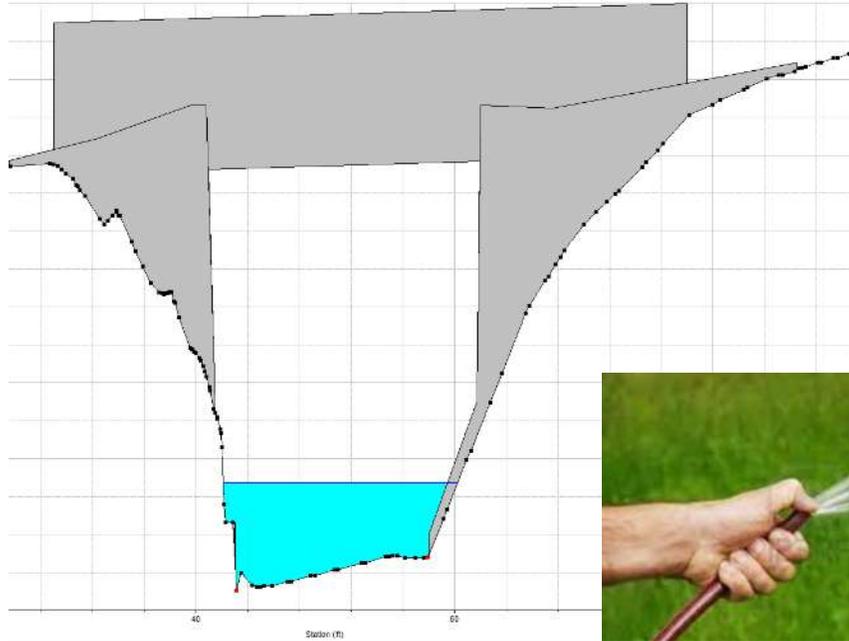
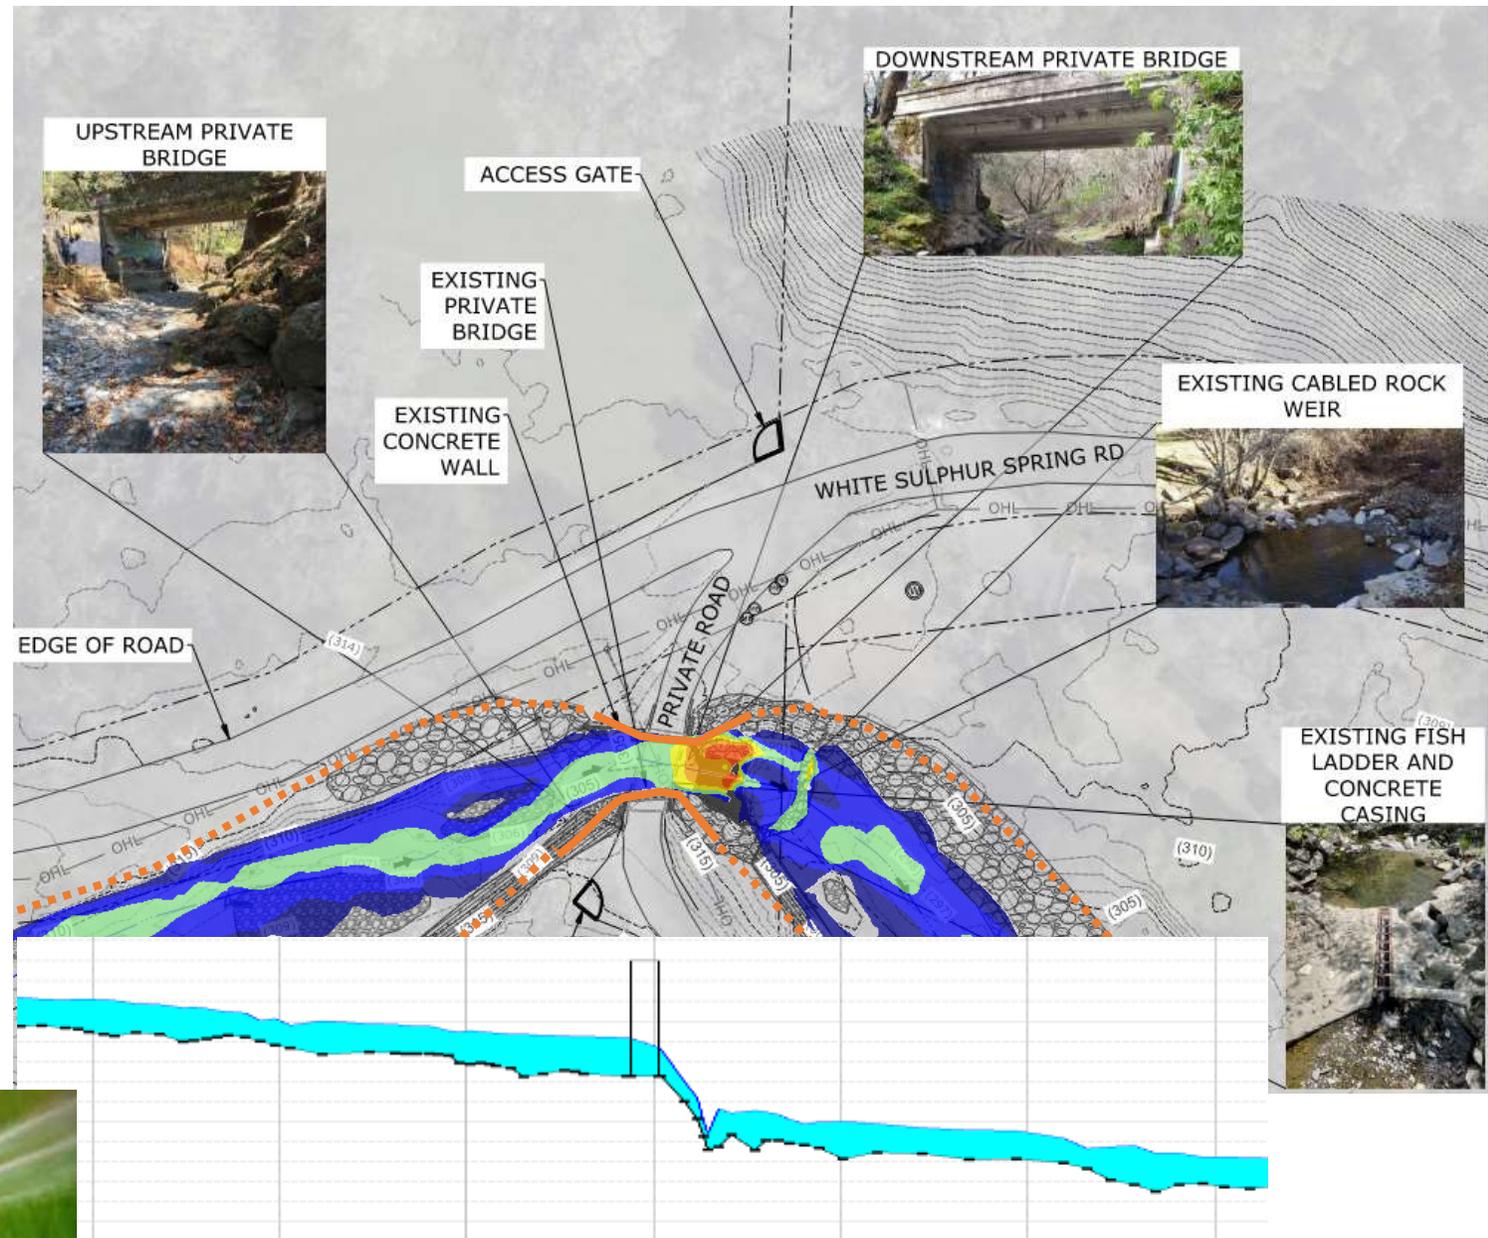
Existing Conditions

- Channel
 - Avg 2.5% slope
 - Mix of large boulders, cobbles, gravels
 - Bankfull width = 25 to 30 feet
- Bridge
 - Confining Channel = **15 feet wide**
 - Considered historical
 - 5-foot drop at 25% slope
- Existing Concrete and Rock Revetments

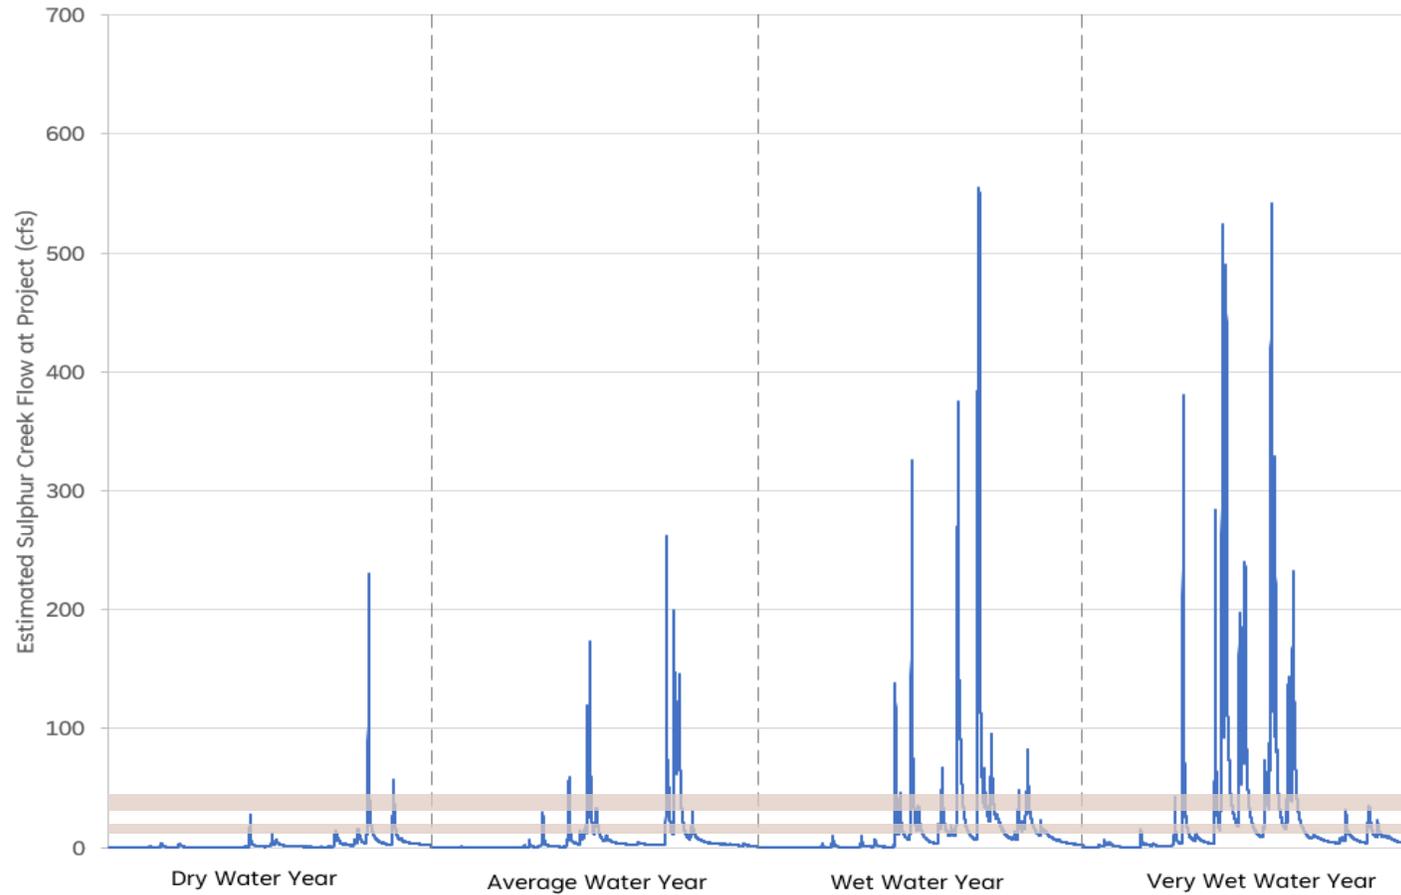
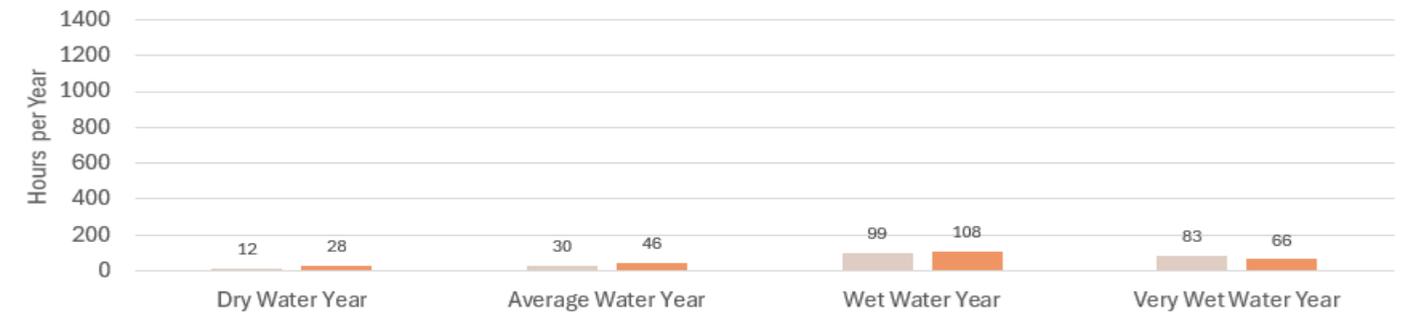
Existing Conditions Fish Passage

Existing fish passage flows

■ Adult Existing Passage (30 to 35 cfs)
 ■ Juvenile Existing Passage (12 to 13 cfs)

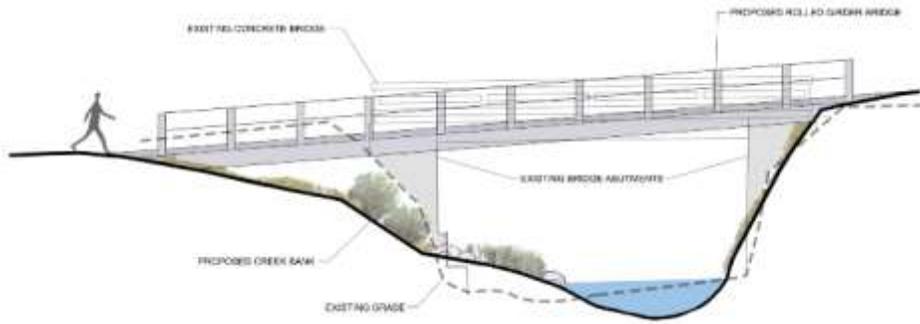
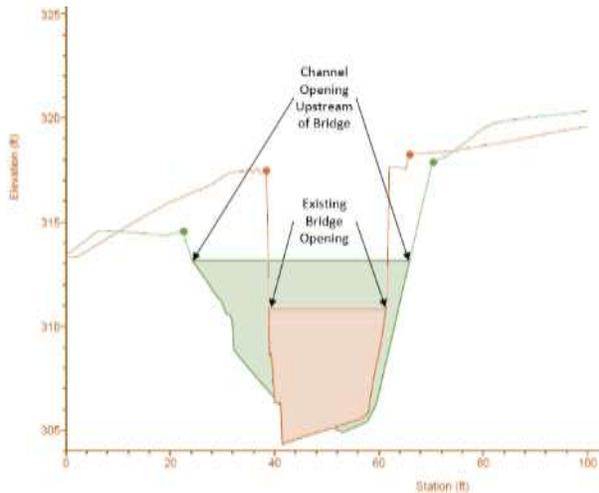
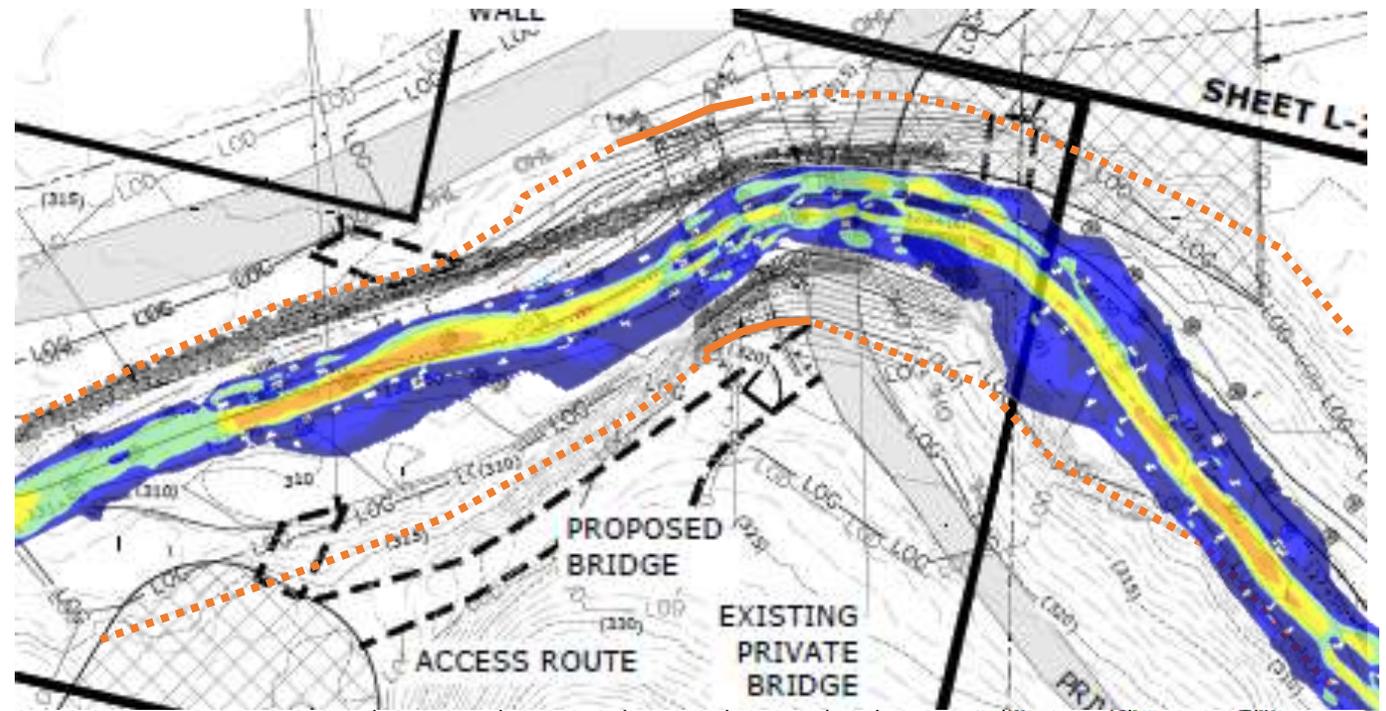
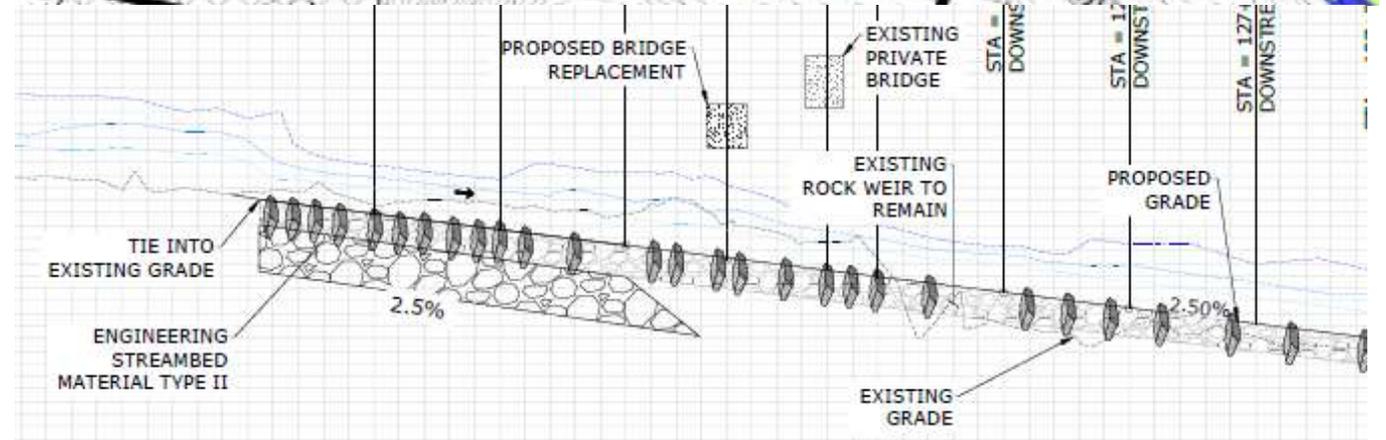
Current Design

- Larger Span
- Fish Passage Greatly Improved
- “Natural” Channel
- Allows for Wildlife Movement along Creek
- Minimal Risk of Flooding

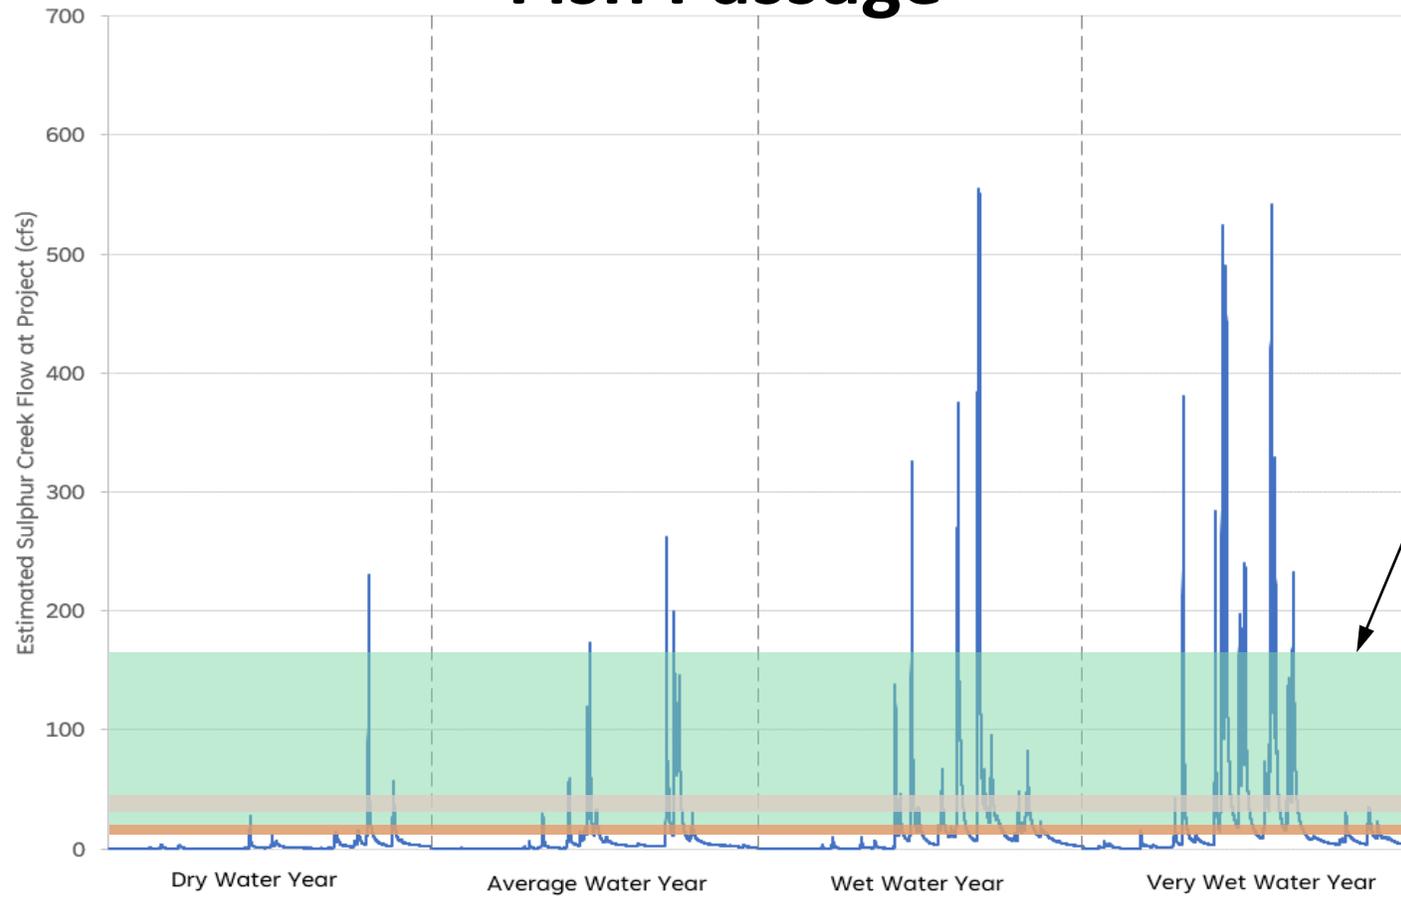
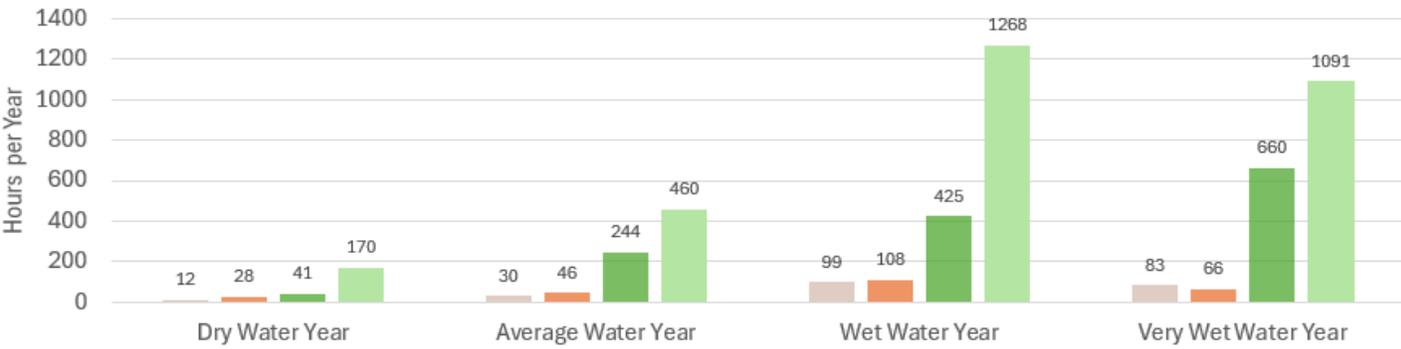
Existing and Project Conditions Fish Passage

Project fish passage flows

Existing fish passage flows

- Adult Existing Passage (30 to 35 cfs)
- Juvenile Existing Passage (12 to 13 cfs)
- Adult Project Passage (30 to 150 cfs)
- Juvenile Project Passage (12 to 70 cfs)

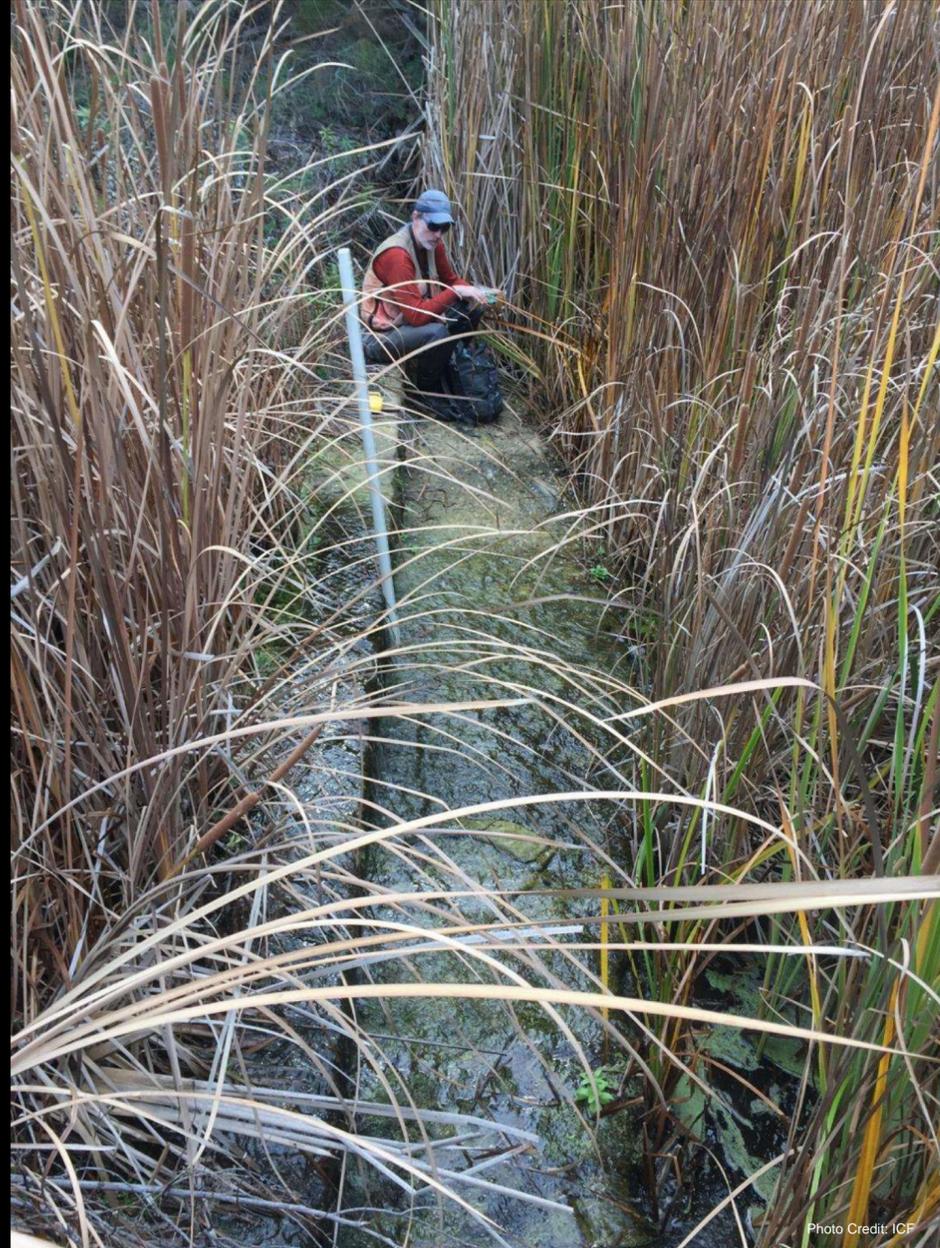
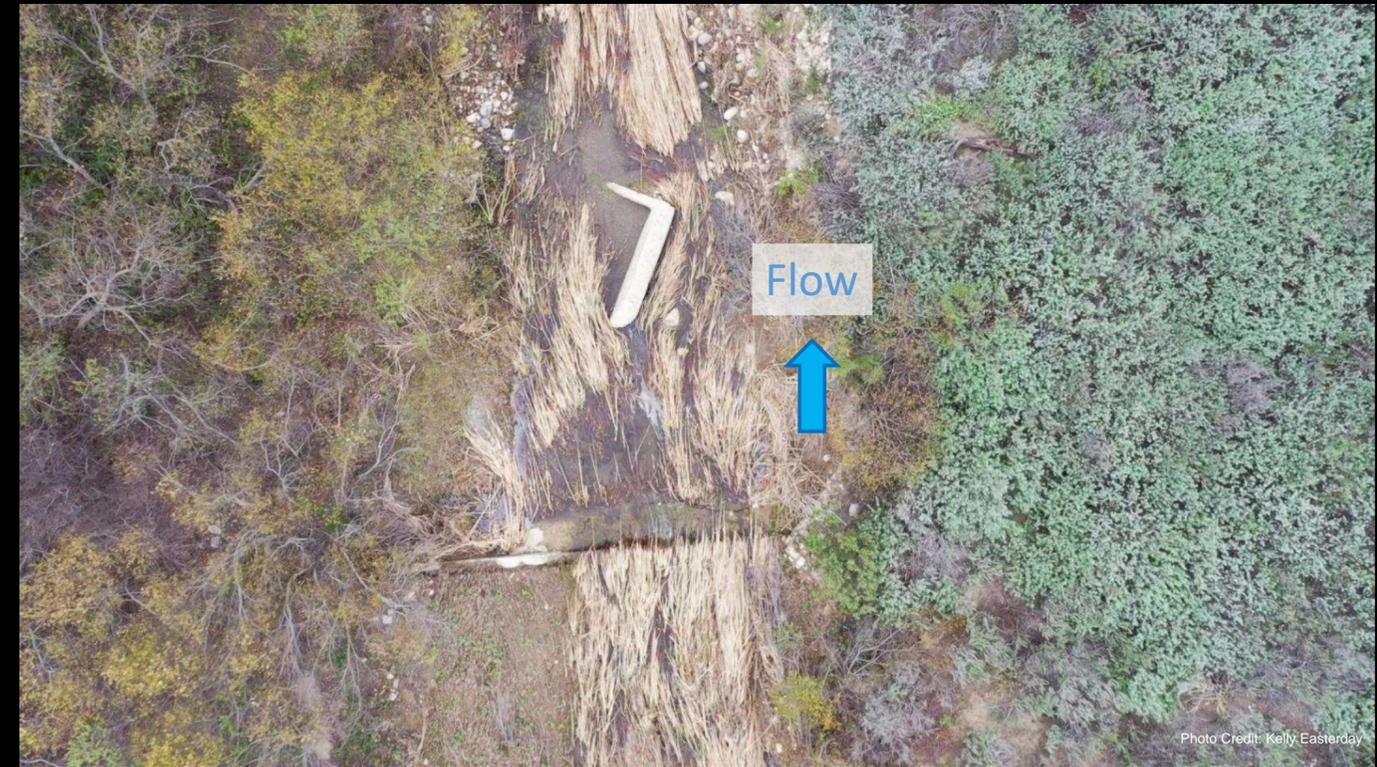
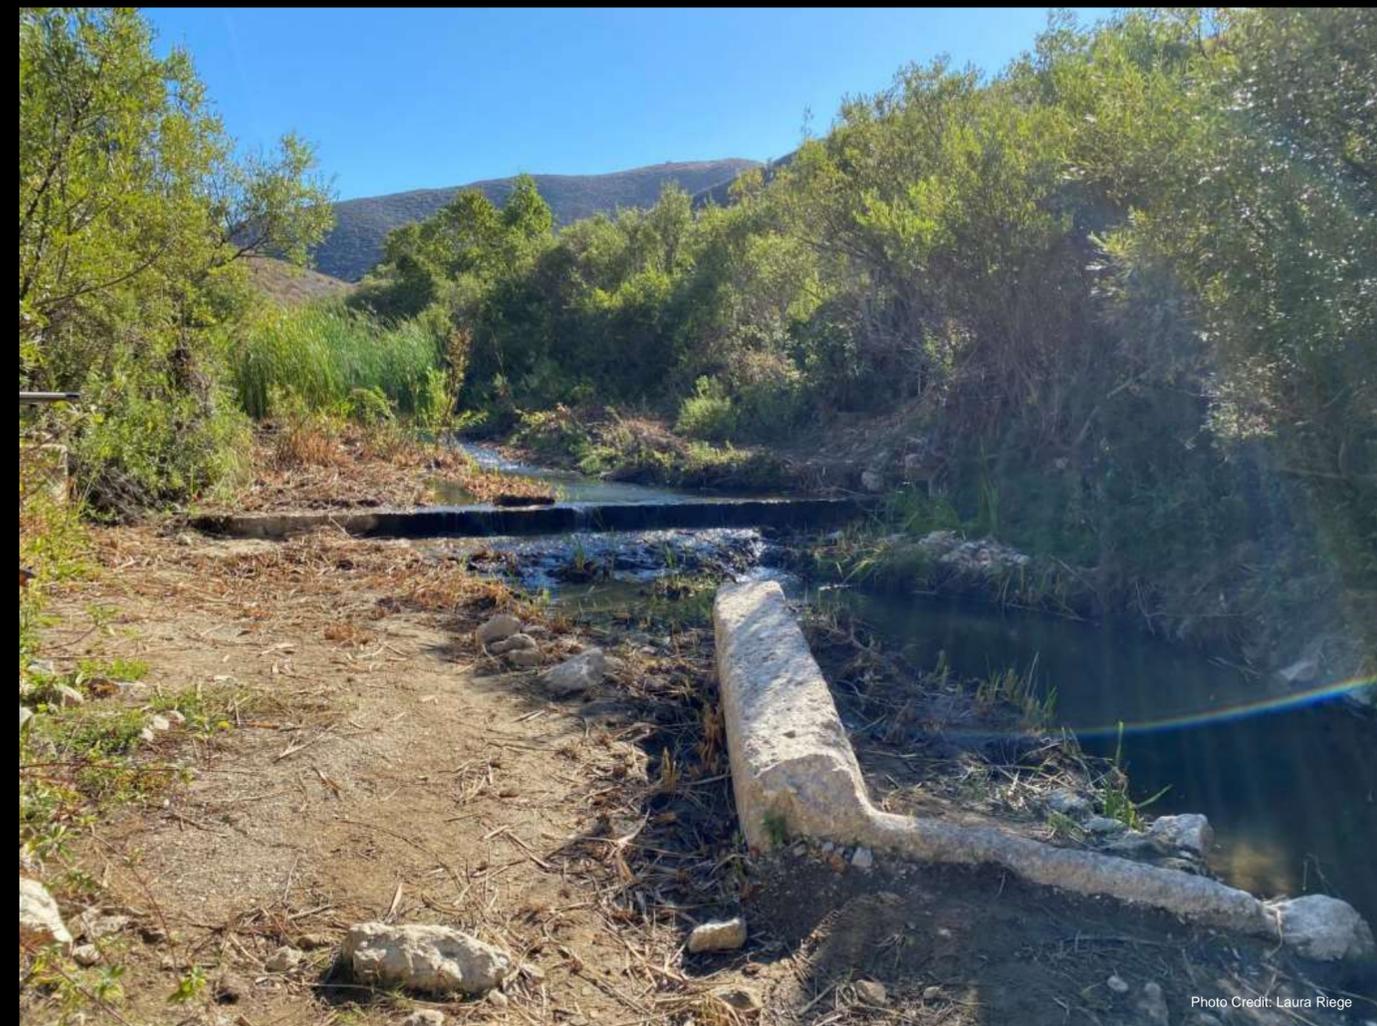
Barrier JA-1

Built in 1968

4.5-foot-long (stream length)

Blocks steelhead passage under most flow conditions

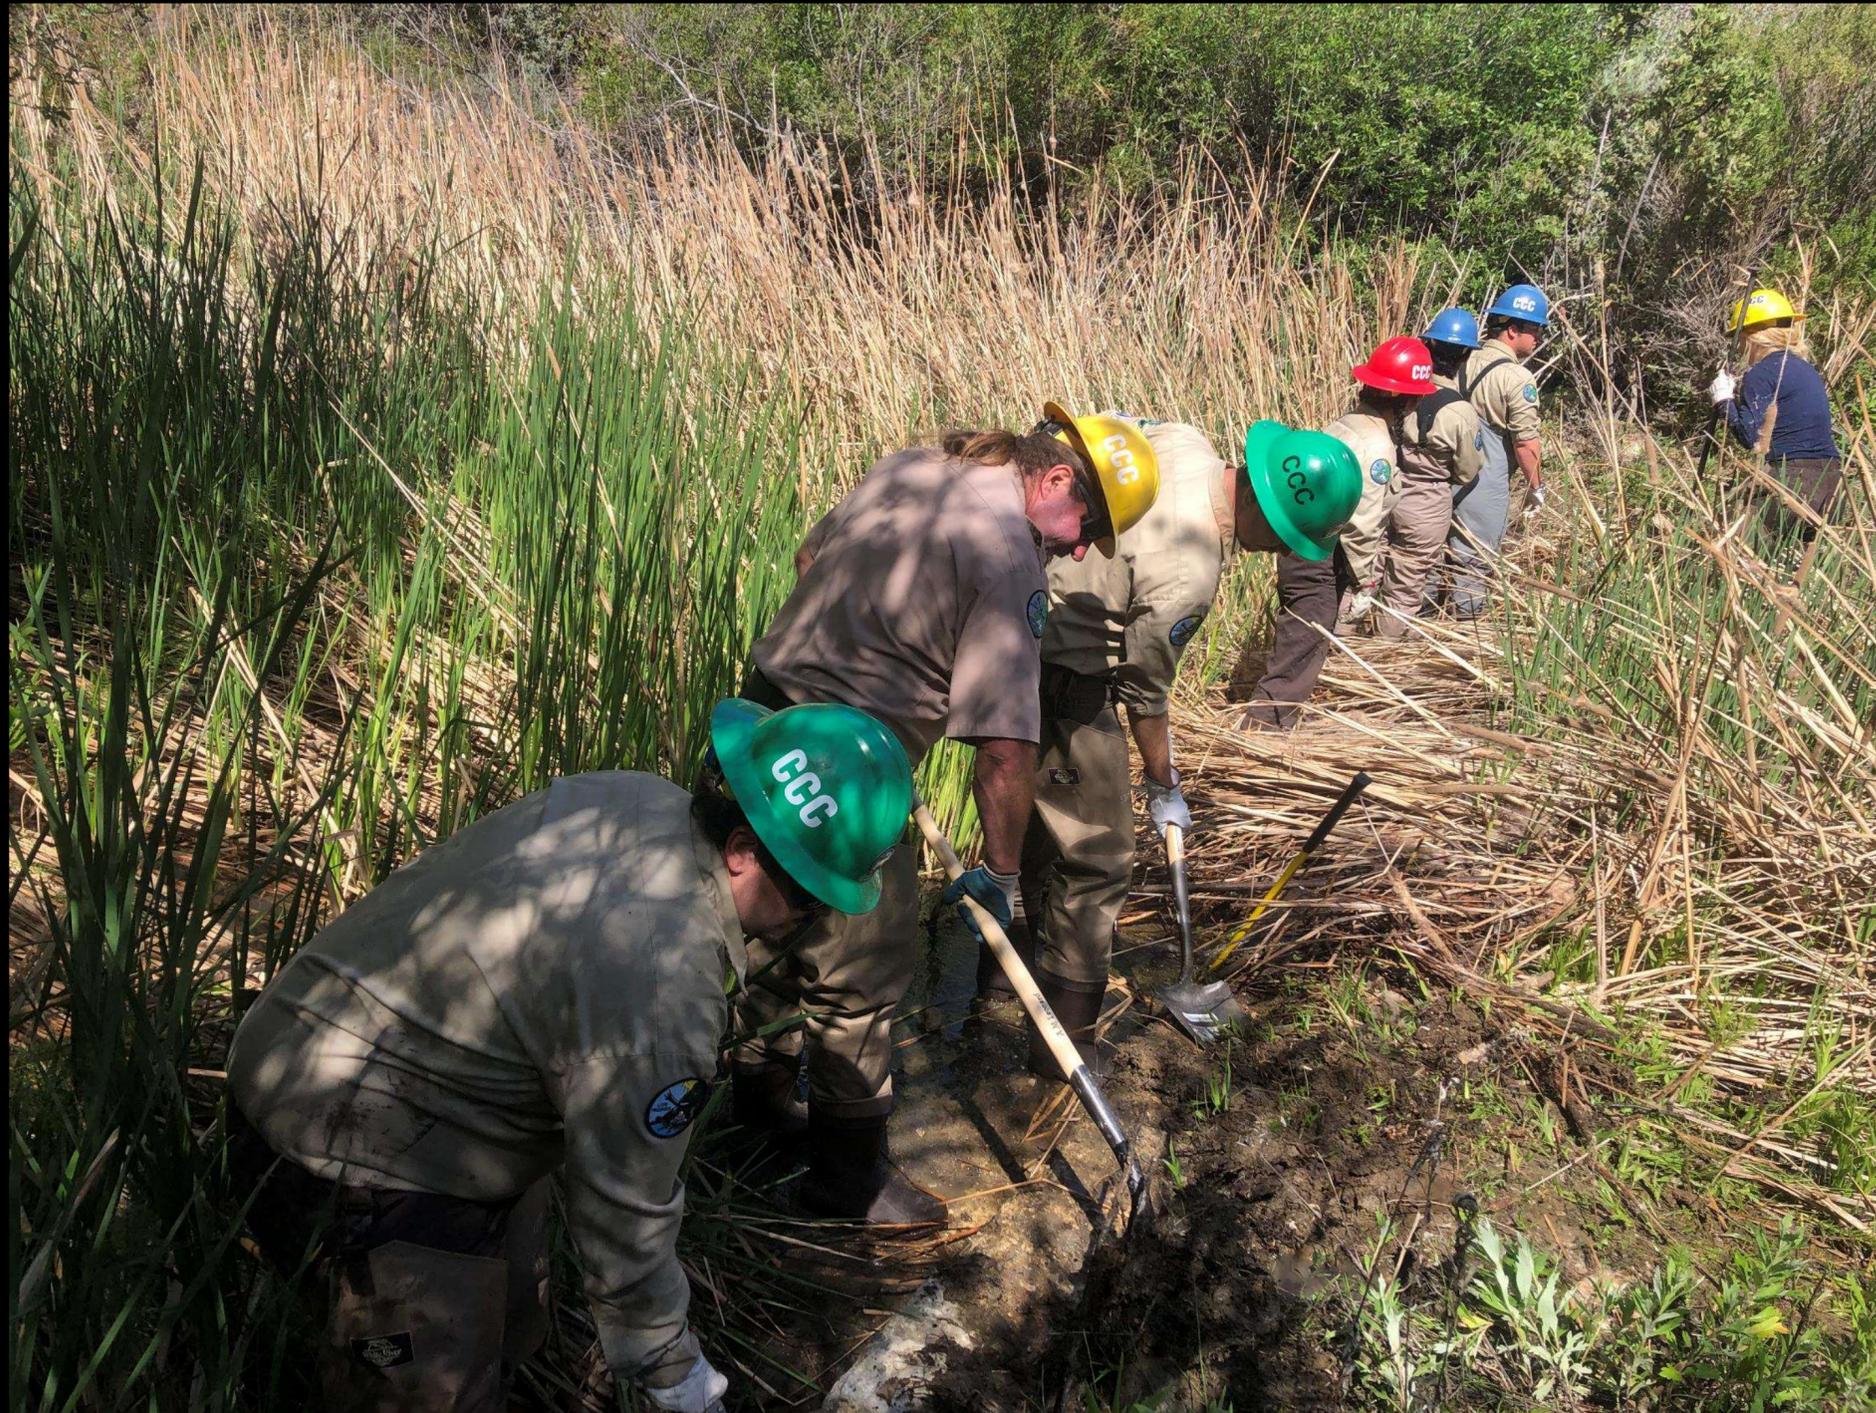
Removal Approach

- CCC access on foot via VSFB
- Dewater the creek to protect CA red-legged frogs, fish/steelhead, pond turtles
- Break up concrete
- Load concrete into megabags
- Helicopter lift megabags to staging area
- CCC digs a starter channel
- Winter storms will reset the creek
- September 1 – November 1
