Fish Passage and Other Intriguing Talks

A Concurrent Session at the 41st Annual Salmonid Restoration Conference
Santa Rosa, California, March 26-29, 2024

Aquatic Organism Passage (AOP) and Culvert Asset Management in North America

Sulphur Creek Fish Passage Restoration Project

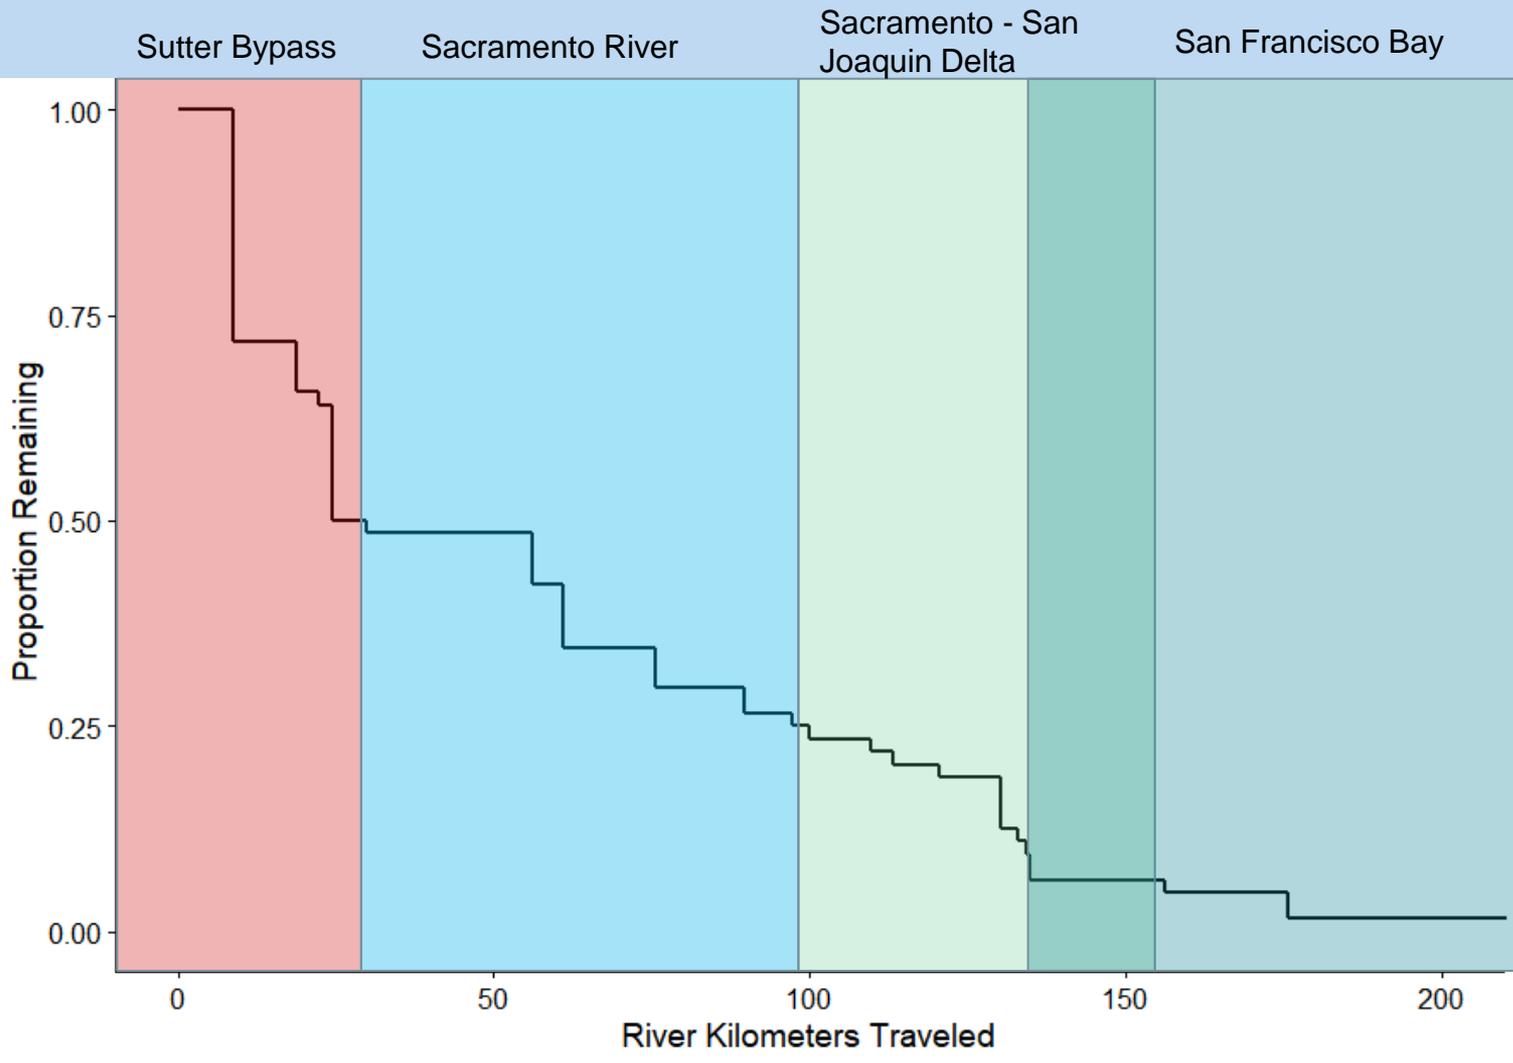
Kaplan- Meier survival curve showing proportional survival over distance from release. The distinct regions of migration are displayed in colored and labeled columns.

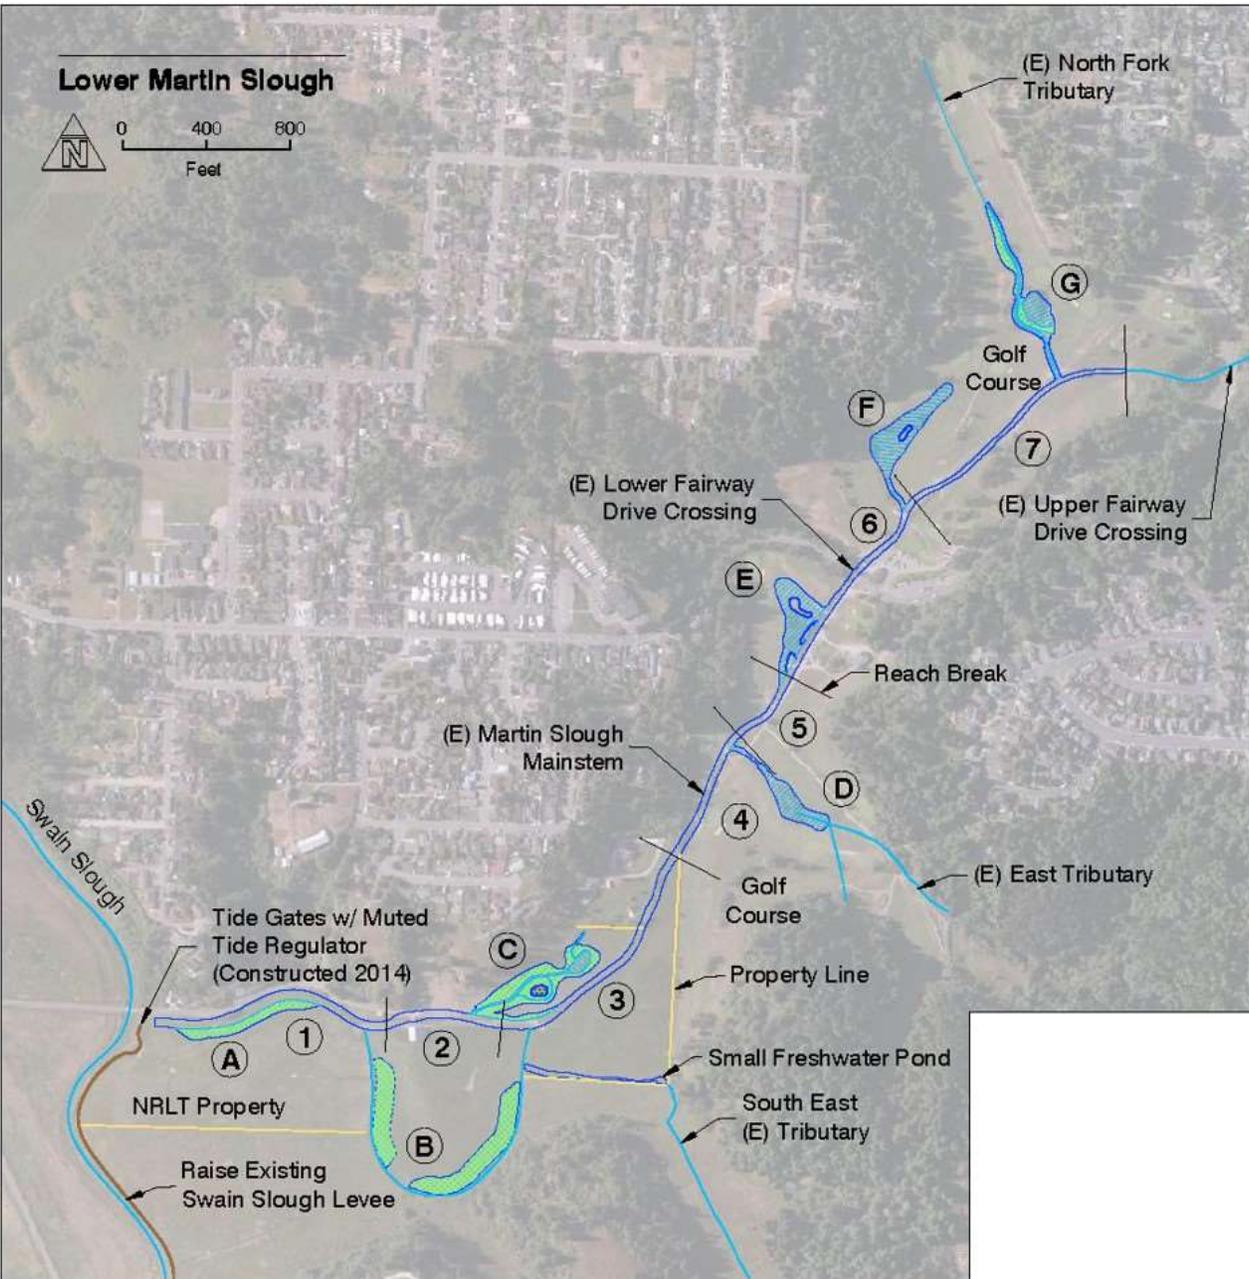
- Description**
- New tide gates to increase conveyance and restore limited tidal influence, construction and enlargement of tidal and freshwater wetlands to increase floodwater storage and provide enhanced fisheries and waterfowl habitat, and enlarged channel to increase floodwater and tide water conveyance through project area.

- A & B** (2.75 acres) - salt marsh plain 50 ft wide paralleling slough channel and 70 ft wide along abandoned meander.
 - C** (1.72 acres) - Salt marsh with low elevation pond connected to springs.

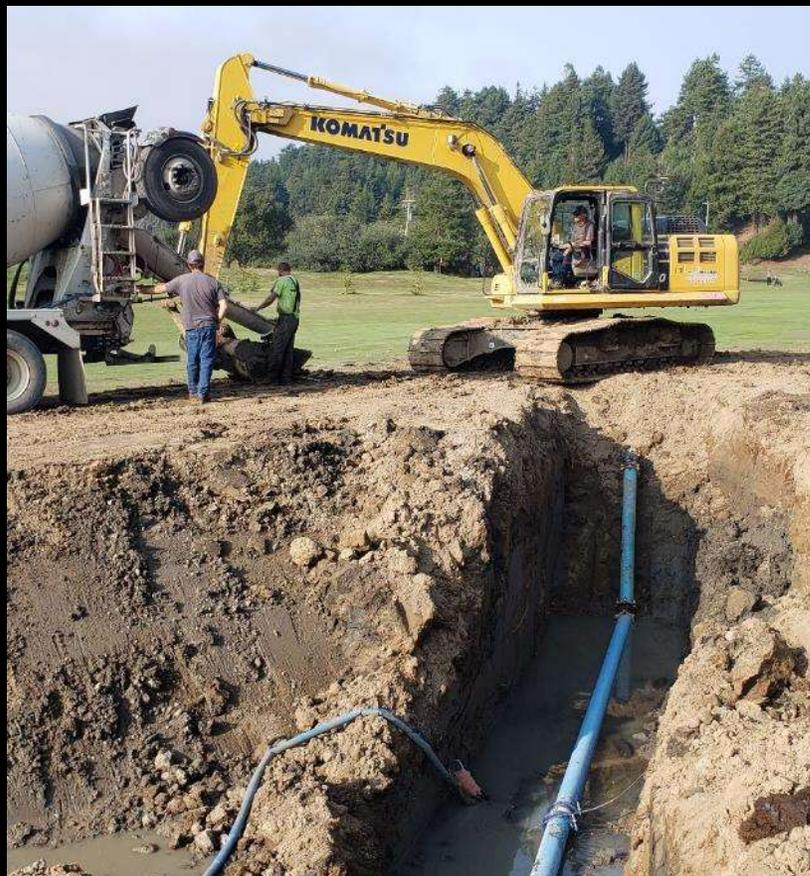
Irrigation Water Line Replacement Under Widened Channel

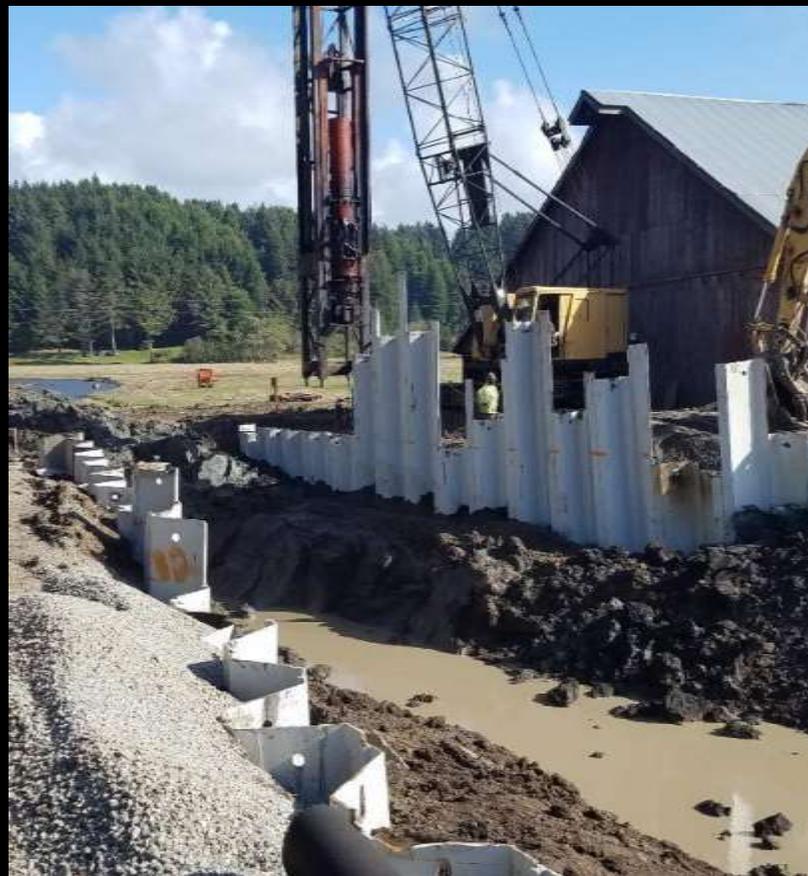
Sheet Pile Installation Near Narrowed Channel and Barn Crossing
