SRH-2009-47

River Spanning Rock Structures Field Investigations 2008

Pacific Northwest Region

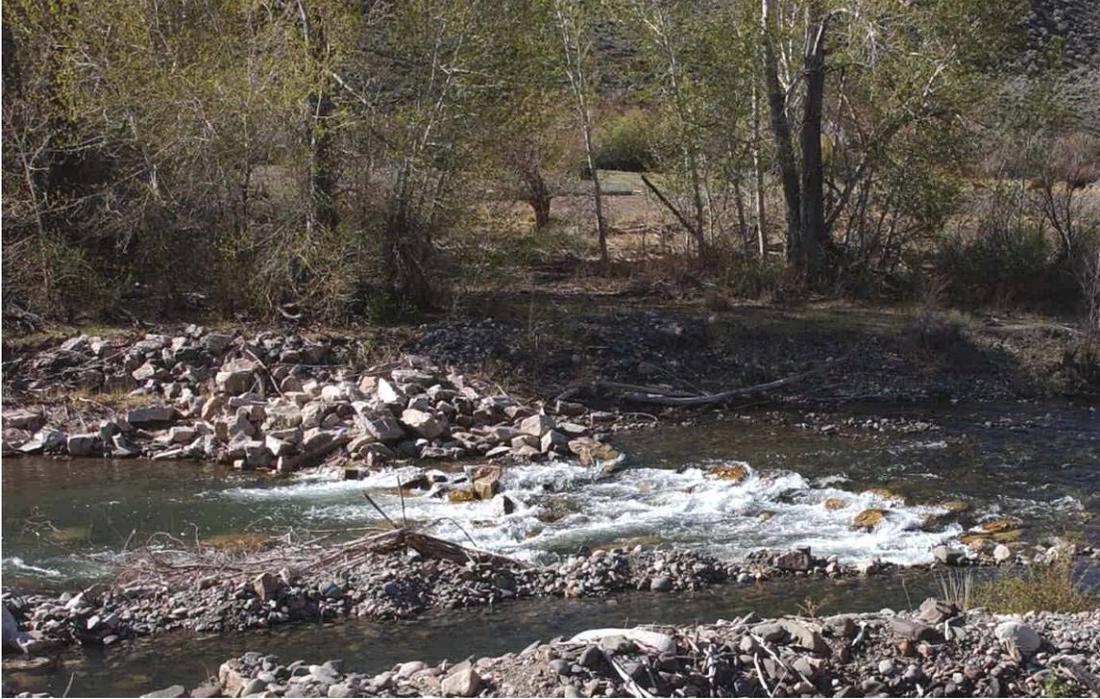
Structure EF 7-8 is located in a system with a high sediment load, but has mostly maintained its structural integrity over the last 10 years likely due to its location in a fairly straight section of channel that is not associated with active deposition or lateral channel migration. Several years of photographs are available to evaluate changes to the structure between 2003 and 2008. However, there was some mobilization of member rocks that occurred between 1998 and 2003 that are not visible in the photographs. The displacement that has occurred appears to be associated with sliding and rolling of some of the smaller constituent rocks and/or geotechnical slumping of some of the footer rocks (footers) and subsequent mobilization of the header rocks (headers). Figure 5 illustrates mobilization in several of the header rocks along the throat and arms of the structure by April 2004. By October 2008, even more of these rocks have mobilized (Figure 6), and backfill along the left arm of the structure has either been mobilized or additional large rock was placed to protect the irrigation ditch. It is unclear if the design intentionally created a ramp-like feature on the downstream end of the structure or if rocks have been mobilized to this area, creating a sloped ramp.

Figure 5. East Fork Salmon EF 7-8 on April 2004. Note smaller material along the left arm of structure.

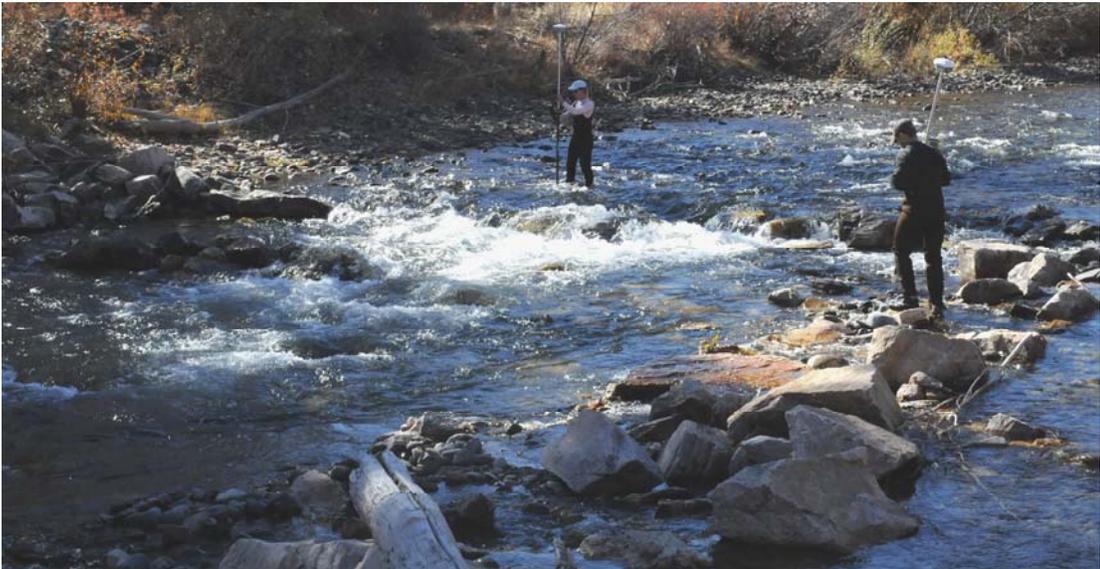
Figure 6. East Fork Salmon EF 7-8 on October 2008. Smaller material seen in Figure 5 is no longer present along the left arm and flow is conveyed through seeps from the irrigation canal to the river.

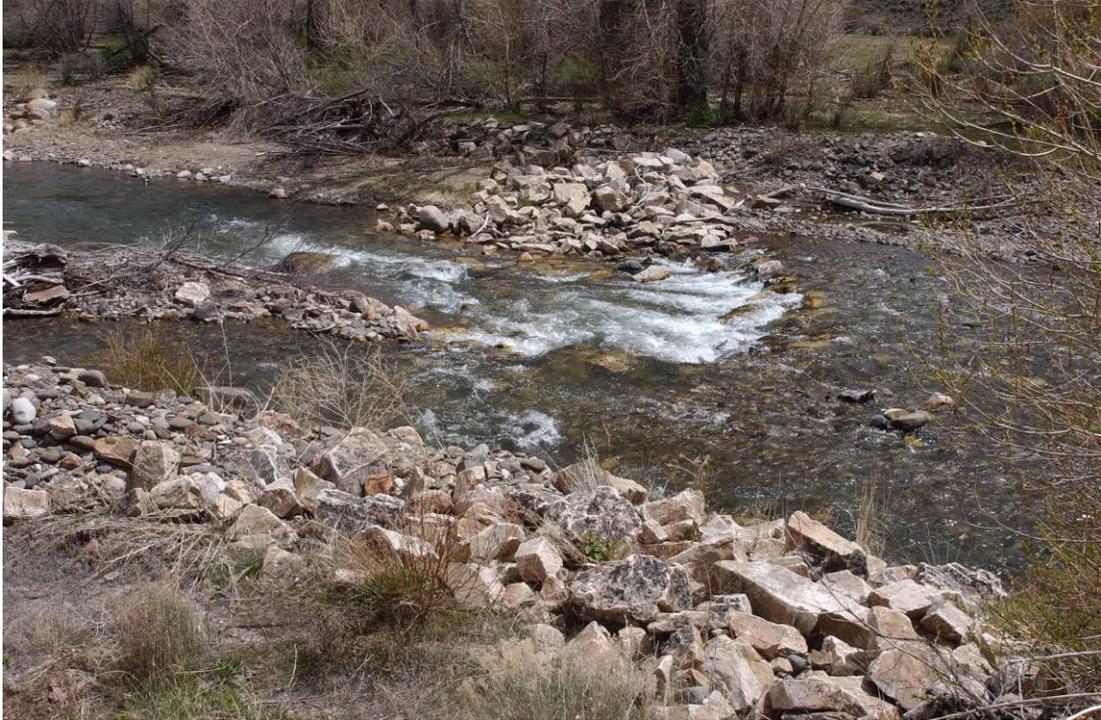
High flows have maintained a large scour pool downstream of the structure (maximum depth of 3 feet), as evidenced in Figure 7 and Figure 8. Some larger headers have slumped into the scour pool. Material in the bed of the pool appeared coarser than the material upstream of the structure. Sands were present around the fringes of the scour pool and in associated eddies.

Figure 7. Looking down across the top of the East Fork Salmon EF 7-8 structure in May 2003. Note the lack of a berm extending upstream of the structure.

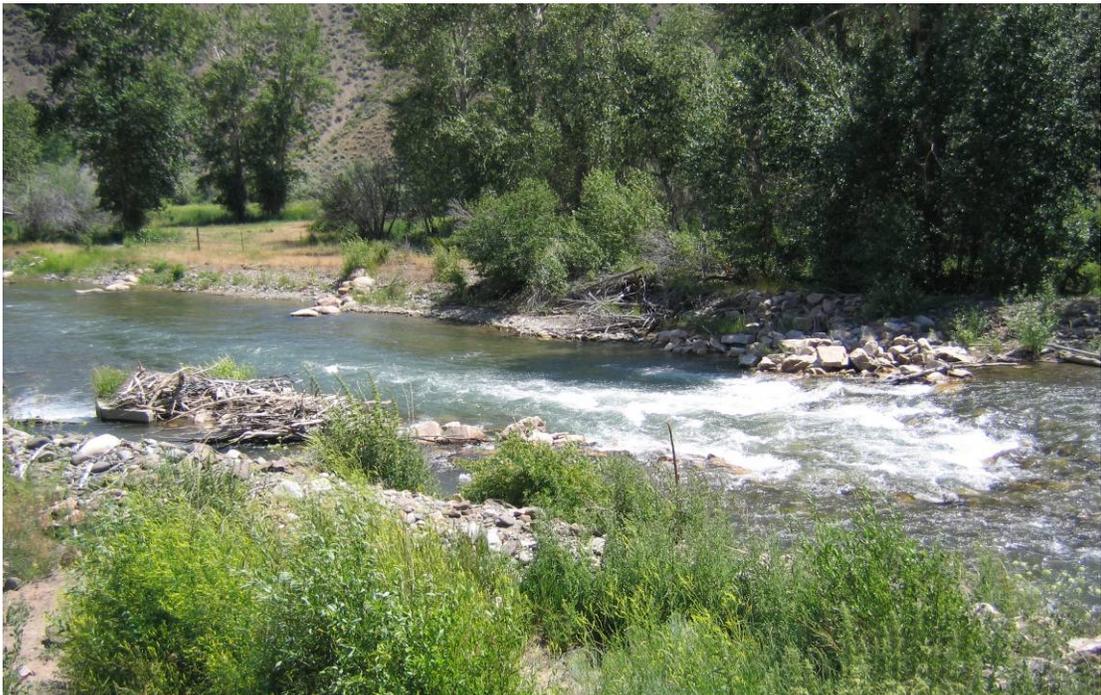
Figure 8. Looking across the East Fork Salmon EF 7-8 structure in May 2005.

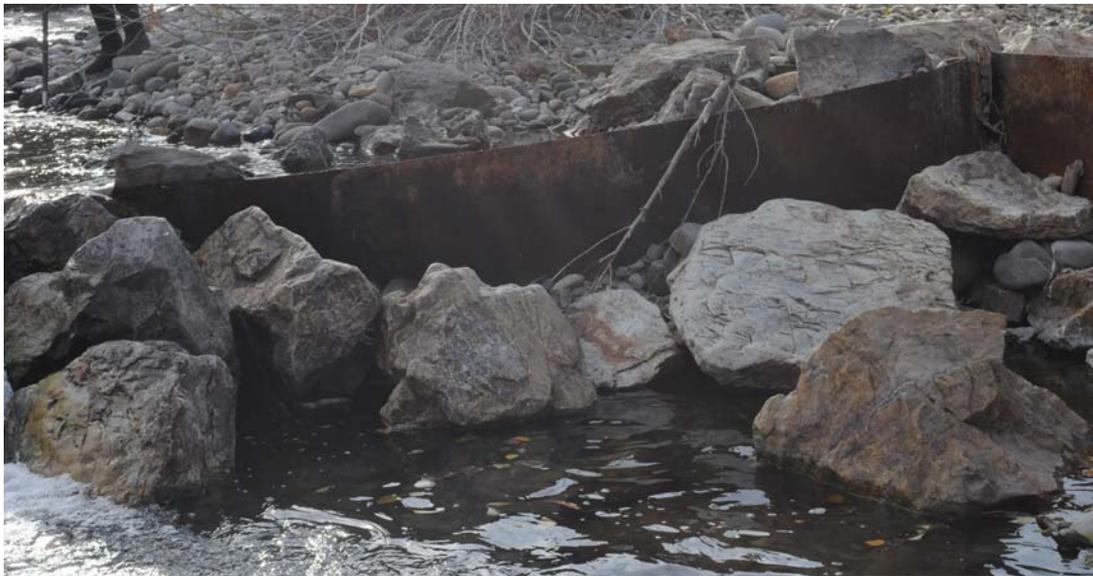
The most difficult problem, however, is in dealing with the current structure without causing adverse impacts to the diversion canal. The metal plate and large boulders are creating a stable point in an actively migrating location. Allowing the channel to migrate into the right bank of the channel is not a problem (from a river process perspective) as long as the left side of the channel does not become abandoned or completely filled with sediment, thereby cutting off access to the diversion. This appears to be the current trend of the channel based on the time series of photographs. If lateral migration of the right bank becomes a social or political constraint, bank stabilization measures could be taken to eliminate lateral migration at this location. This would not necessarily change the depositional zone along the left bank upstream from the structure however. Removing the metal plates and filling the drops with large boulders to create a ramp through the current structure would alleviate the fish passage jump height problems. However, the throat of the structure may need to be widened to reduce velocities through the confined width and potentially encourage more sediment transport through the structure. Prior to any modifications, it is recommended that a fluvial geomorphologist visit the site to evaluate the stability of the surrounding surfaces and determine the tools needed to adequately assess potential solutions.

Figure 23. Exposed metal support along East Fork Salmon EF 10-11 structure cross bar (October 2008).

In its current state, the A-weir is not capable of maintaining the irrigation head alone due to sediment deposition upstream and in the canal. A push-up berm is maintained by the land owner to guide flow to the diversion channel. Potential short-term fixes would be to excavate the diversion canal and extend a more stable (larger rock) berm longitudinally upstream. This option may require annual maintenance during critical life stages of salmonids.

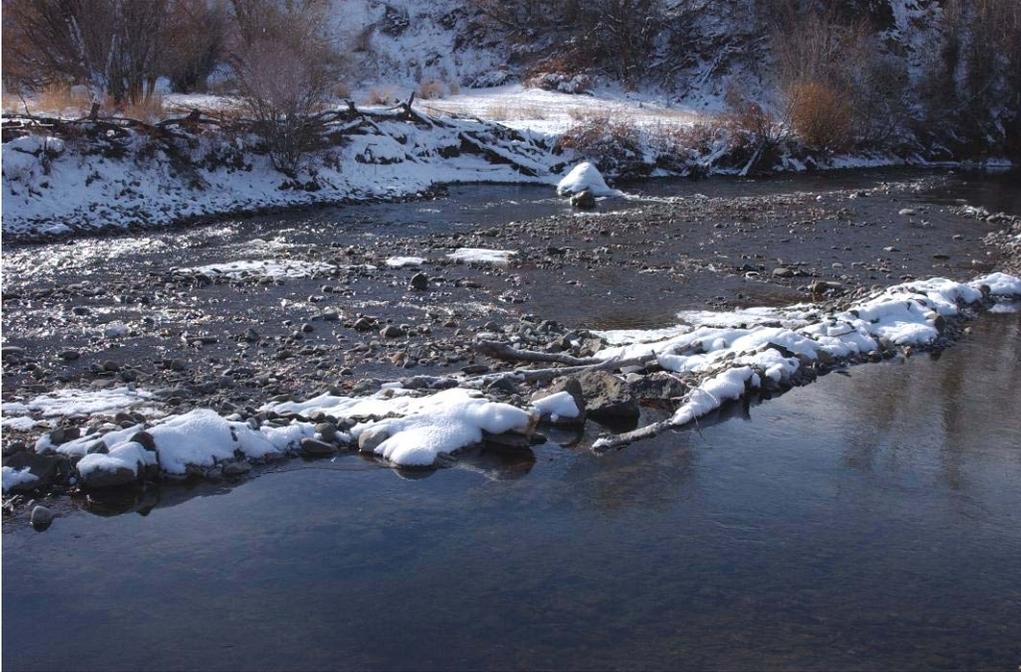
The hydraulics associated with the A-weir inherently induces low velocity zones along the structure arms. The installation of the structure supported the continued development of the gravel bar along the left arm of the structure, which gained substantial rock and organic material during the 2006 high flows (Figure 25). This has resulted in complete burial of the left arm of the structure and flow being limited to a confined throat (with high velocities), which forces flow against the downstream right bank. Material settling in the gravel bar resulted in a sediment deprived condition just downstream from the structure (similar to a dam) and caused local erosion of the channel bed and banks (Figure 26 through Figure 28). Several small rills and channels have formed through the gravel bar, none of which conveys sufficient flow to mobilize the deposited gravels and cobbles.

Figure 24. Gravel bar formation between the channel and the irrigation diversion prior to construction of East Fork Salmon EF 10-11 (February 2002).

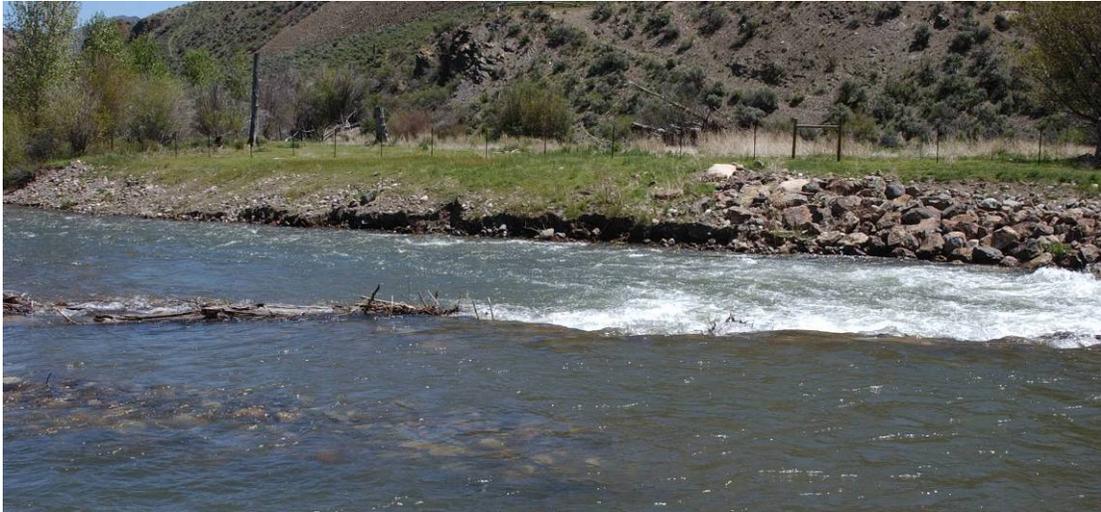
Figure 26. East Fork Salmon EF 10-11 in May 2005. Note initial bank erosion along right bank.

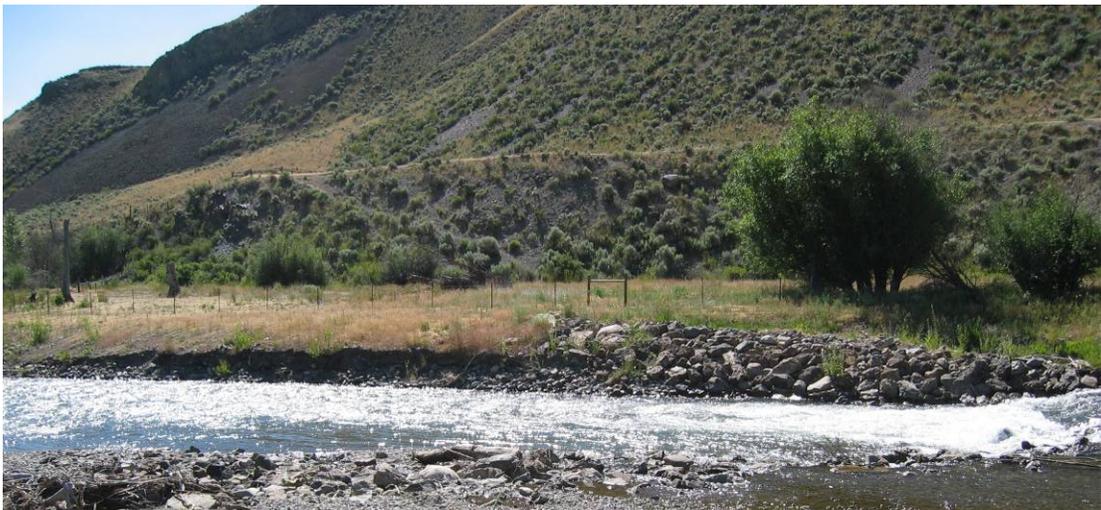
Figure 27. East Fork Salmon EF 10-11 in July 2005. Increased erosion in visible following spring run off.

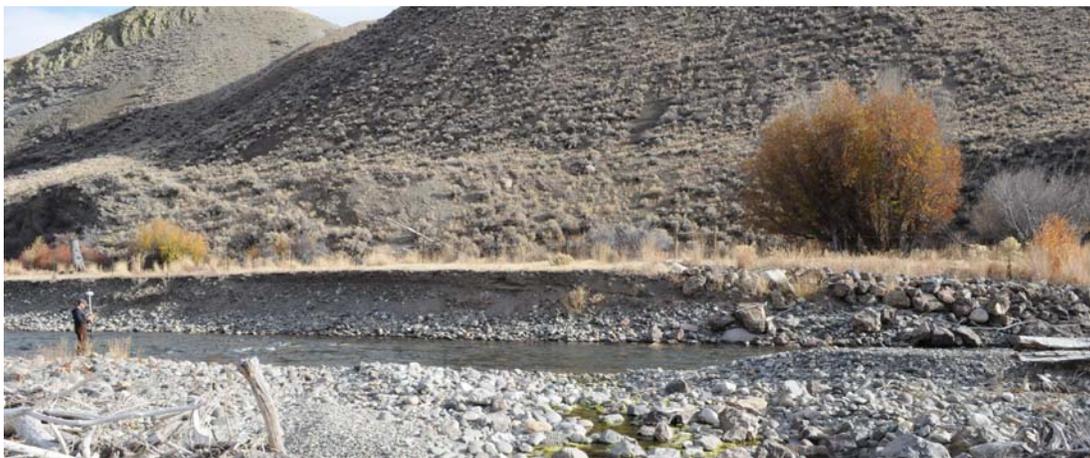
Figure 28. East Fork Salmon EF 10-11 in October 2008. Erosion has resulted in destabilization of structure tie-in.

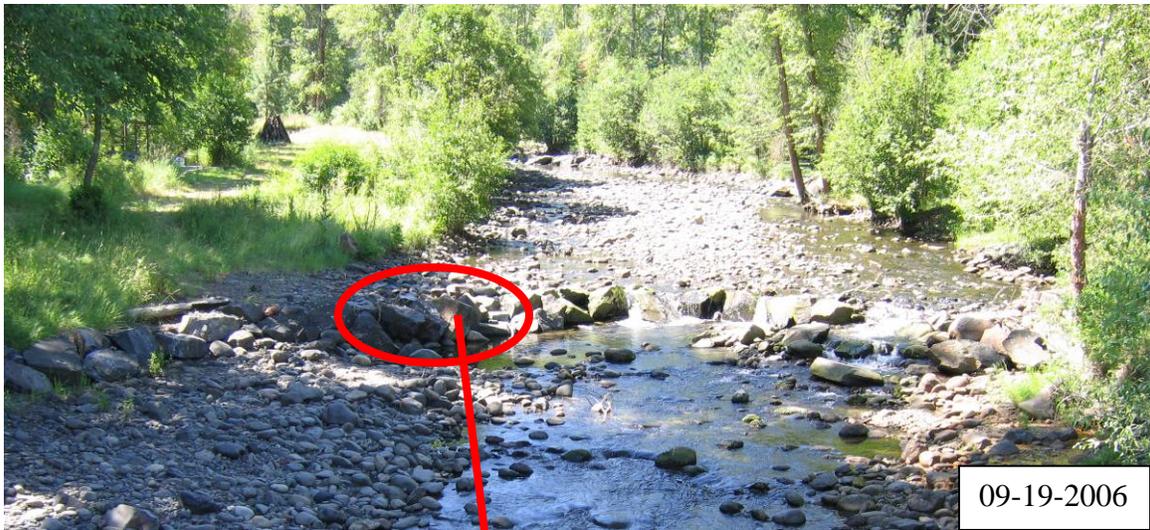
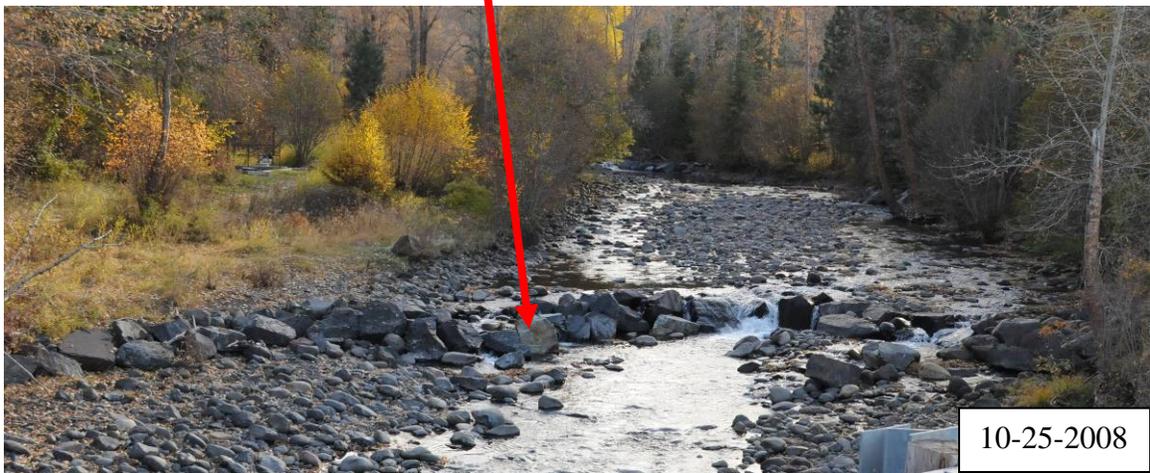
Figure 36. Bear Creek Site D1 U-Weir Looking Upstream displaying rock movement along both arms.

Header rocks in the throat and arms of all the structures appear to have moved just downstream of the originally constructed positions, with structures B and D1 exemplified in Figure 37 and Figure 38, respectively. Footer rocks are visible and appear to have shifted forward (downstream) from their original position. Construction plans called for symmetrical structures so the current alignments likely resulted from motion after installation. Misalignment in plan, reoriented rocks, and visibly protruding footers indicate motion. Incipient motion would not be expected to alter the footers. Movement is likely due to geotechnical slumping of the footer when the scour pool depth exceeded the depth of the footer. Incipient motion would be expected to move the header rocks farther downstream while geotechnical slumping might explain the current positions. Material was naturally deposited upstream of the structure arms to within approximately one foot of the top elevation of the structure in most locations. The formation of gravel bars upstream of the structures and filling along the structure arms indicates a significant sediment load in the system. Large mid-channel bars upstream of structures B and D1 are

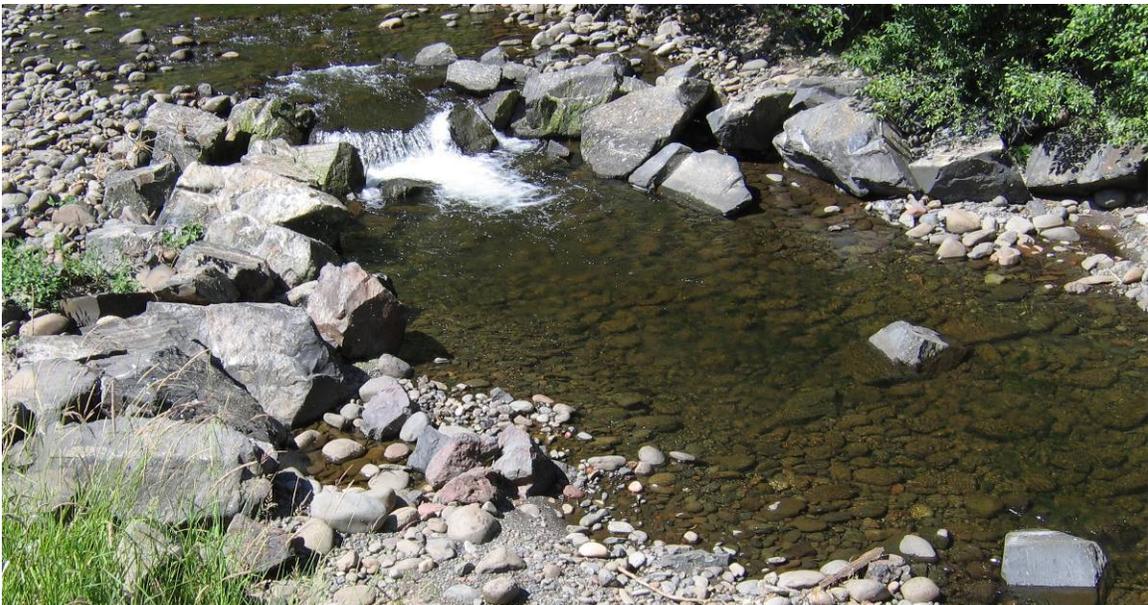
Scour pools were not pre-excavated during construction but do appear to have been hydraulically formed during the high flows, with some deposition in the center of the channel and some scour below each of the arms at each of the structures. Material in the scour pools consisted of large cobbles and small boulders, Figure 39.

Figure 39. Bed Material in Scour Pool at Bear Creek site B.

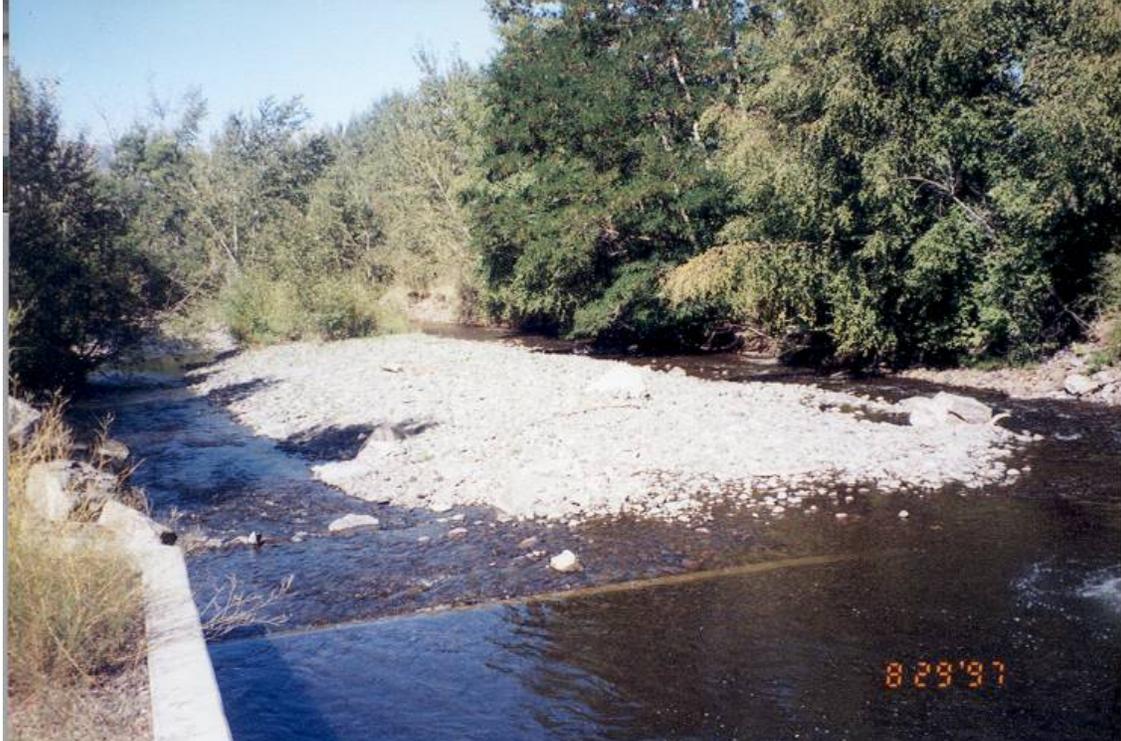
The area just downstream from the concrete weir appears to have been a depositional area over the past 15 years; at least since the concrete weir was constructed (Figure 42 and Figure 43). The depositional nature may be a result from the wider channel conveyance area downstream from the concrete structure and from a reduction in channel slope. The W-weir is located within this depositional zone and has experienced substantial growth of the gravel bar behind the center and right arm of the weir. Another point bar has begun to establish upstream of the W-weir, splitting flow into two paths that converge near the left throat of the structure. Currently, the W-weir is acting as a U-weir across half of the width of the historical channel, acting to concentrate flow along the left portion of the channel and reduced velocities and shear stresses along the right bank (Figure 44 and Figure 45). Because the W-weir is essentially two U-weirs with only one actually conveying flow, the active structure is referred to throughout this field report as the left U-weir.

Figure 42. Prior to installation of the W-weir at Swackhammer, the area downstream from concrete weir was a depositional zone. This picture illustrates the conditions on August 29th, 1997 looking downstream.

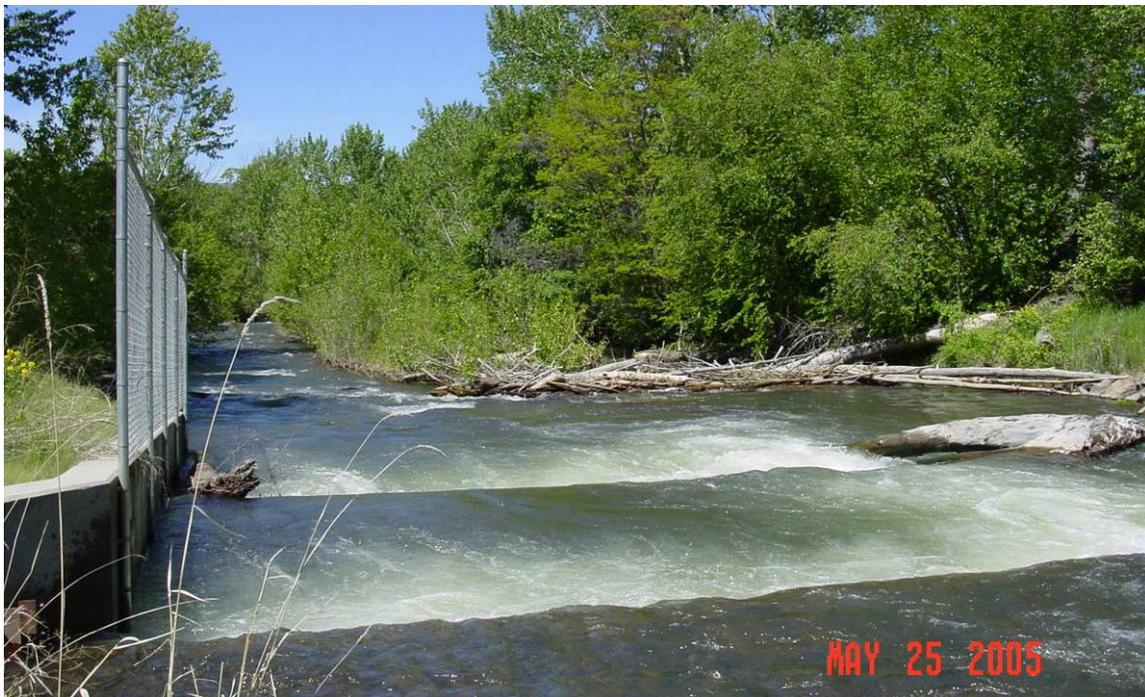
Figure 43. This picture is in the same location as that shown in the previous figure. Photo was taken a couple of months prior to the construction of the rock weirs at Swackhammer on May 25, 2005.

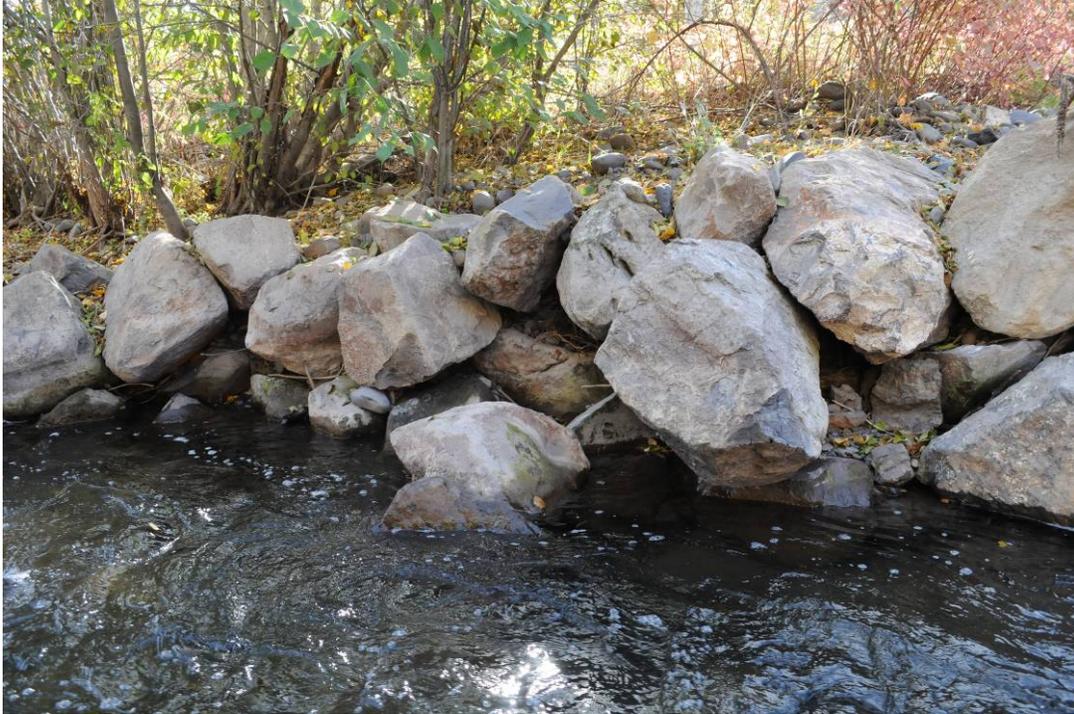
Figure 47. Left arm of left U-weir at Swackhammer. Note the slumping of some of the material where the footers have been dislodged and scoured. Some of this material does not appear to be present following initial construction but may have just been covered with backfilled material. October 2008.

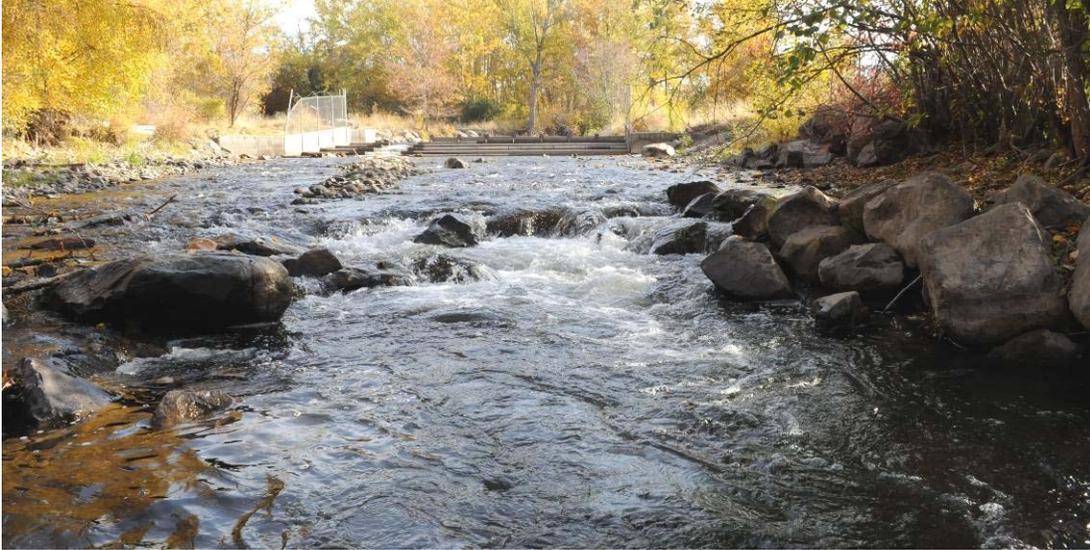
Several headers have fallen into scour pool (Figure 51). Material at the bottom of the scour pool consists of very large cobbles and boulders in the deepest parts with fining downstream to gravel of approximately 32 mm in diameter.

Figure 51. Photo looking upstream across left U-weir at Swackhammer. Several dislodged rocks have fallen into the scour pool. October 2008.

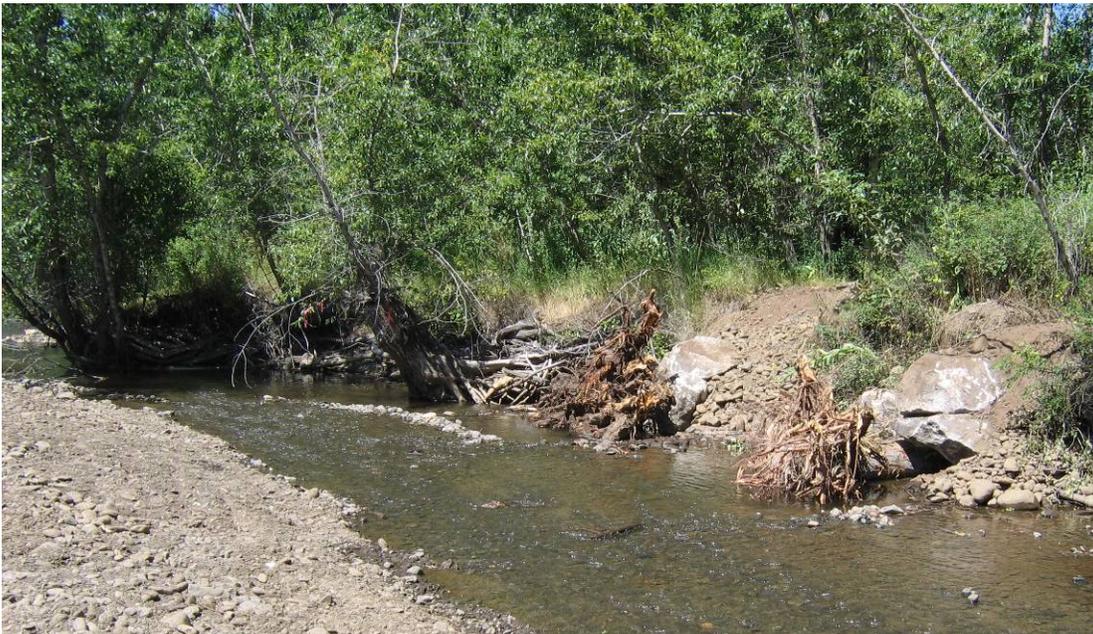
Figure 52. Rootwads installed along right bank between W- and U-weirs at Swackhammer. Photo looking downstream just after construction (July 2005).

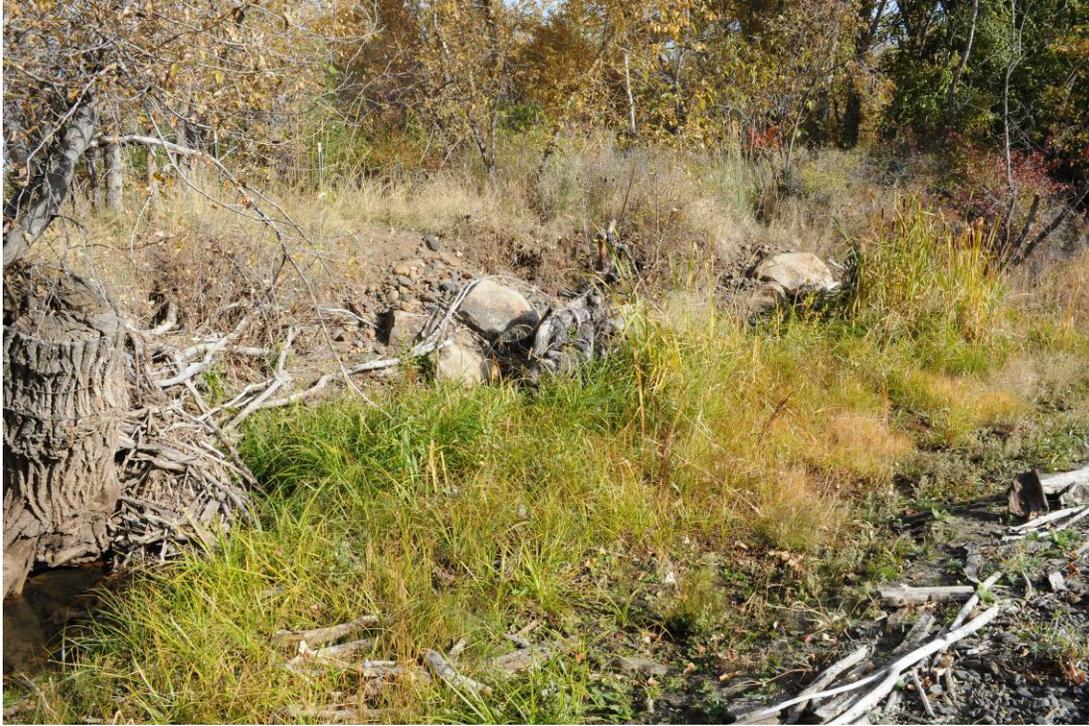
Approximately 200 feet separate the W-weir and U-weir with a large bar on river right, several root wads (3) in the right bank, and multiple boulders placed in the channel between the structures to provide additional slow-velocity habitat areas. Although the side channel has become plugged at the upstream end and has filled in with sediment, it may be activated at high flows and could possibly provide some backwater habitat (Figure 52 and Figure 53).

Figure 53. Rootwads along right bank looking upstream at Swackhammer (October 2008).

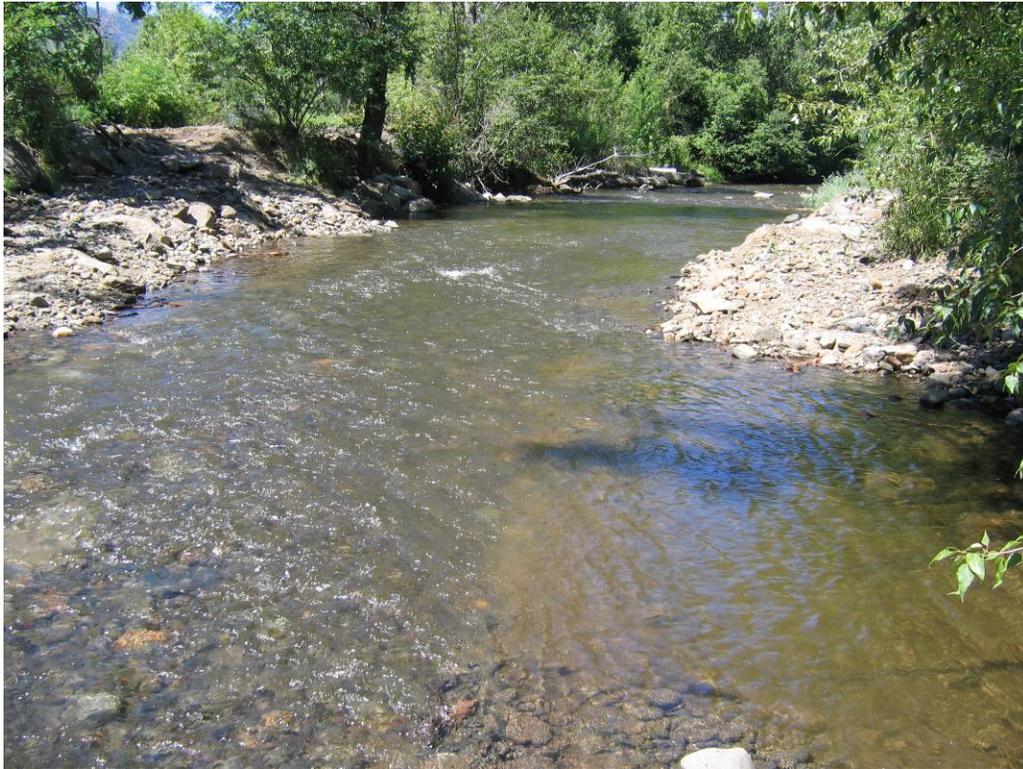
Comparison of the U-weir condition just following construction (Figure 54) with the condition during the October 2008 field visit (Figure 55) suggests that structural components of the U-weir have not experienced substantial mobility. The native backfilled material provided a natural appearance post-construction and filled in voids between the larger rocks. However, a large portion of the exposed gravels and small cobbles have been transported out of the structure and voids remain between the larger rocks where the angularity of the rocks prevented interlocking (Figure 56).

Figure 54. Photograph of the U-weir at Swackhammer just after construction in July 2005. The arms of the structure were backfilled and the throat set at grade.

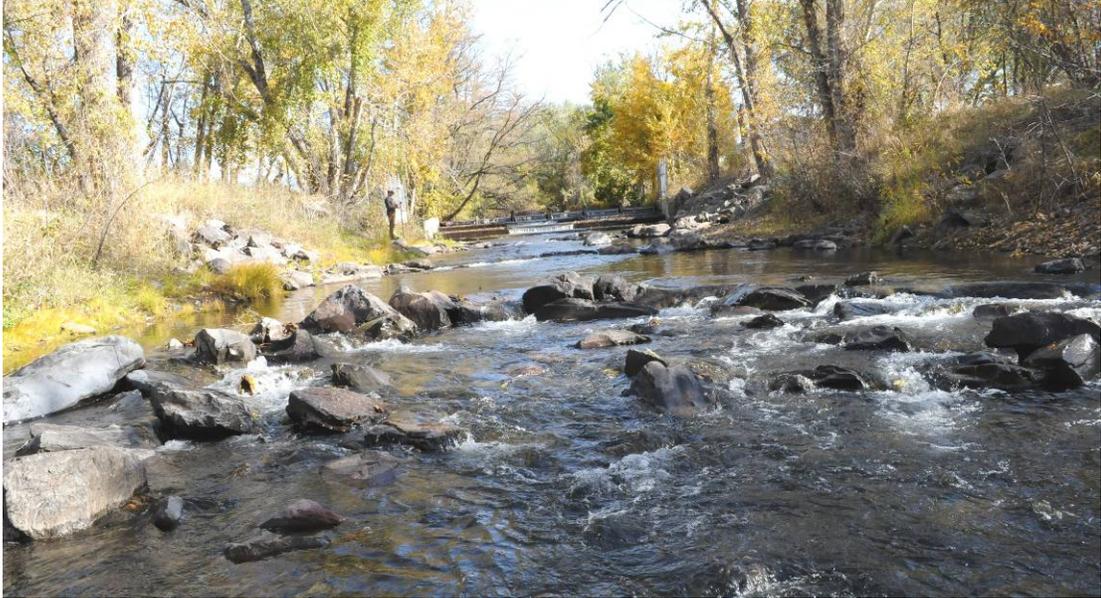
The downstream-most structure currently acts more like a roughened channel feature than a stable U-weir. Photo comparison between 2005 and 2008 suggests that some minor shifting of the structure rocks has occurred over the past few years (Figure 63 and Figure 64). Almost all of the header rocks have slumped inward, part of which may have to do with the angular nature of the rocks used in the structure. Some spaces were noted between the rocks where edges of rock were not interlocking. The size of the voids between the rocks ranged from 6 inches to 1 foot. Some flow was noted between the larger voids along the structure arms. A shallow pool is present just downstream of the structure throat with bed material size of approximately 180 mm on average. Because of the roughened nature of the structure, fish passage through the structure is very good. A depositional zone is present downstream from the structure where coarse sands were noted in the bed. This structure is tied-in to the bank and riprap.

Figure 64. Structure HH1 at Hempe-Hutchinson in October 2008. Comparison of the 2008 photo with the 2005 photos indicates additional minor shifting of rock along the right arm.

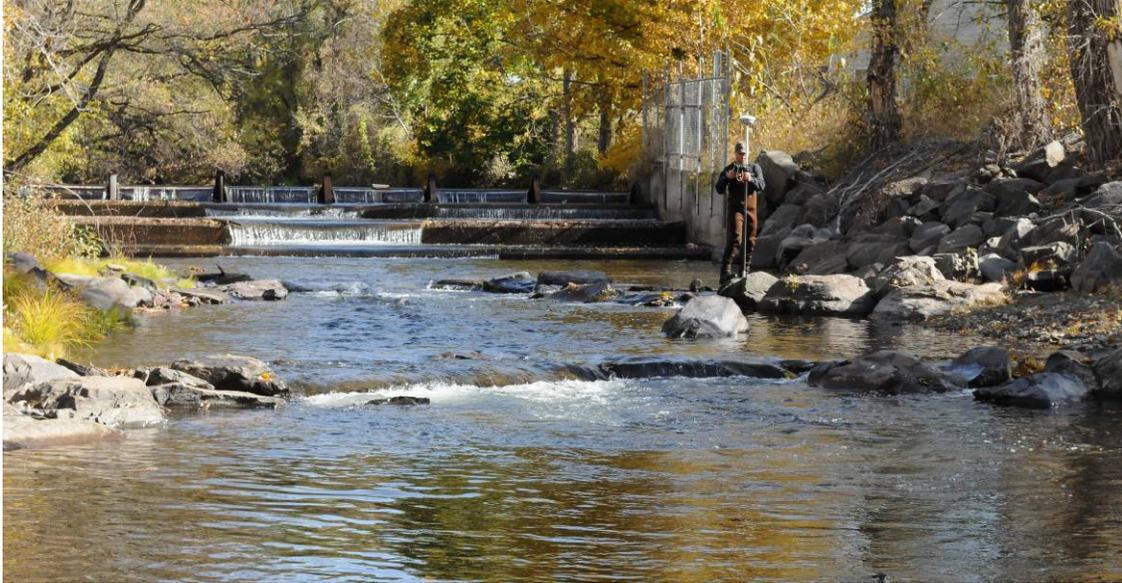
Structure HH2 is located approximately 50 feet upstream from HH1. The tail water of HH2 is controlled by the head water/header rocks of HH1. The header rocks along the right arm and throat of the structure have shifted (Figure 65). Some of the throat headers have moved into the downstream scour pool due to apparent geotechnical slumping of the footer rocks, which have noticeably tilted forward. Along the intact portions of the arms, the headers are locked together well with smaller material filling the voids between the headers. The scour pool was approximately 3 feet deep and comprised of a few large rocks from the structures with a matrix of sands and gravels. The remaining footers in the structure throat (with no headers) were visibly interlocked (Figure 66). Upstream of the throat, the structure has filled with cobbles and gravels. This structure is tied-in to the bank and riprap.

Figure 65. Structure HH2 at Hempe-Hutchinson in October 2008.

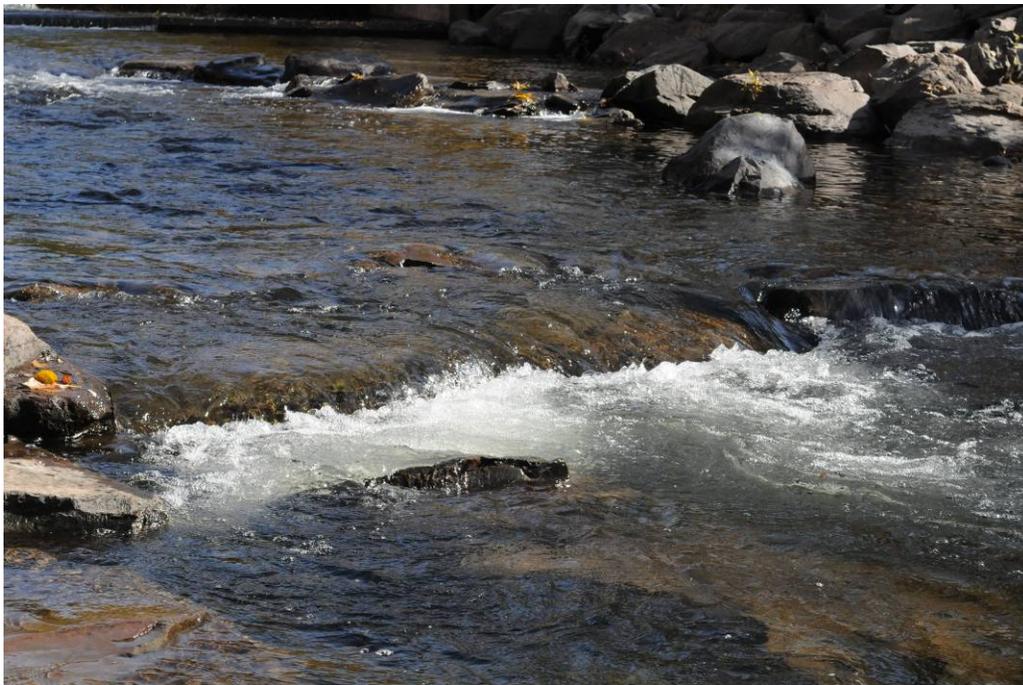
Figure 66. Remaining throat of HH2 at Hempe-Hutchinson. Note the tilting of the footers and the headers that have slumped into the downstream scour pool.

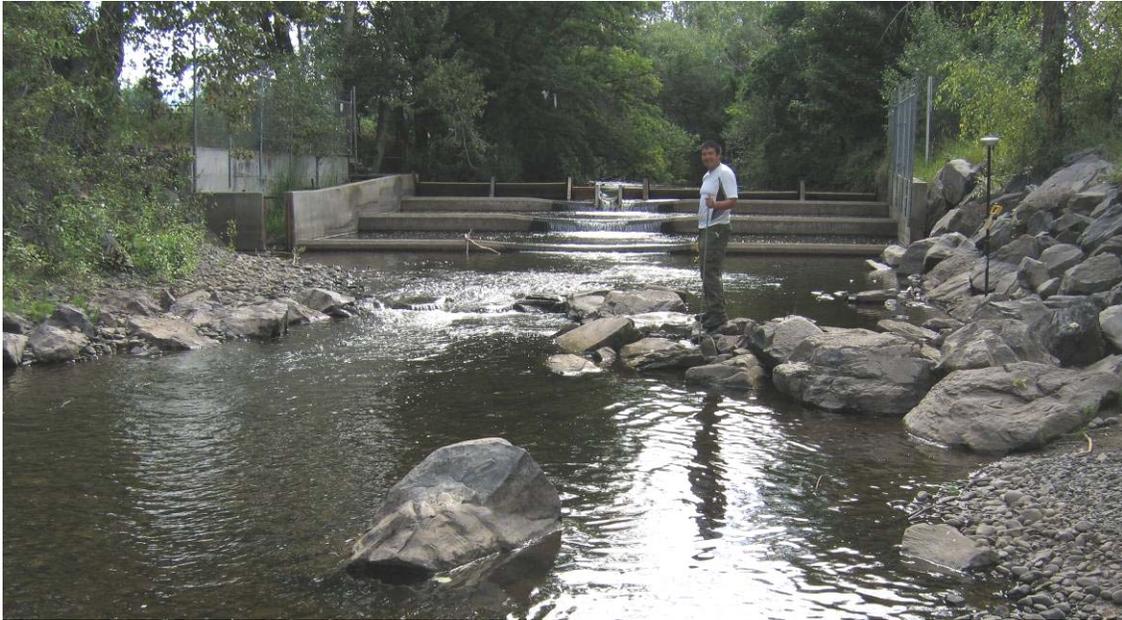
was evidenced between July 2005 and October 2008 (Figure 67 and Figure 68). On the downstream side of the structure, the pool was not well developed. Within the pool, bed material typically ranged between 64 mm to 180 mm in diameter. A header rock appeared to be missing from the throat of the structure, but it was difficult to discern if it was initially present. Some of the crest rocks have shifted forward. Most of the voids present in the header were filled with gravels approximately 32 mm to 45 mm in diameter. This structure is tied-in to the bank and riprap.

Figure 67. Structure HH3 at Hempe-Hutchinson in July 2005.

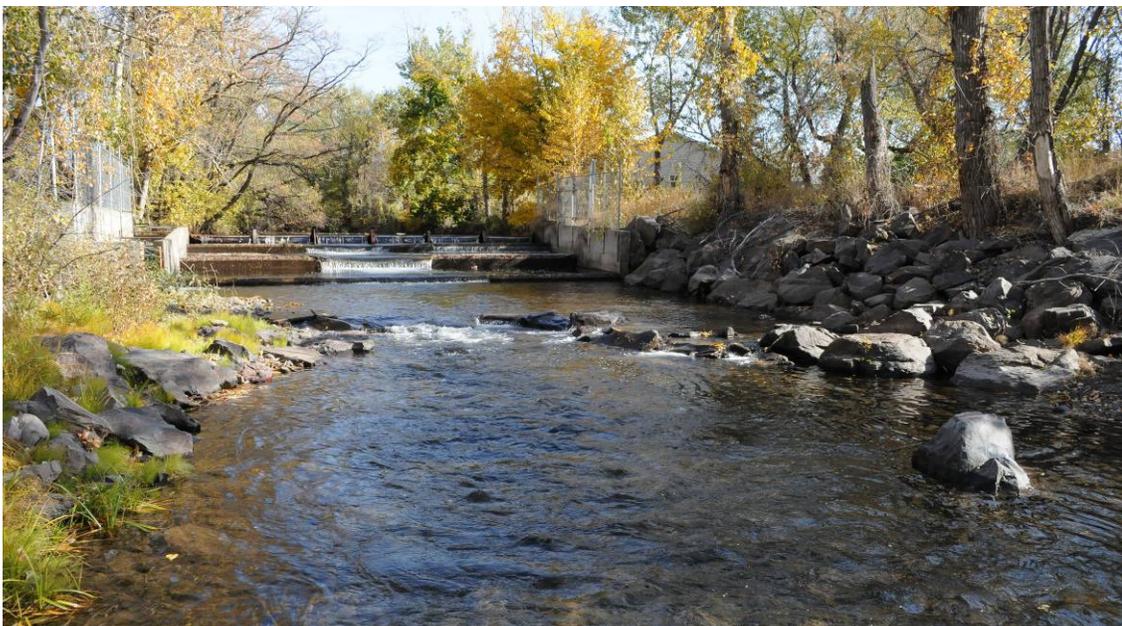
Figure 68. Structure HH3 at Hempe-Hutchinson in October 2008.

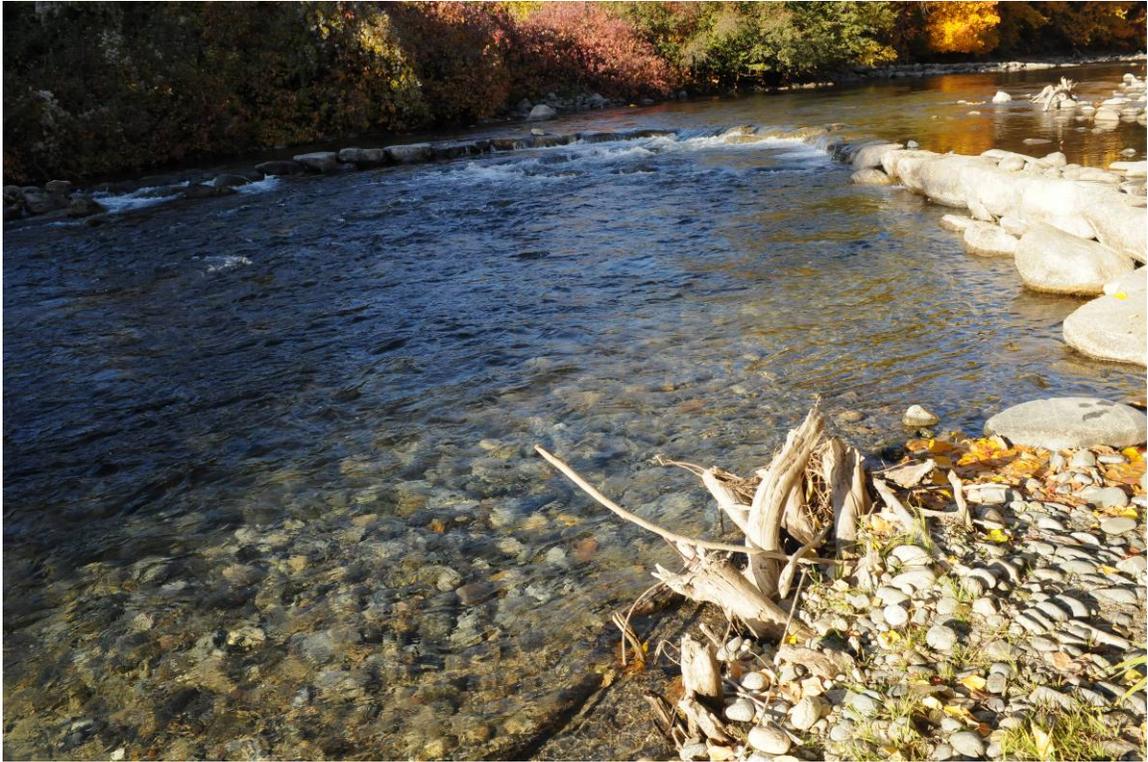
Figure 73 shows a photo of the round nosed U weir structure at RM 3.1 seen in October 2008. The right arm is missing several header rocks and the throat is also missing a header rock (Figure 74 and Figure 75). The left arm is intact with some shifting of the footers. It appears that many of the footer rocks are offset from the headers with material filling in behind structure. Approximately 30% of the flow is going through the right arm where the header rocks dislodged. The scour pool has been partially filled with material consisting of cobbles and boulders with diameters exceeding 500 mm. Because of the filling in the middle of the scour pool, the majority of the scour pool is now located along the right arm upstream and downstream of the gap in header rocks. Based on the 2006 field visit, the movement of the header and footer rocks occurred before 2006. Since that visit it does not appear that there have been major changes in structure form.

Figure 73. Entiat River structure at RM 3.1 in October 2008.

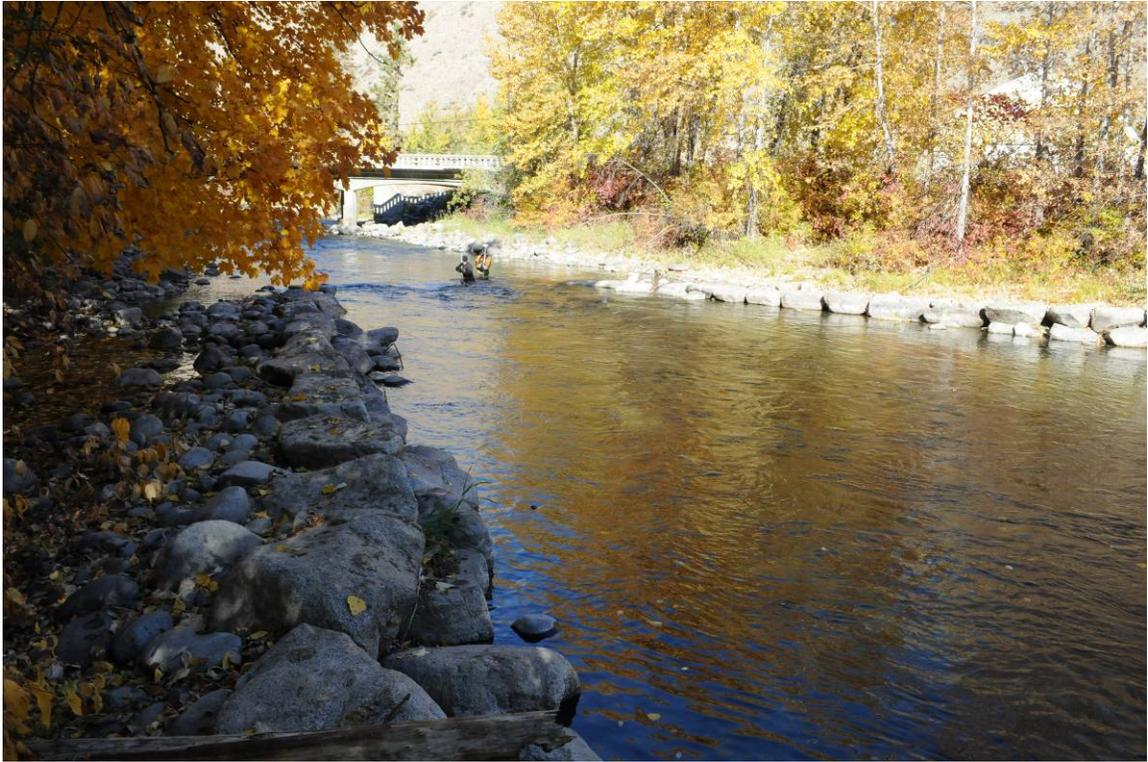
Figure 76 shows a photo of the blunt nosed U weir structure located at RM 3.2. The header rocks along the throat (shown in Figure 77) are no longer intact but several footer rocks remain. A very small head drop is present, approximately four to six inches, because of the mobilization of the throat header rocks. There is sediment filling downstream and a pool has been created upstream of the throat. The upstream pool is about 40 feet long and 3 to 4 feet deep during base flow. The right and left arms appear to have had little mobilization of the header rocks except near the throat where some header rocks have been offset from the footer rocks (Figure 78 and Figure 79). Based on the 2006 visit, the movement of the throat rocks and the offset of the header rocks from the footer rocks along the arm occurred prior to 2006. There are gaps in the footer rocks which have been filled with gravel and fines. The upstream sides of both arms have filled with fines and gravel/cobbles. The deposition upstream of the structure arms was present in 2006 and appears to be maintained by the structure hydraulics. A pool has formed along the right arm which was also present in the 2006 visit.

Figure 76. Entiat River structure at RM 3.2 in October 2008.
