SRH-2009-47

River Spanning Rock Structures Field Investigations 2008

Pacific Northwest Region

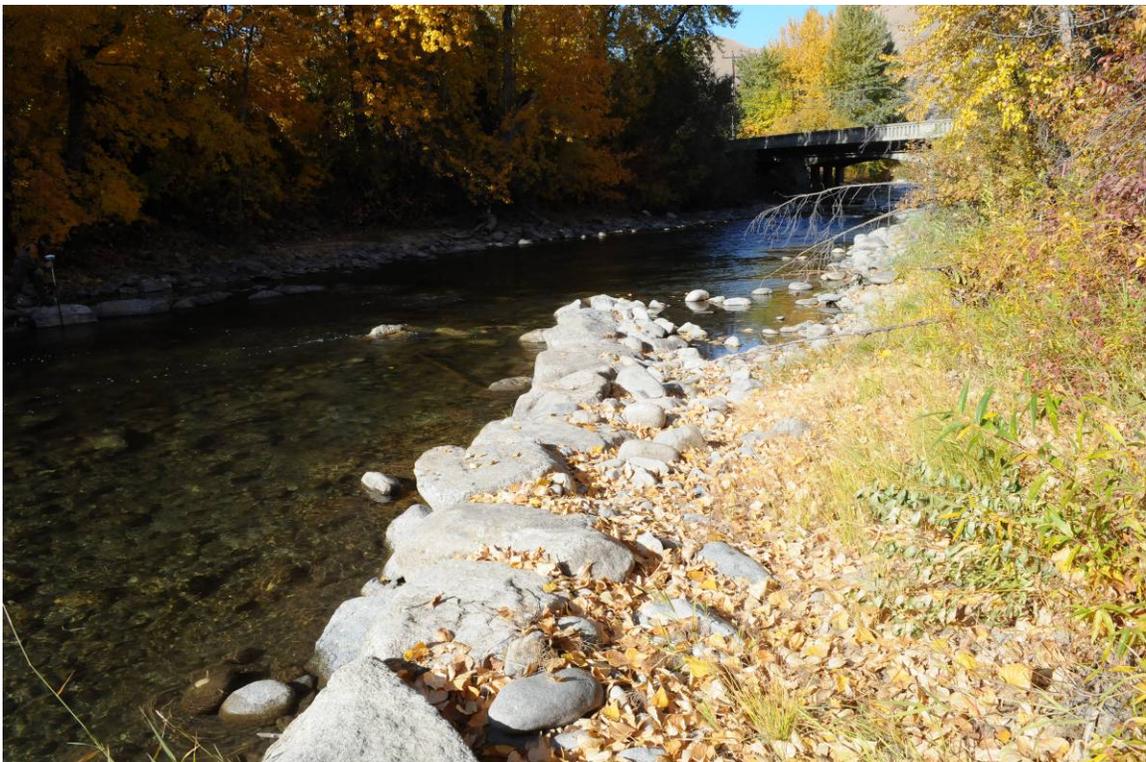
Figure 79. Left arm of Entiat River structure at RM 3.2.

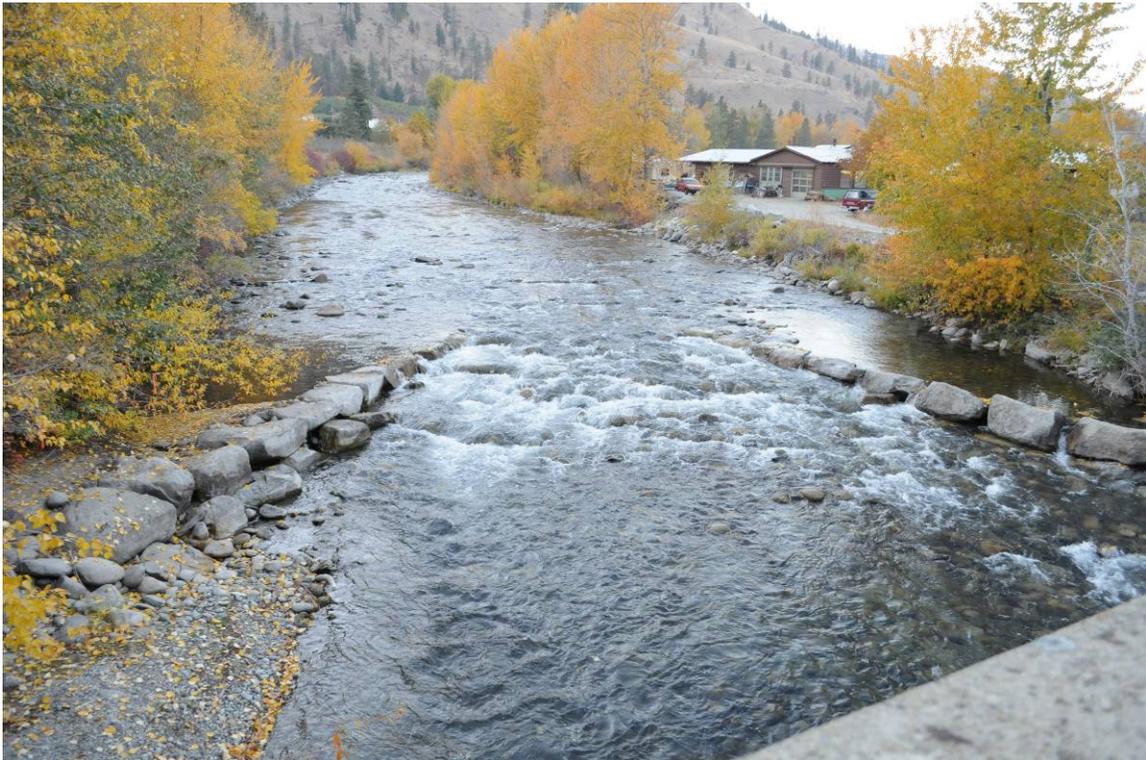
Figure 80 shows the current configuration of the A weir structure located at RM 4.6. The scour pool has been filling in with bedload and has buried the throat and cross bar producing more of a rock ramp configuration than rock weir. The throat, left arm, and right arm are still intact. Spawning gravel has deposited at the downstream extent of the right arm. Figure 81 and Figure 82 show the structure header rock configuration in 2005 and 2006. Between 2006 and 2008 there does not appear to be dramatic differences in the scour pool and the structure appears to have stabilized at its current configuration. Figure 83 shows the right arm; there appears to be little movement of the header rocks. There are pockets of fine sediment located between the header rocks (see Figure 84). The largest header rock spacing was approximately 4 inches. However, the rocks are still locked together. Several pocket pools have been created along the right arm as well as a pool approximately 3 feet in depth downstream of the cross bar along the right arm.

Figure 80. Entiat River structure configuration at RM 4.6 seen in October, 2008.

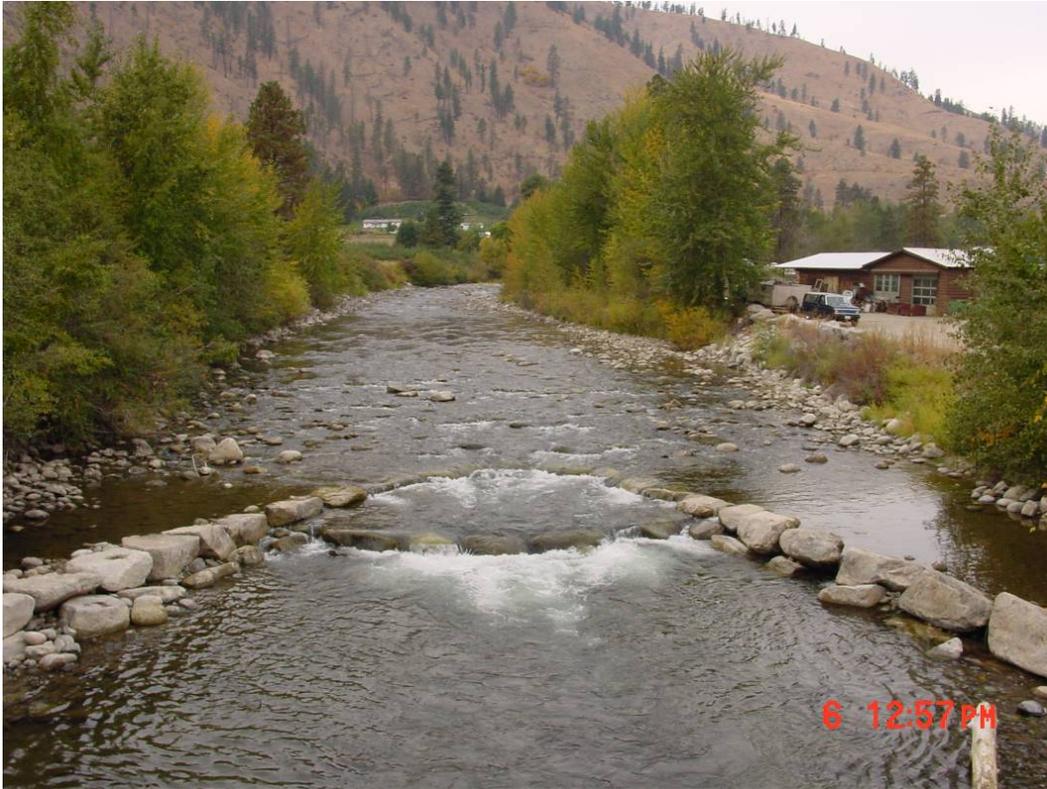
Figure 81. Entiat River structure configuration at RM 4.6 on October 06, 2005.

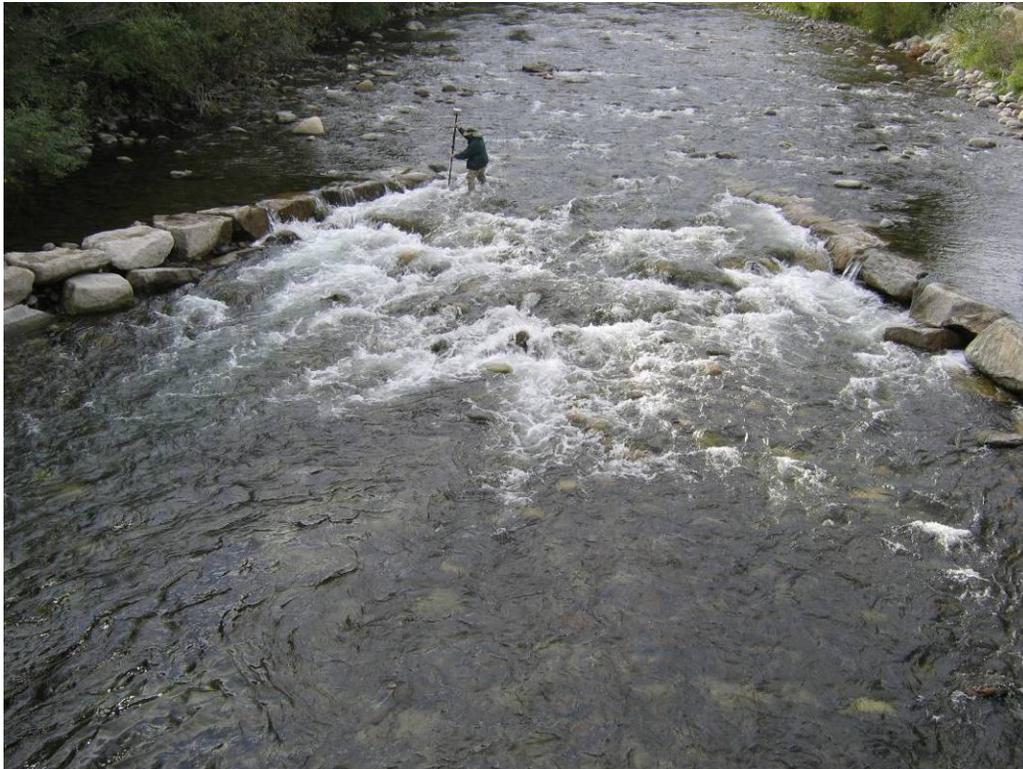
Figure 82. Entiat River structure configuration at RM 4.6 on September 20, 2006.

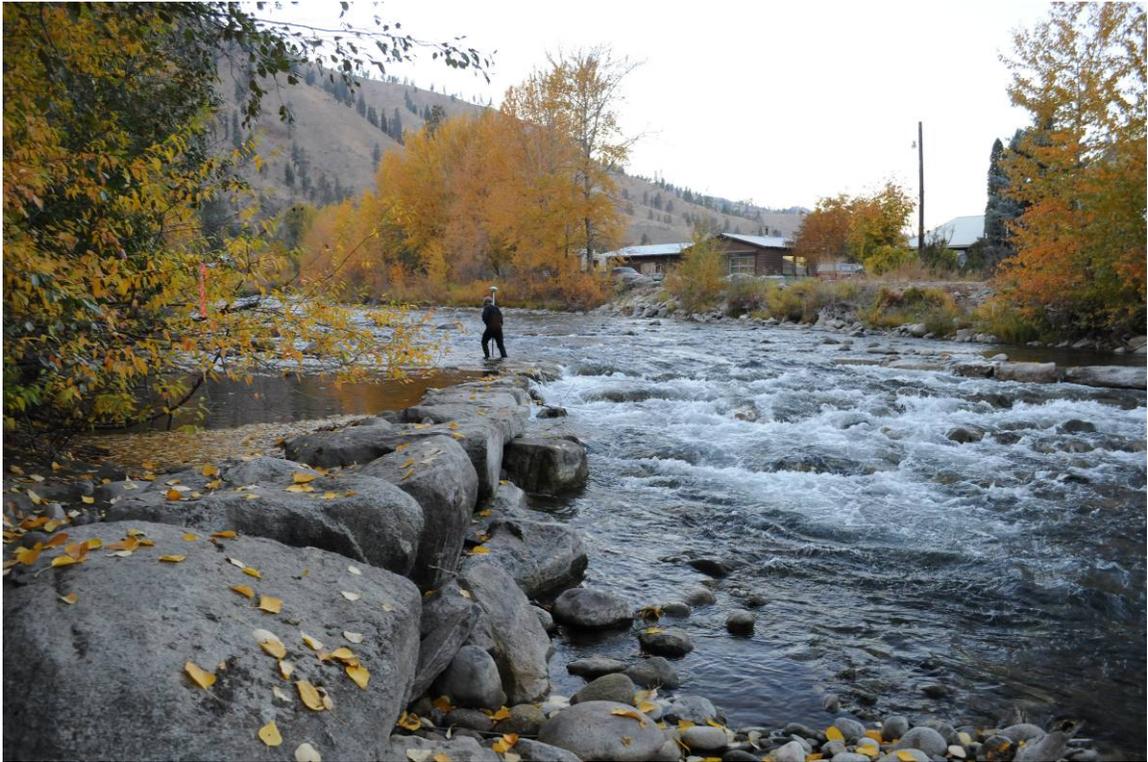
Figure 83. Header rocks along right arm of Entiat River structure at RM 4.6.

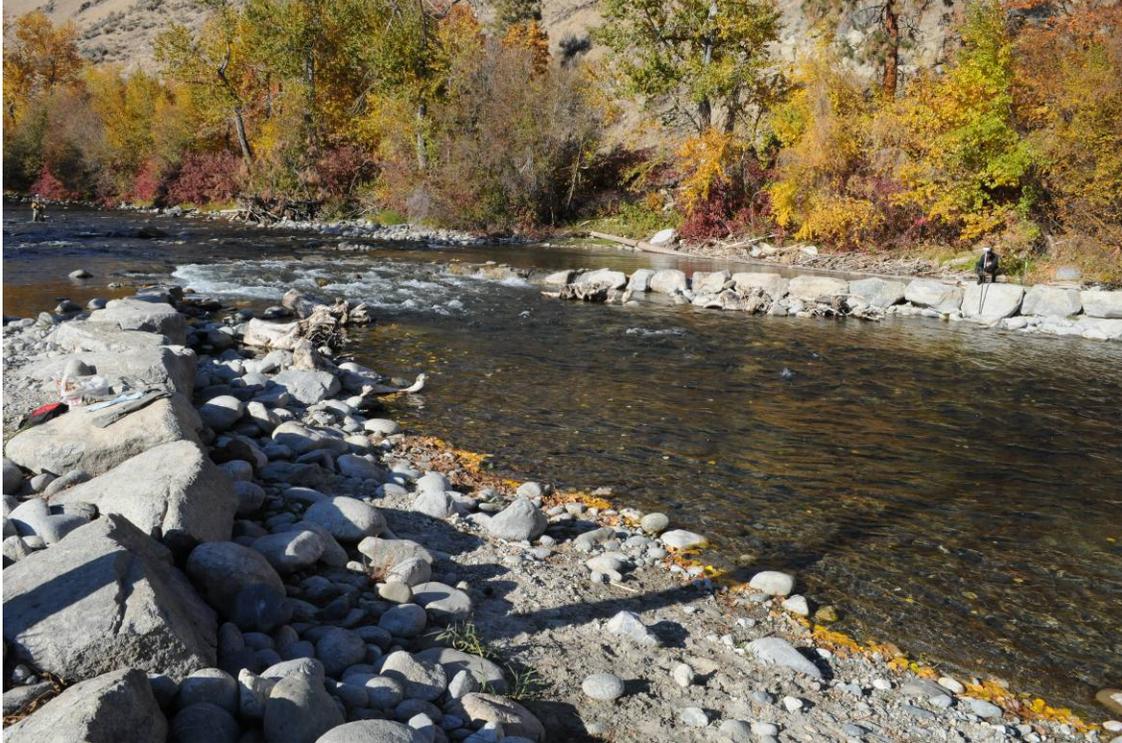
Figure 89 shows a photo of the structure seen in October 2008. The original pool that was excavated during construction has largely, but not completely filled. It is thought that the filling is due to a construction oversight where the spoil pile was placed upstream of the structure during construction and quickly moved downstream into the pool post construction. In October, 2008 a pool approximately 40 feet long and 2.5 feet deep remains. Figure 90 illustrates the depth of the pool as the people can be used for scale. The deepest portions of the pool occur about one-third to one-half of the distance along both of the structure arms. Because of the filling of the pool, the structure is hydraulically acting more like a ramp rather than a drop (Figure 91). The rootwads placed in the pre-excavated pool had very small rootballs. Two of the rootwads were unanchored during storm events and dislodged from the downstream pool. The remaining

Figure 89. Entiat River structure at RM 3.4 in October 2008.

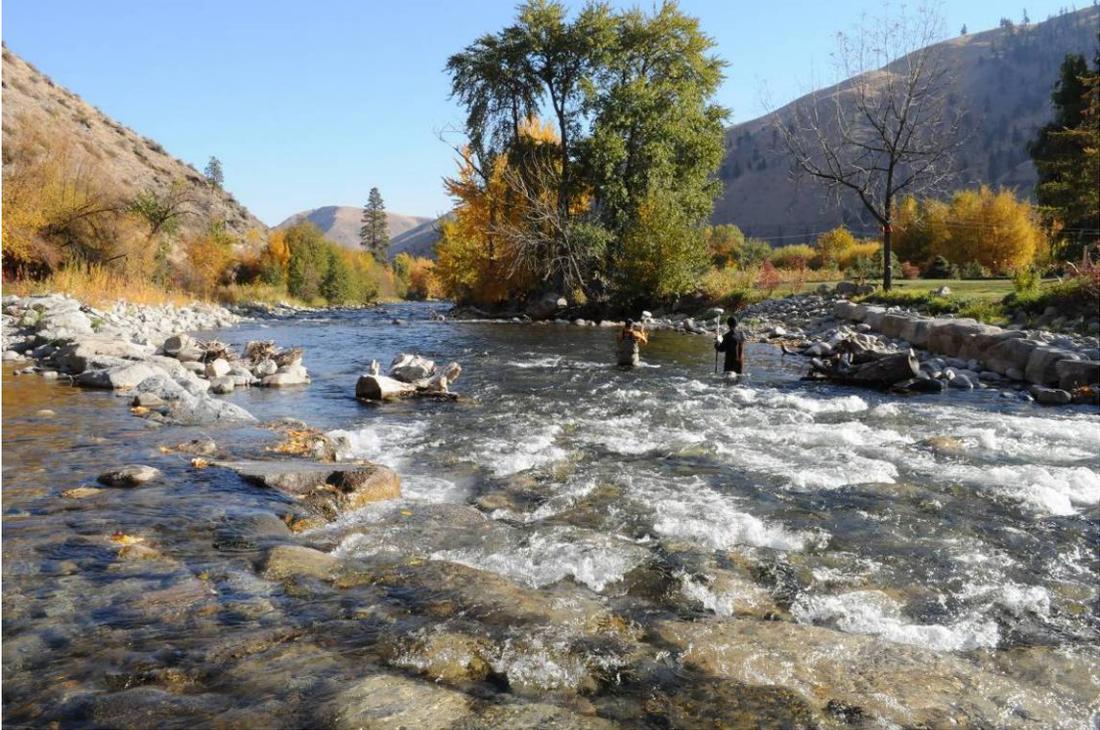
Figure 90. Looking downstream at Entiat River structure at RM 3.4. The pool is approximately 2.5 feet deep.

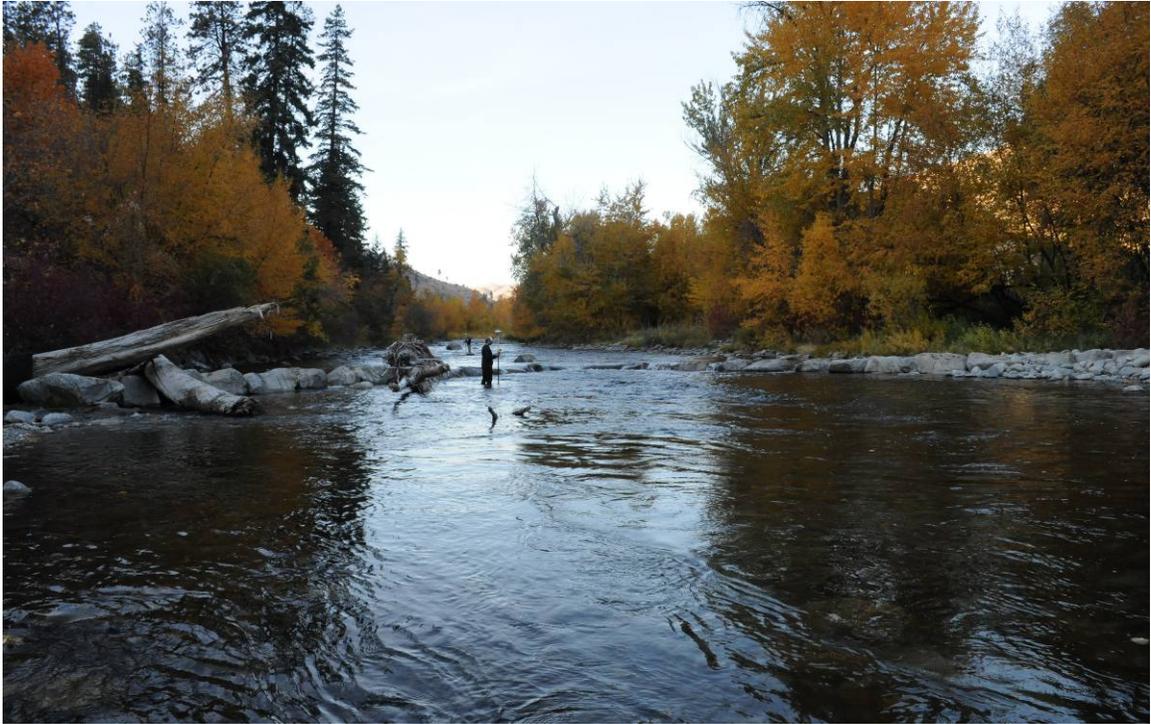
Figure 93 shows a photo of the structure as seen in October 2008. Since construction, several logs have been caught on the structure. One is blocking the sluice gate that was constructed; therefore the gate is no longer working effectively; Figure 94 shows the right arm of the structure with the sluice gate blocked. Another log along the right arm is causing deposition at the downstream end of the arm. Most of the rock spacings have been sealed with gravels and finer sediment. The throat of this structure has an approximate 1.5 foot drop as seen in Figure 95. The downstream end of the pool appears to have fine gravels and sand. The structure does not appear to be filling rapidly which may be due to the riffle at the downstream end acting as a hydraulic control and the reach appears to have a flatter slope than other areas with rock structures. Figure 96 illustrates the depth of the pool as the people can be used for scale.

Figure 93. Entiat River structure at RM 5.1 seen in October 2008.

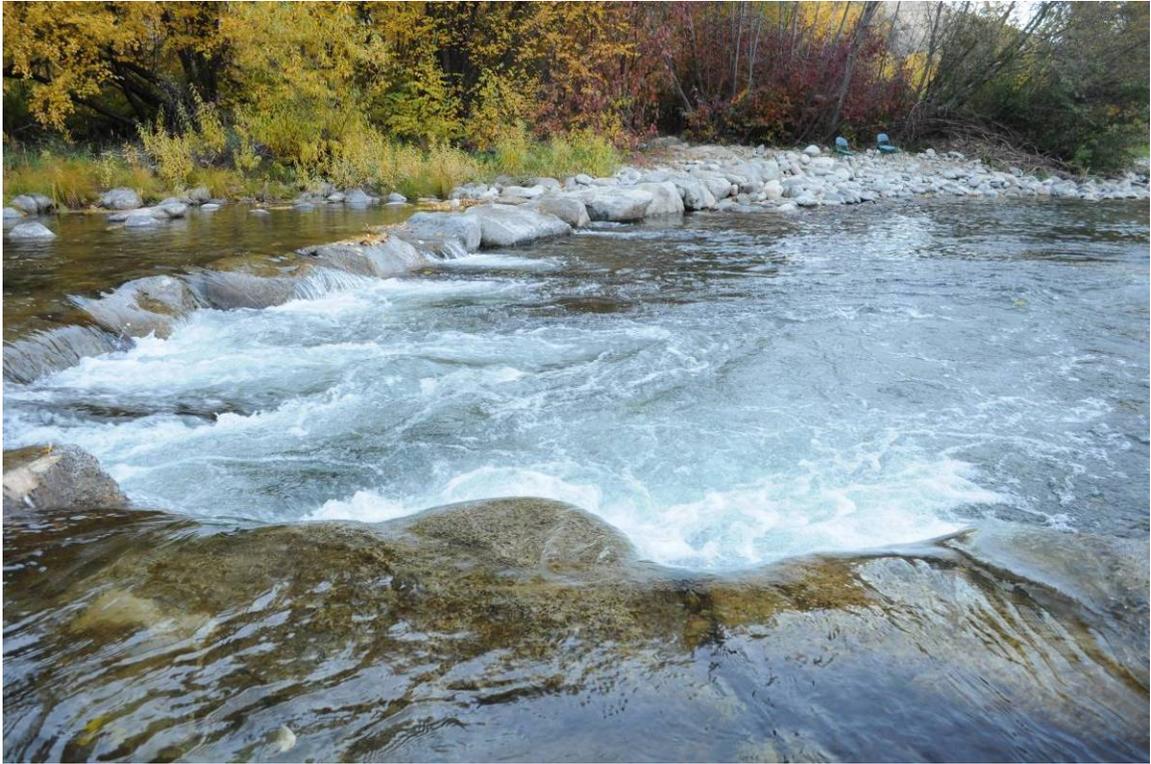
Figure 95. Throat of Entiat River structure at RM 5.1 which is acting hydraulically like a drop.

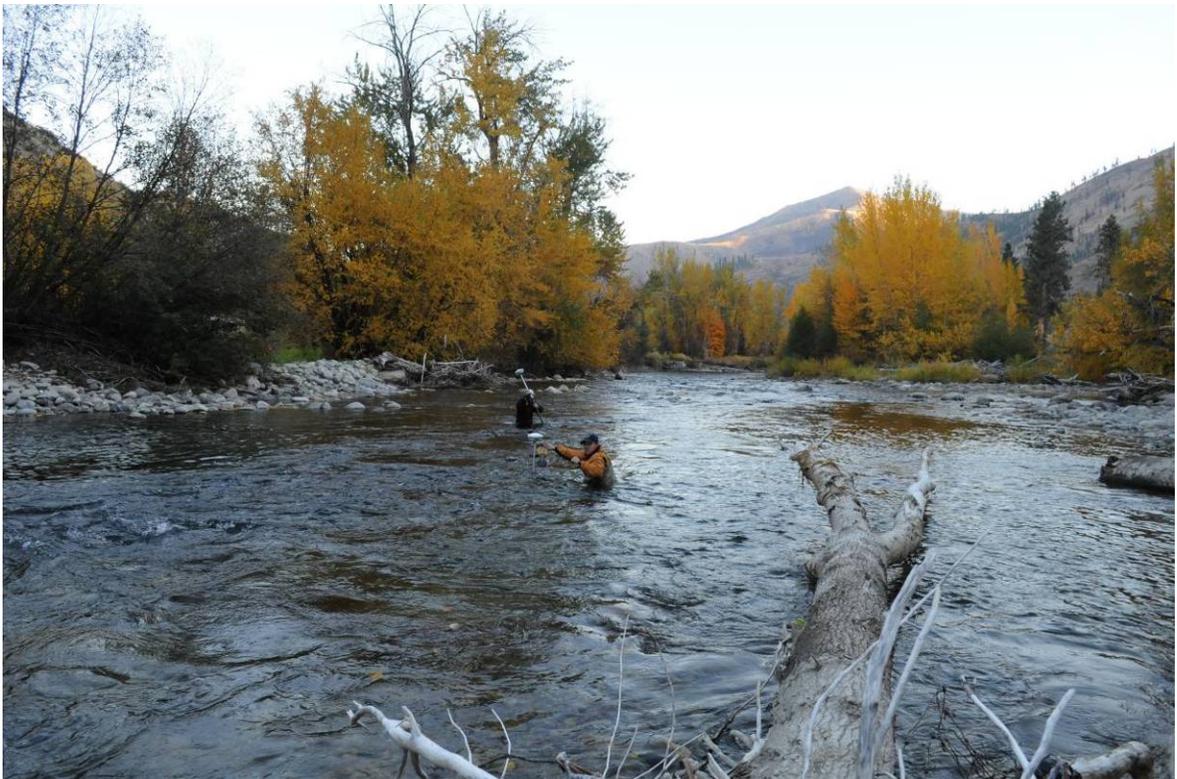
Figure 96. Pool of Entiat River structure at RM 5.1. Pool was estimated to be at least 6 feet deep.
