Developing Plans to Integrate Wood Loading Techniques into Watershed Scale Restoration

Tom Leroy and Chris Moore

Pacific Watershed Associates

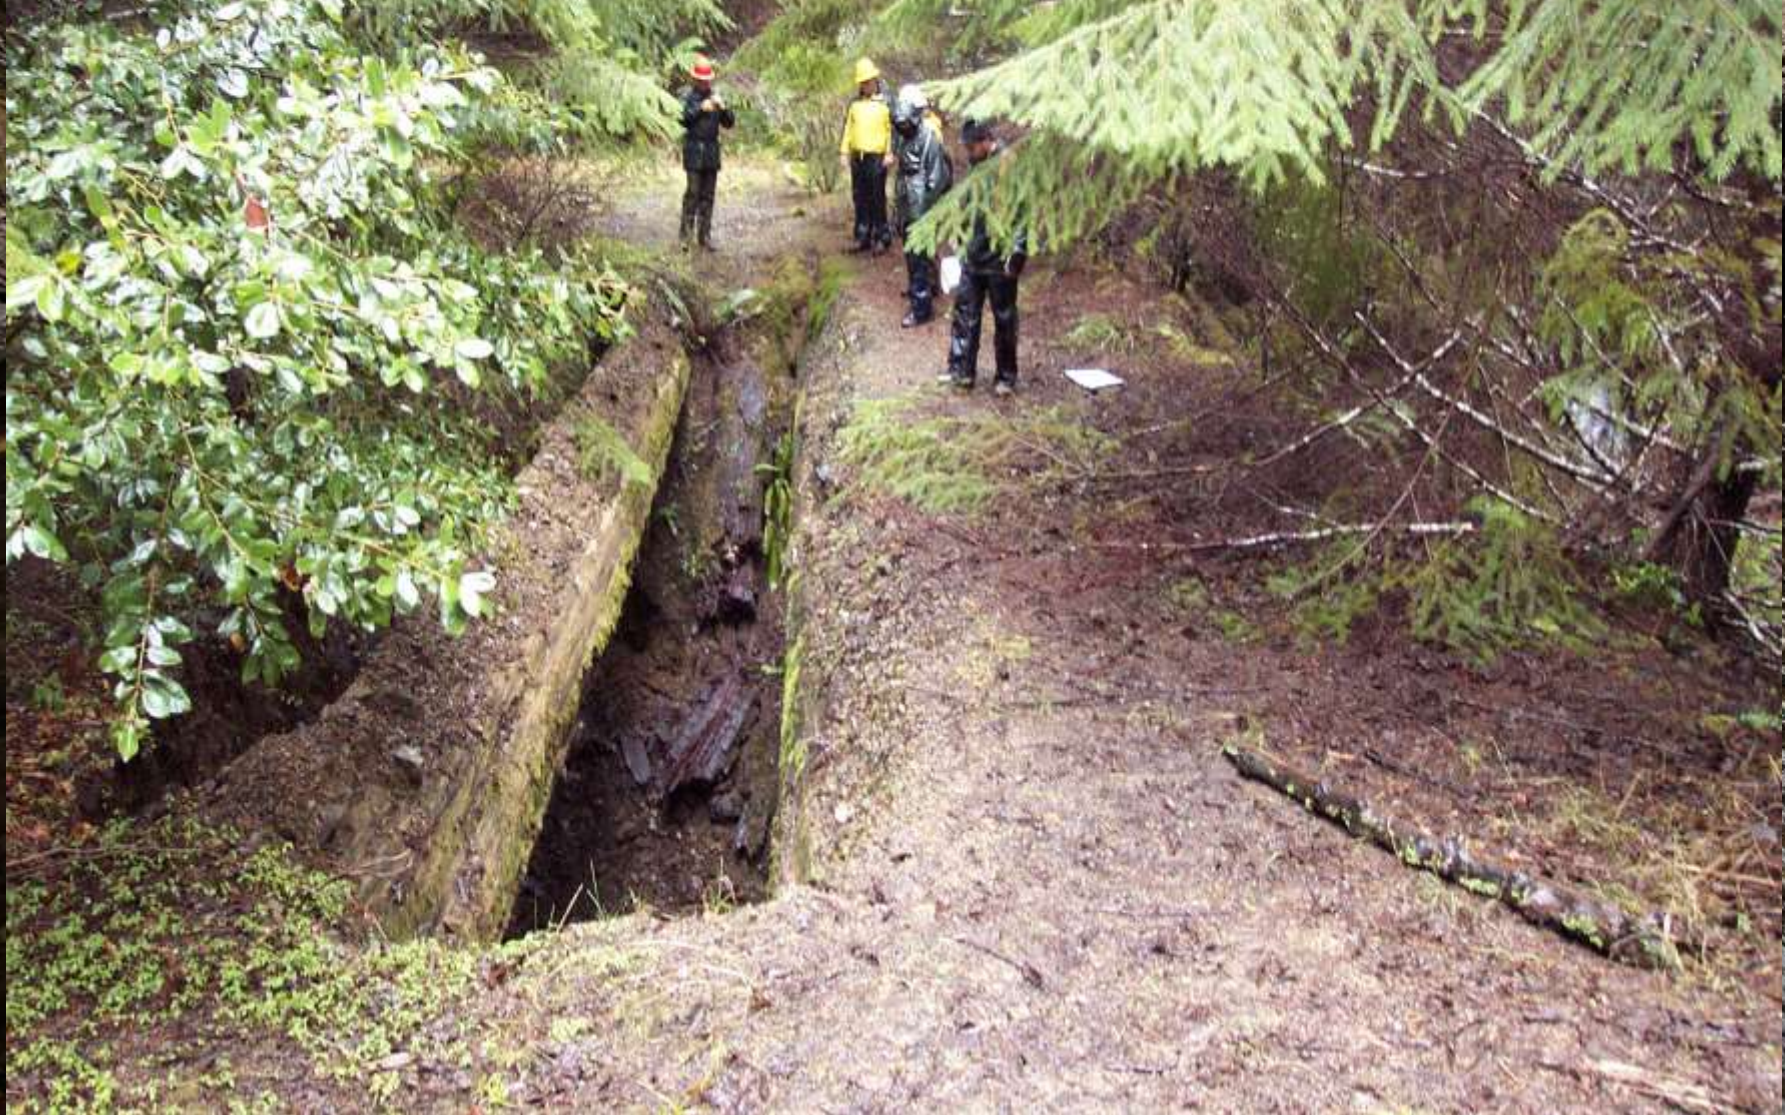
Failing log spanner bridge
(nice big fat reusable logs)

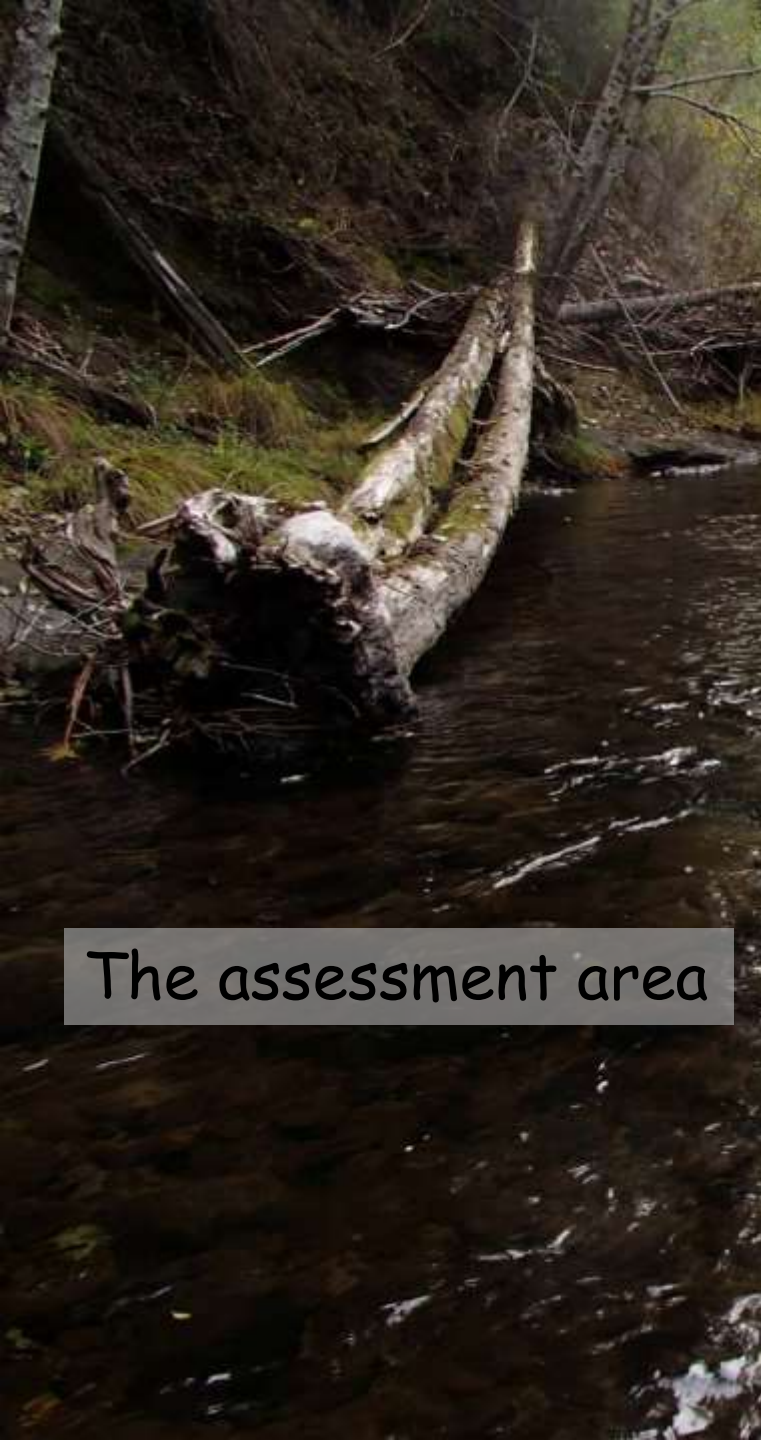
The assessment area

Usal Forest Coho Recovery Plan

Goal: Codevelop upslope sediment reduction and instream habitat improvement prioritized action plans on 5 watersheds over a 50,000 acre area.

Location: South Fork Eel River, Leggett CA.

Watersheds: Wildcat, Bear Pen, Standley, Piercy, Indian

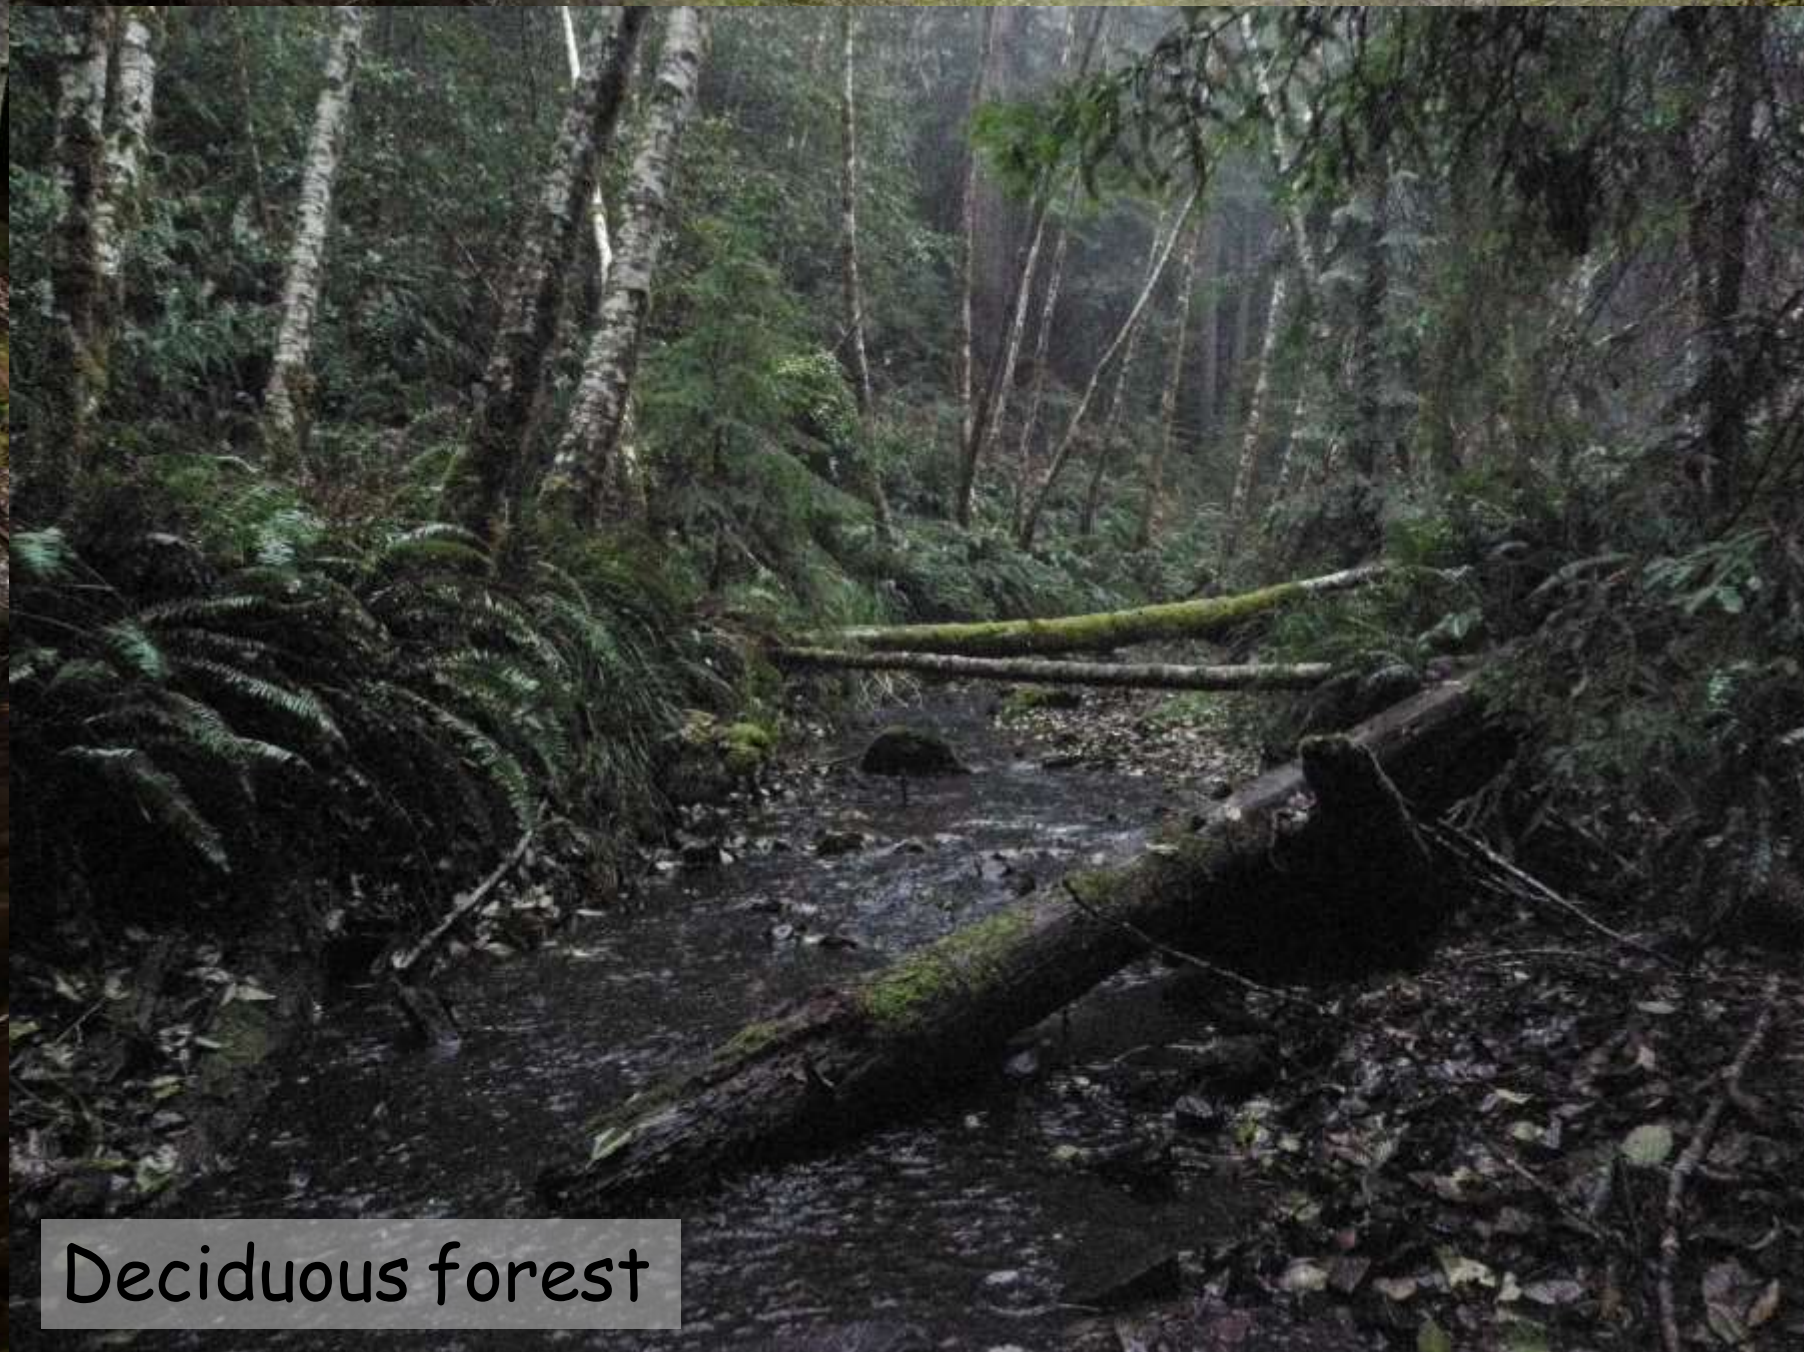
Deciduous forest

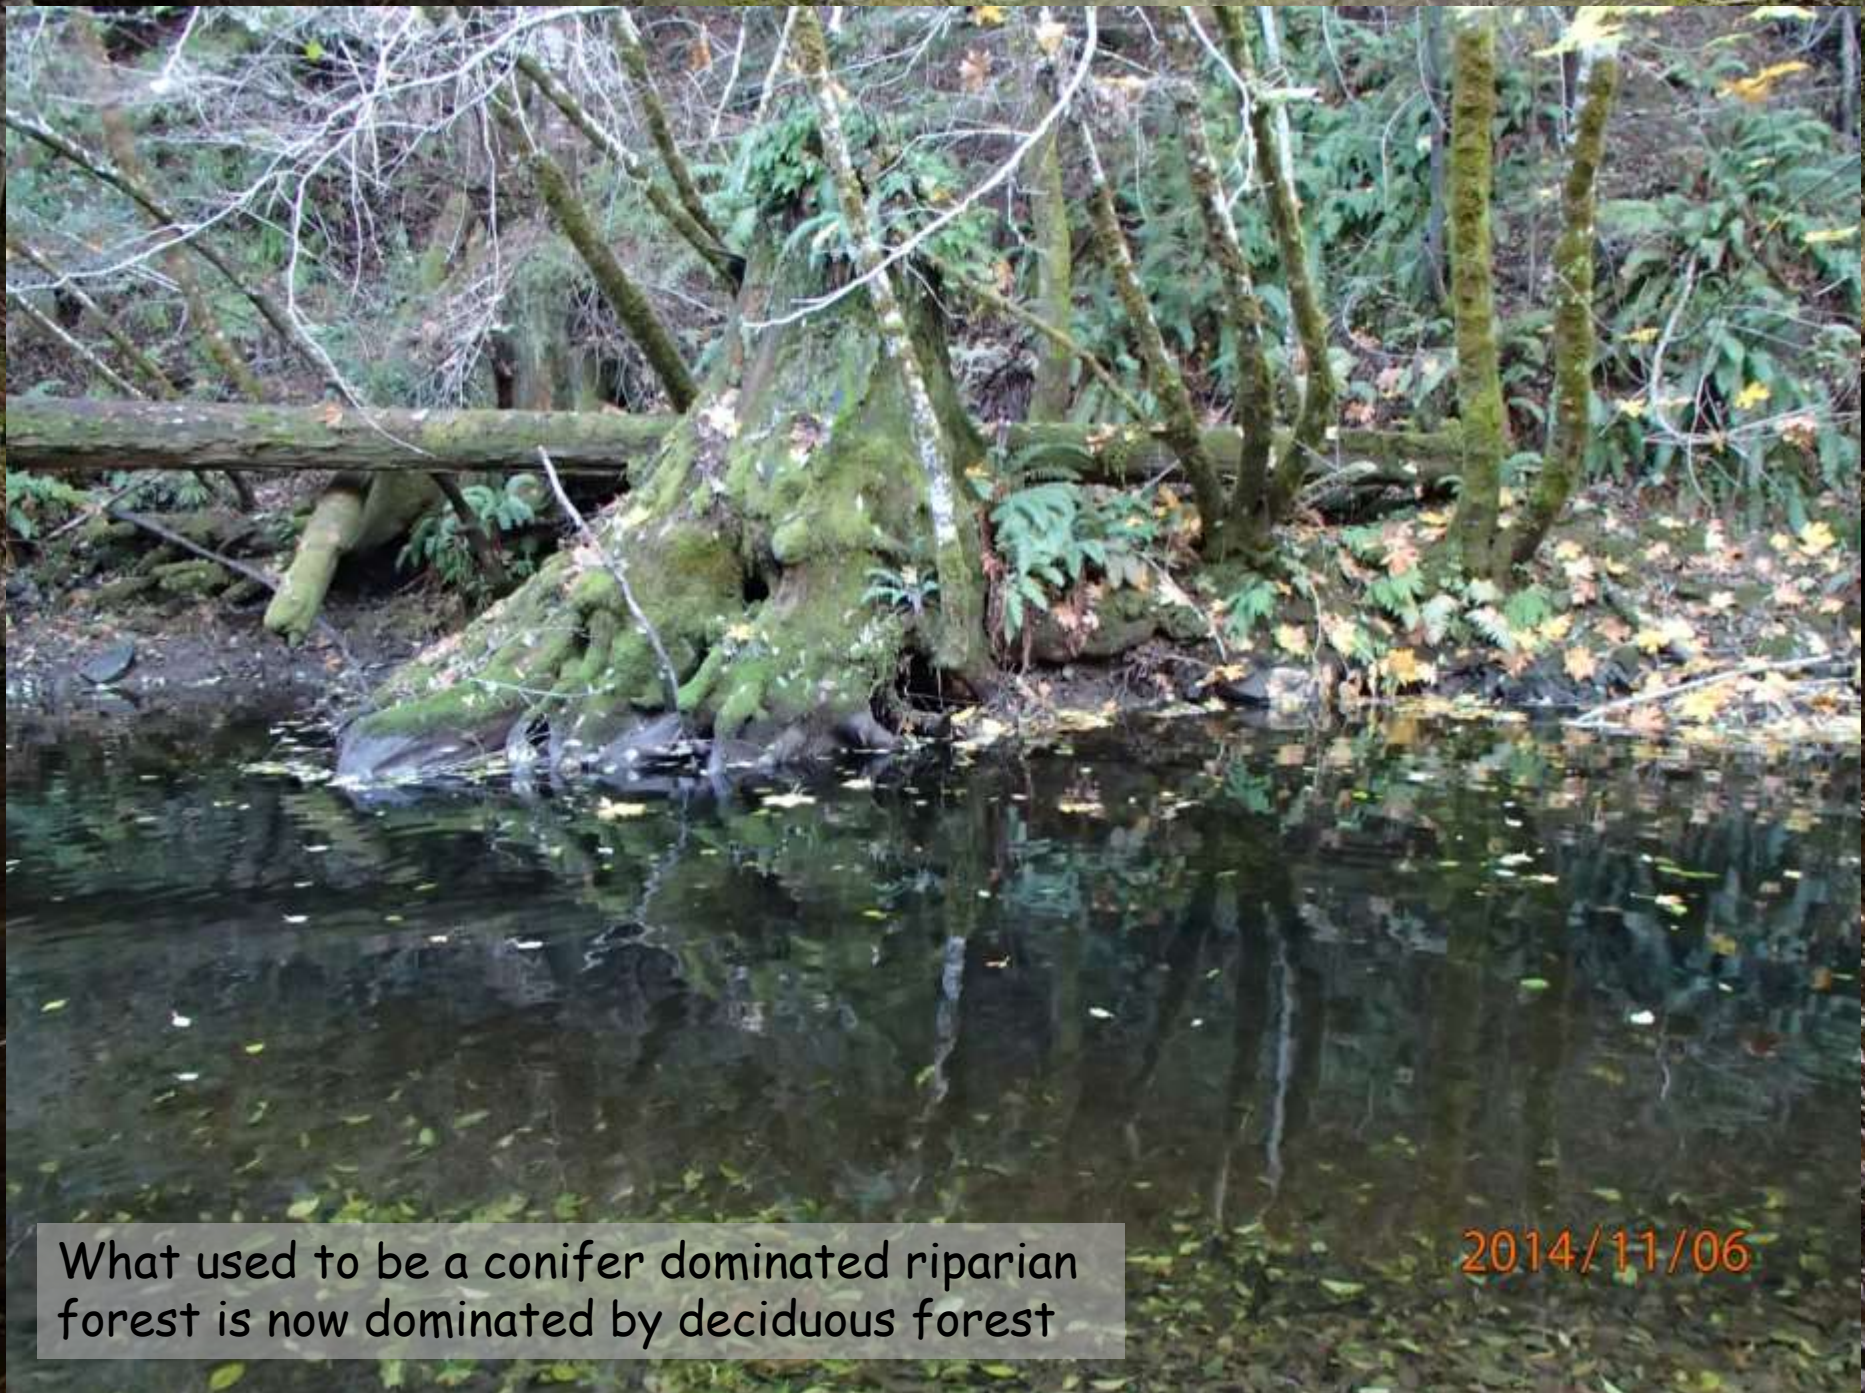
What used to be a conifer dominated riparian forest is now dominated by deciduous forest
