# THE GUALALA RIVER WATERSHED COUNCIL

# Jam' in for salmon...

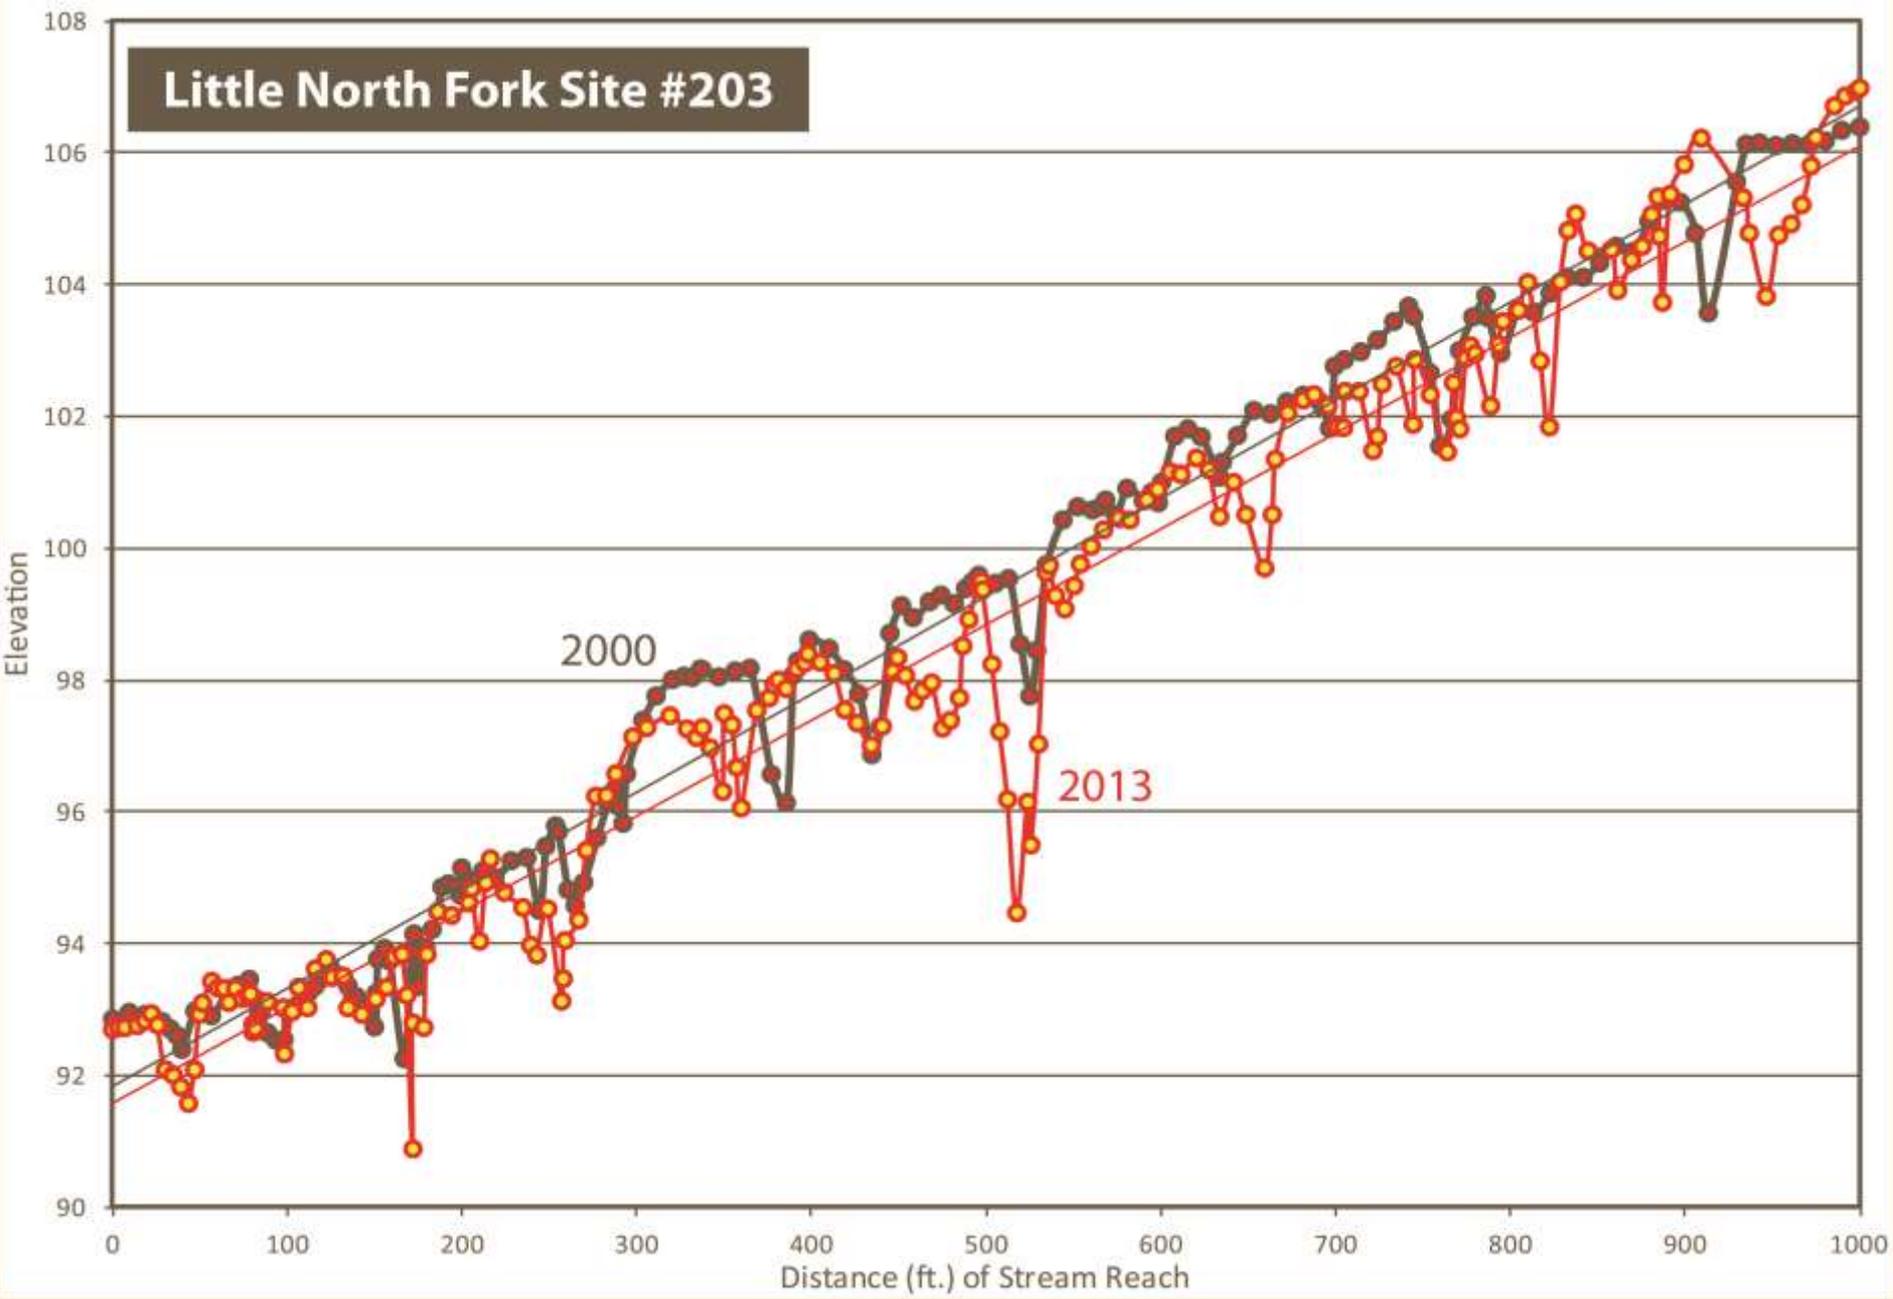
# Little North Fork Site #203

**Forty-one (41) logs** have been placed in Little North Fork Reach (#203) increasing the number of logs by 24% and the volume of large wood in the channel by 50%.

**Large wood placement** has doubled the number of pools and increased the maximum pool depth by three (3) feet.

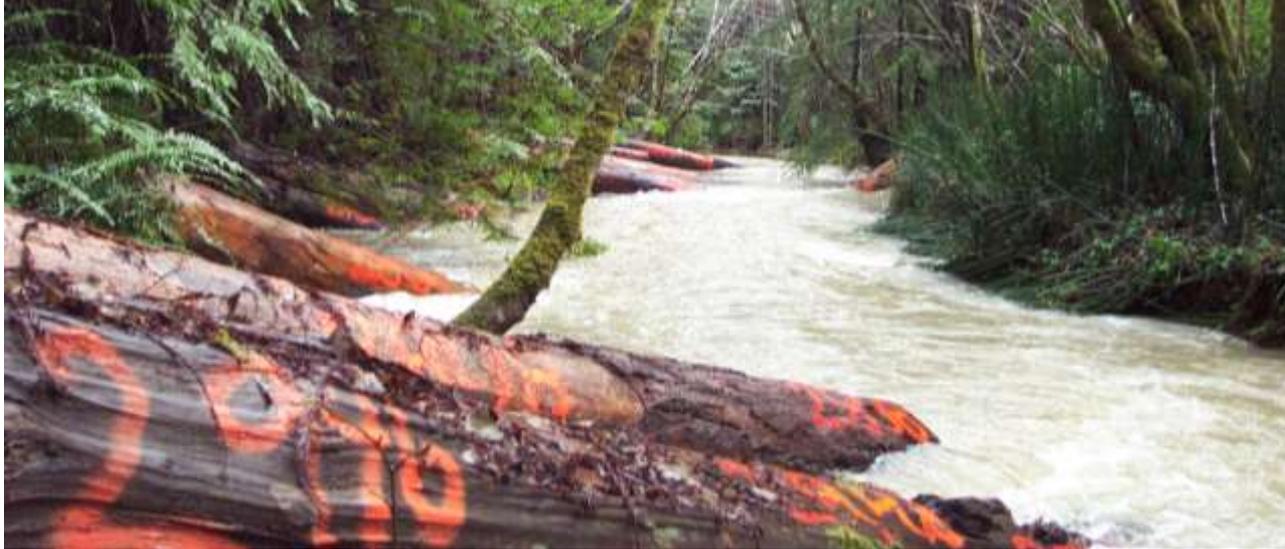
Pool Metrics for 1,000 ft. of Stream Reach  
Pre & Post Large Wood Placement  
Little North Fork Reach #203

**Comparing** large wood placement pre-project data and post project data demonstrates increasing wood levels in stream reaches generates increased pool formation.

Pre-project data

Year	Total Number of Pools	≥ 1ft. Pool Depth	≥ 2 ft. Pool Depth	≥ 3 ft. Pool Depth	MAX Pool Depth	Linear Pool Area Sq. ft.
1998	8	35%	0%	0%	2.0	264
1999	9	38%	0%	0%	2.0	275
2000	7	23%	0%	0%	1.9	150
2001	7	23%	7%	0%	2.1	161
<b>2002</b>	<b>12</b>	<b>42%</b>	<b>14%</b>	<b>4%</b>	<b>3.2</b>	<b>304</b>
<b>2003</b>	<b>13</b>	<b>39%</b>	<b>16%</b>	<b>3%</b>	<b>3.2</b>	<b>363</b>
<b>2004</b>	<b>13</b>	<b>47%</b>	<b>25%</b>	<b>4%</b>	<b>3.1</b>	<b>374</b>
<b>2005</b>	<b>11</b>	<b>42%</b>	<b>20%</b>	<b>6%</b>	<b>3.0</b>	<b>386</b>
<b>2006</b>	<b>15</b>	<b>57%</b>	<b>14%</b>	<b>0%</b>	<b>2.9</b>	<b>436</b>
<b>2007</b>	<b>15</b>	<b>56%</b>	<b>18%</b>	<b>3%</b>	<b>4.4</b>	<b>452</b>
<b>2008</b>	<b>14</b>	<b>61%</b>	<b>24%</b>	<b>3%</b>	<b>4.4</b>	<b>482</b>
<b>2009</b>	<b>14</b>	<b>49%</b>	<b>18%</b>	<b>2%</b>	<b>4.3</b>	<b>434</b>
<b>2010</b>	<b>14</b>	<b>53%</b>	<b>20%</b>	<b>4%</b>	<b>3.9</b>	<b>423</b>
<b>2011</b>	<b>13</b>	<b>46%</b>	<b>15%</b>	<b>9%</b>	<b>5.4</b>	<b>462</b>

<b>2012</b>	<b>9</b>	<b>42%</b>	<b>21%</b>	<b>4%</b>	<b>5.2</b>	<b>416</b>
<b>2013</b>	<b>14</b>	<b>54%</b>	<b>19%</b>	<b>11%</b>	<b>5.0</b>	<b>458</b>

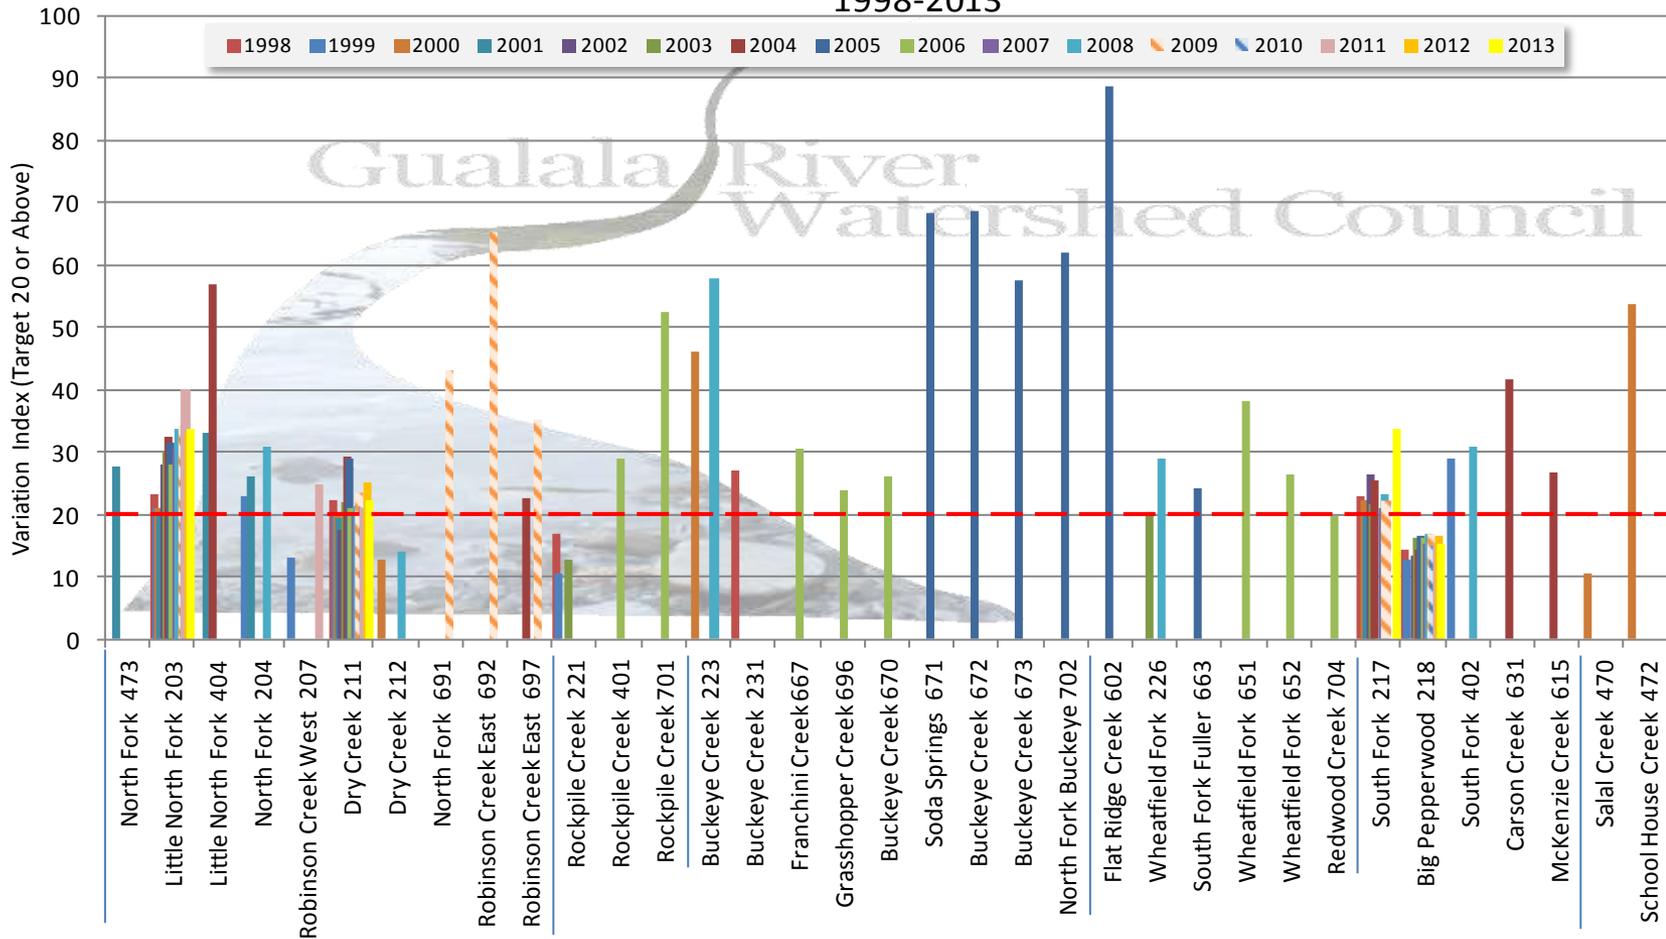
# Gualala River Thalweg Variation Index\*

## 1998-2013

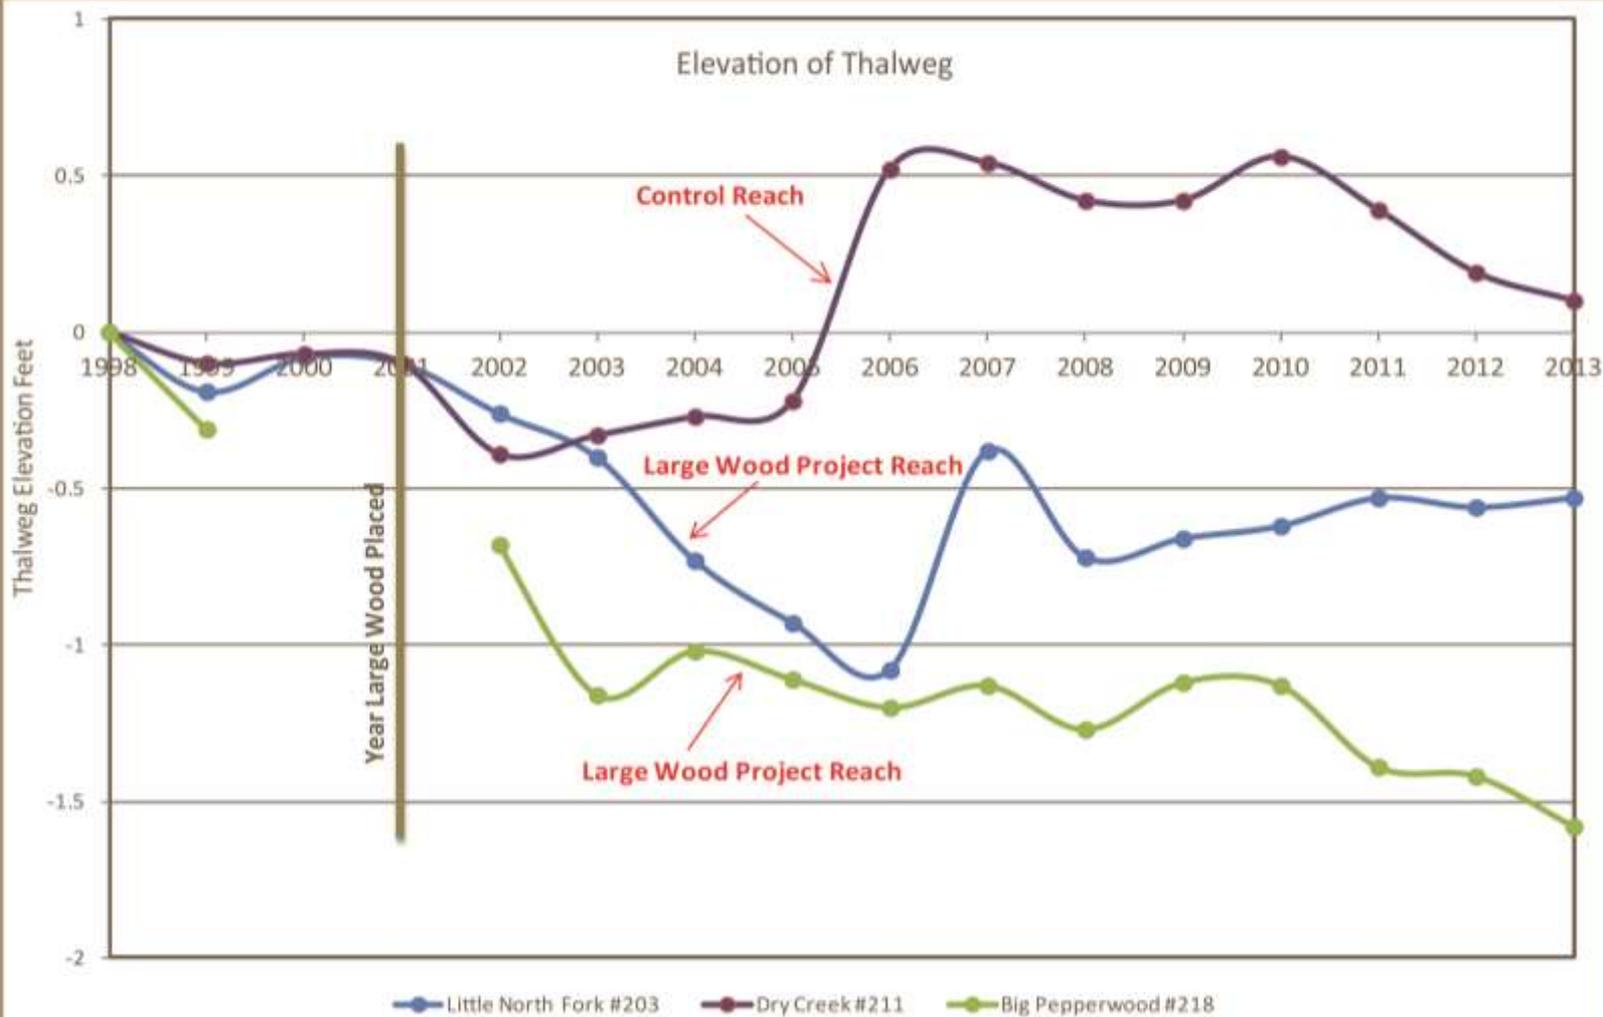
### Elevation of Thalweg

Monitoring Reach Sites
