Eel River Watershed Improvement Group Isaac Mikus – Executive Director Isaac@erwig.org

## The Design Process

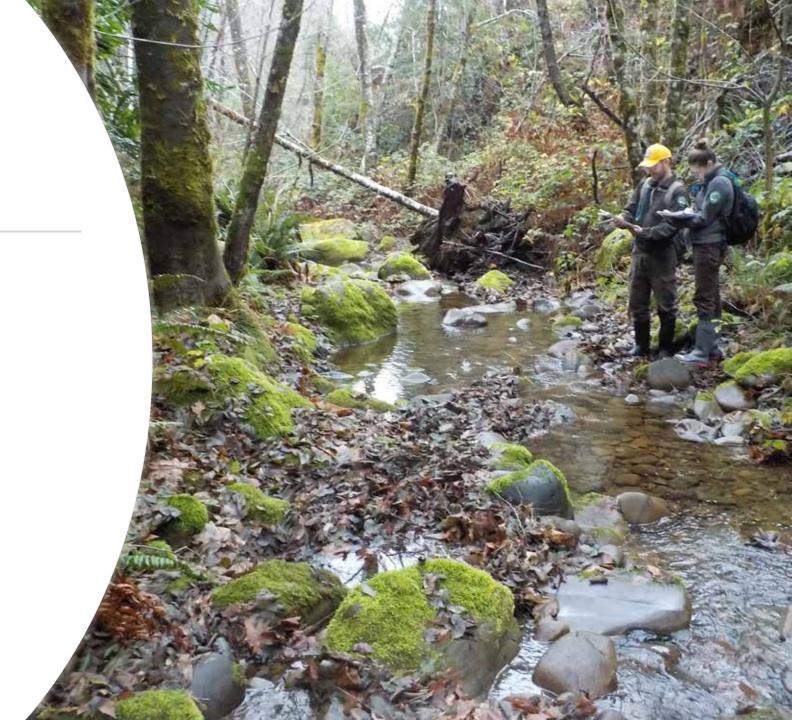
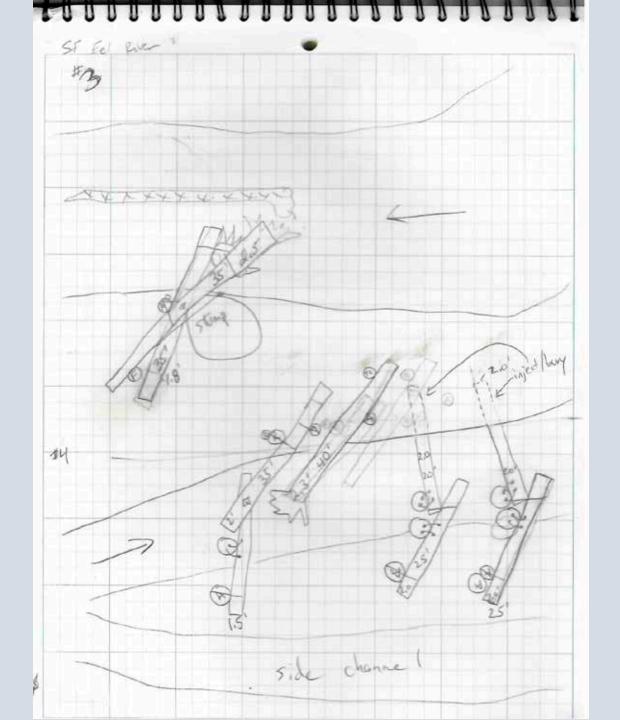
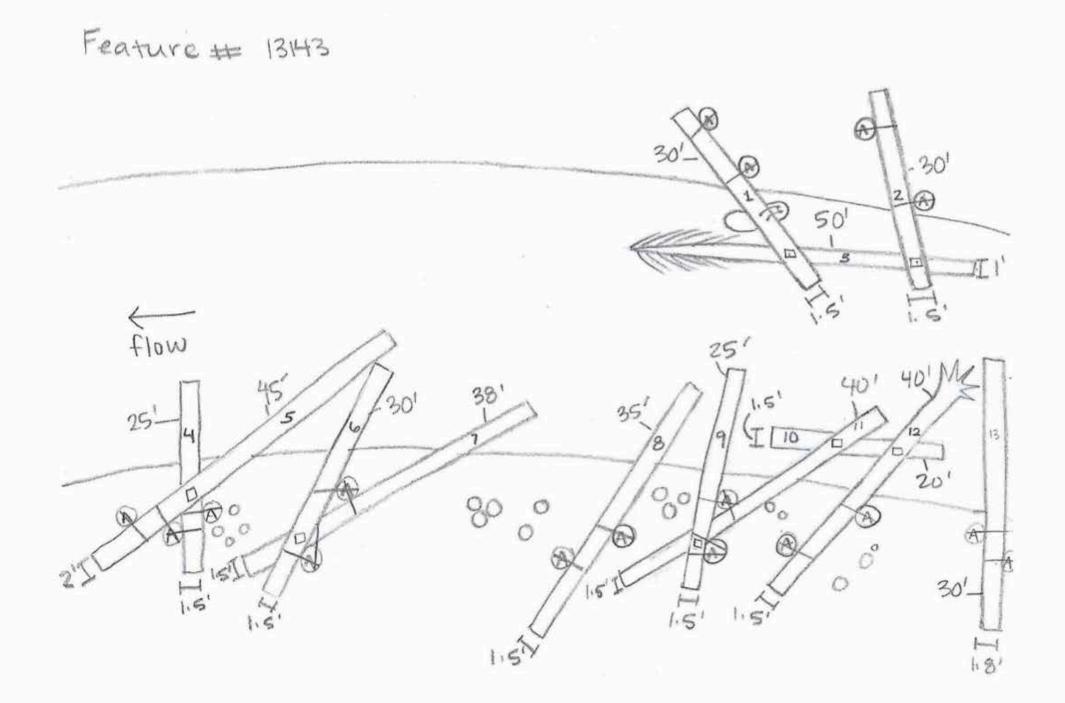
Feature: 13143 Coordinates: 40.05495, -123.85178

Existing Conditions: Run Bankfull Width: 37 feet Max residual depth: 1.4 feet

Dominant substrate: Boulder/gravel Dominant cover type: Boulder, <5%

**Project:** Log 3 is underneath and anchored to logs 1 and 2 as a cover log. Log 5 is on top of and anchored to log 4. Log 6 is on top of and anchored to log 7. Log 9 is on top of and anchored to log 11. Log 10 is underneath and anchored to logs 11 and 12 as a cover log. One dead and down Douglas fir will be used for this project. The rest of the logs will be sourced from riparian and upslope redwoods and Douglas firs.

Length Treated: 85 feet Length Disturbed: 30 feet Square Footage: 335 ft<sup>2</sup>

Objective: Increase cover, scour, and velocity refugia.

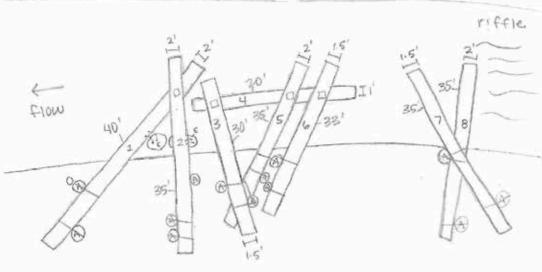
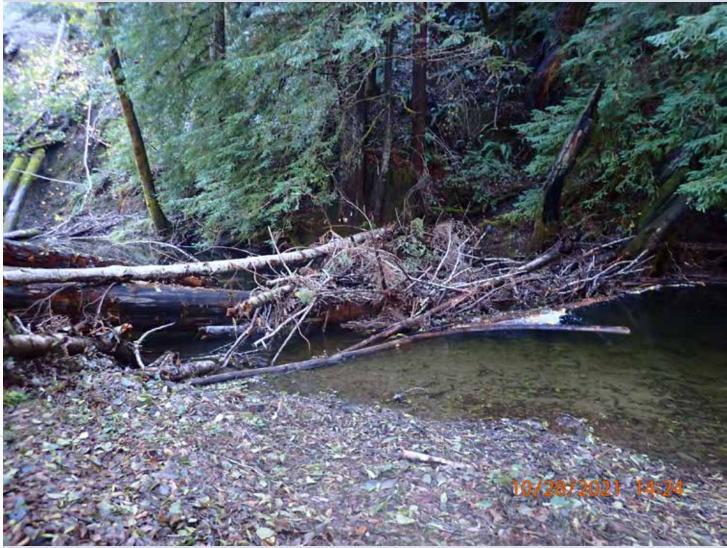
Feature # 11245

Feature: 11245	Coordinates: 40.05378, -123.84845		
Existing Conditions: Pool/run-riffle	Bankfull W	<b>idth:</b> 40 feet	Max residual depth: 3.1 feet
Dominant substrate: Gravel, small cobble		Dominant cover type: Undercut banks, 5%

**Project:** Log 2 is on top of and anchored to log 1. Log 4 is a cover log and is underneath and anchored to logs 3, 5, and 6. Log 3 is on top of log 5. Log 7 is on top of log 8. Logs for this feature will be purchased.

Length Treated: 50 feet Length Disturbed: 20 feet Square Footage: 265 ft<sup>2</sup>

Objective: Increase cover, scour, and velocity refugia.
