2020 Redwood Creek, South Fork Eel River, Dry Season Stream Flow Monitoring Summary

By: Katrina Nystrom, Prepared for: Salmonid Restoration Federation

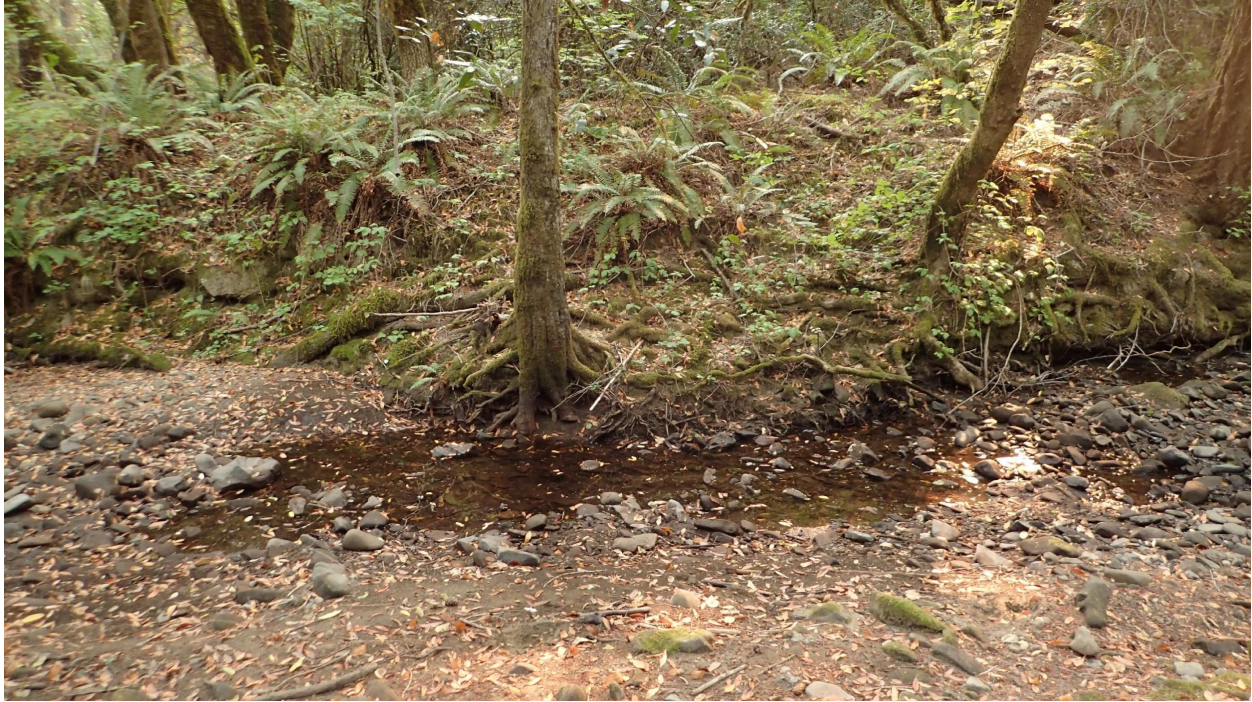
Figure 11. Upper Redwood Creek gage pool 8/27/20, flow coming into the gage pool (0.00076 cfs), but the riffle crest was dry. The sensor was not submerged, just the tip touched the water to read water level.

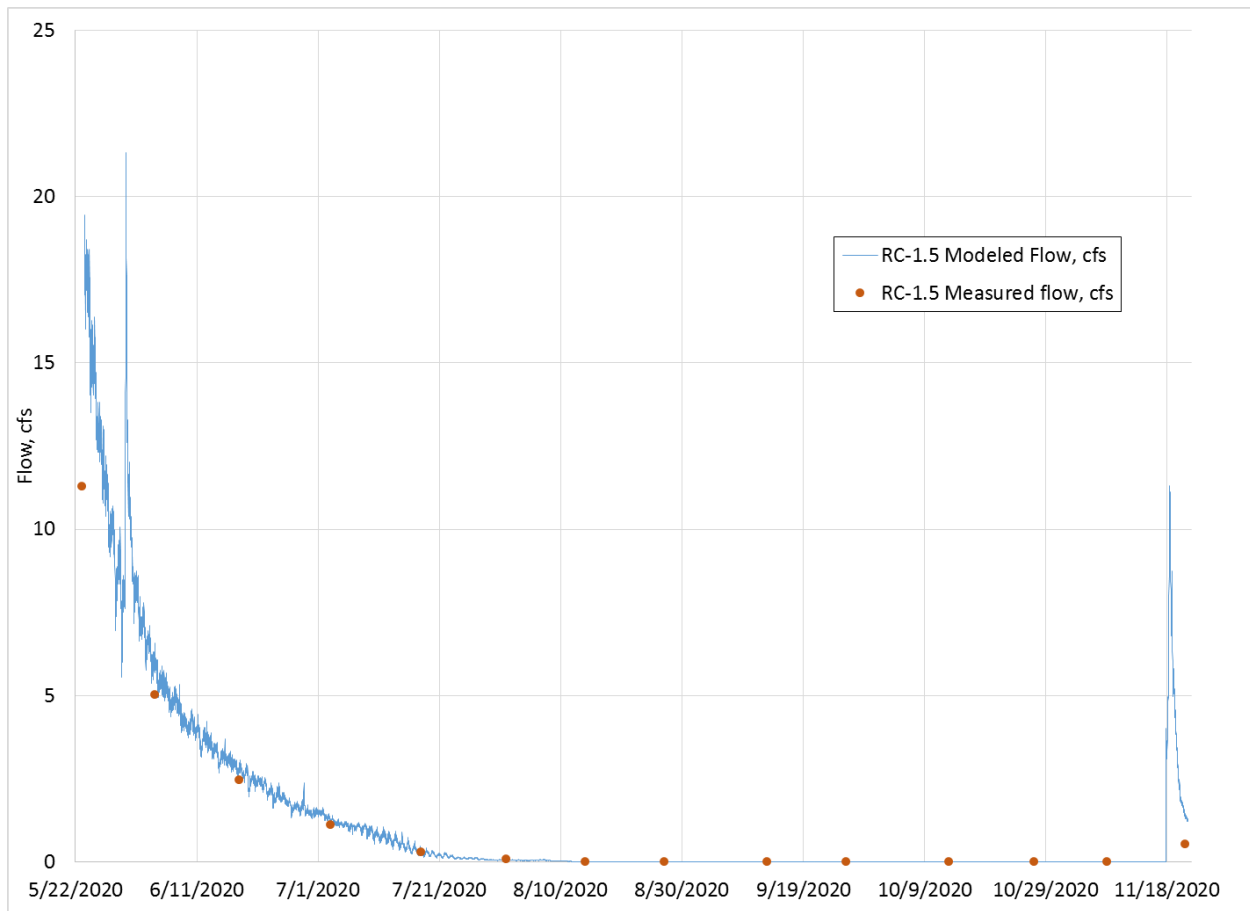
Figure 13. RC-1.5 measured and modeled flow (cfs), 5/23/20 to 11/21/20.

The water receded below the sensor on 8/29/20 and was put back in the water at the next monitoring visit on 9/13/20 (Figure 12). The water receded from the logger again on 9/28/20 and stays out of the water until 11/17/20, there wasn't enough water to move the logger. On 10/27/20 and 11/8/20 the water receded too far away from the stage reference to measure water level. The temperatures begin to have a high diurnal variance when the logger is not completely submerged, about 8/20/20 to 9/13/20 and 8/20/20 to 11/27/20. The streamflow stops on 8/15/20 and doesn't start again until 11/17/20 (Figure 13).

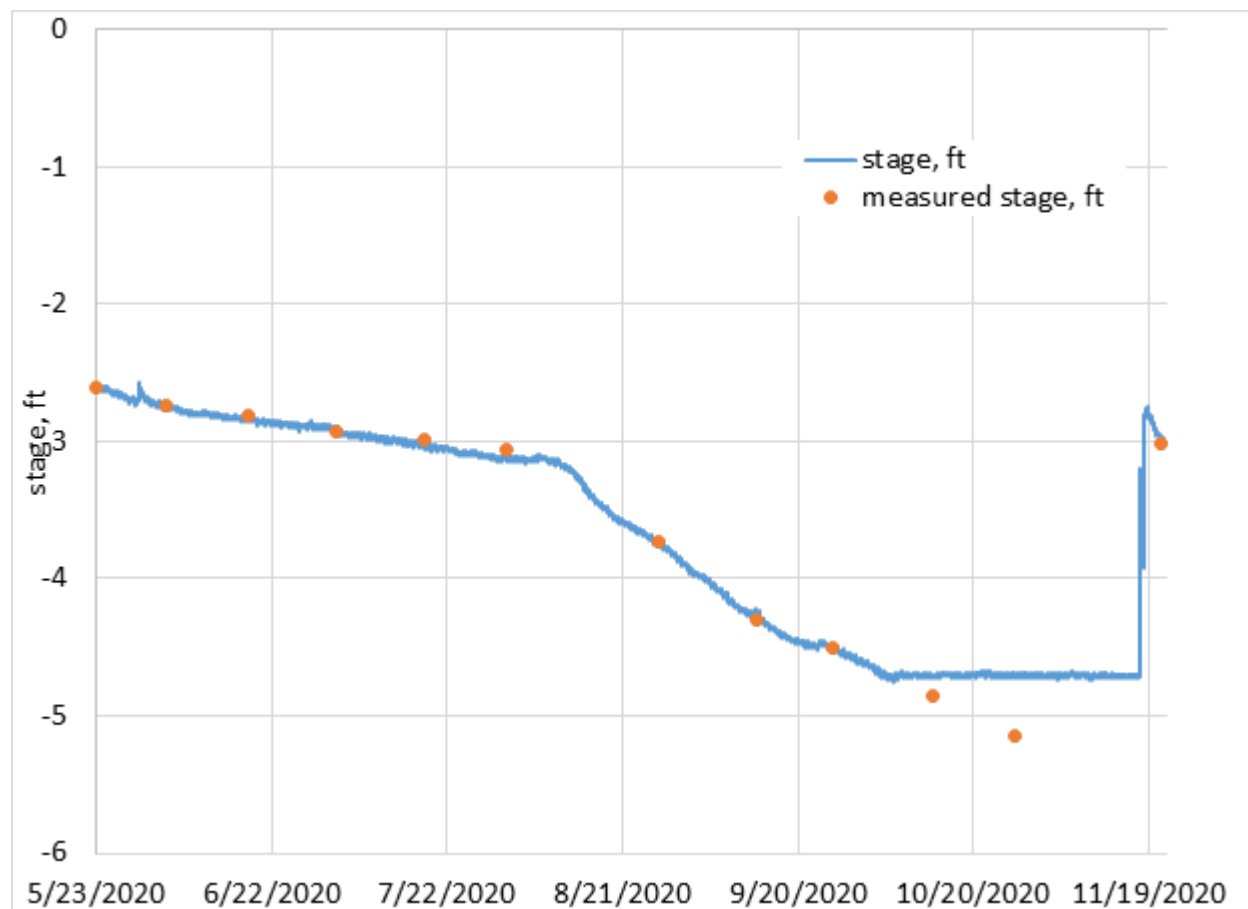
Figure 21. RC-1.8 predicted stage compared to measured stage 5/23/20-11/21/20.

On 11/8/2020, the water surface had receded away from my measuring nail and I could not take a stage reading (Figure 21).

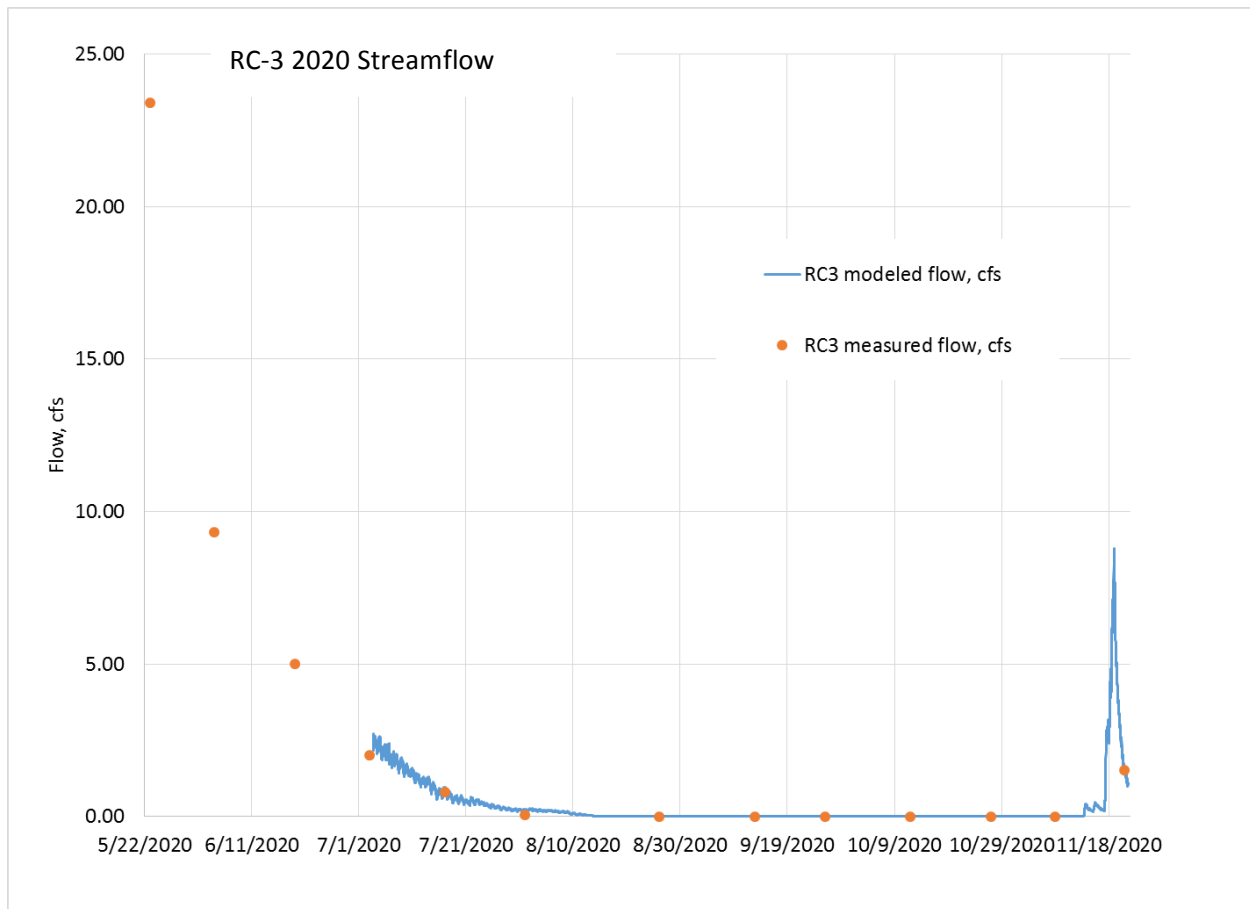
Figure 27.RC-3 flow measurements and the modeled flow from the sensor 5/23/20 to 11/21/20.

The riffle crest in the gage pool is dry at 0.43 ft, but flow did not entirely stop at RC3 until a stage of 1.0 ft (Figure 27). The riffle crest in the gage pool starts to dry 8/3/20. The flow stops at the site on 8/30/20 and does not start again until 11/13/20.

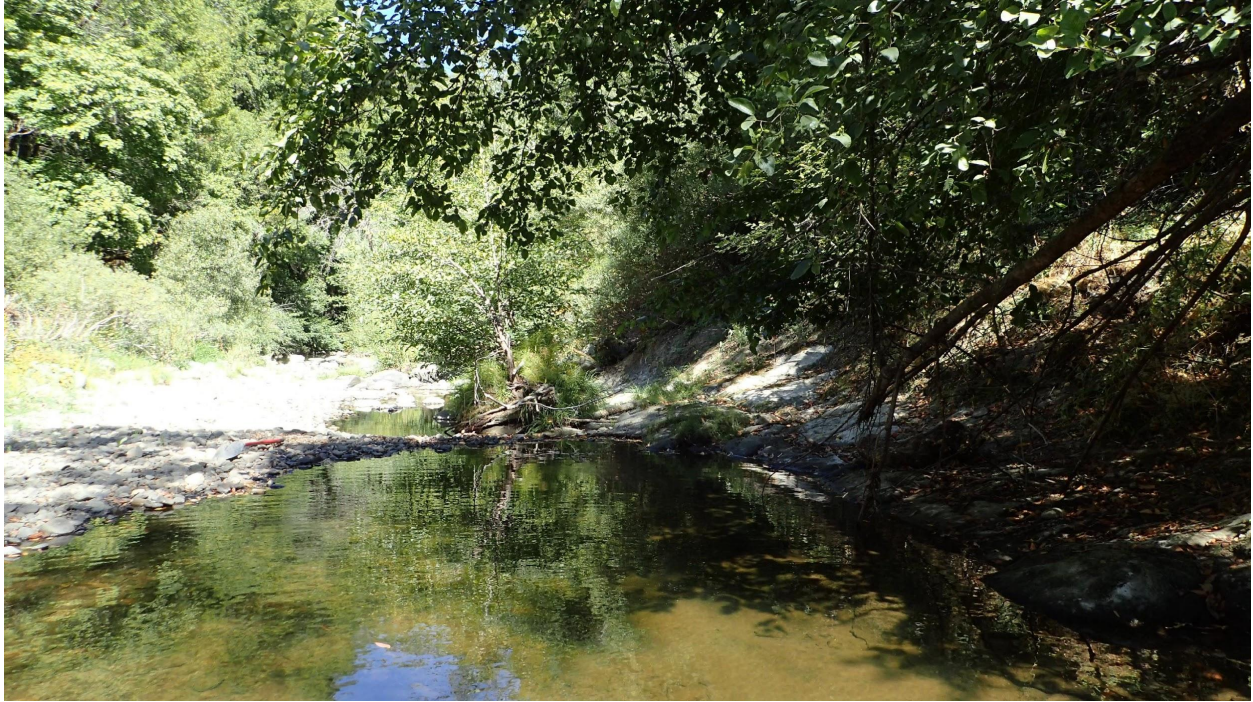
Figure 28. RC-3 facing downstream 8/1/20. The riffle crest at the downstream end of the gage pool is dry, but there is measurable flow at the boulder lip downstream (0.058 cfs).

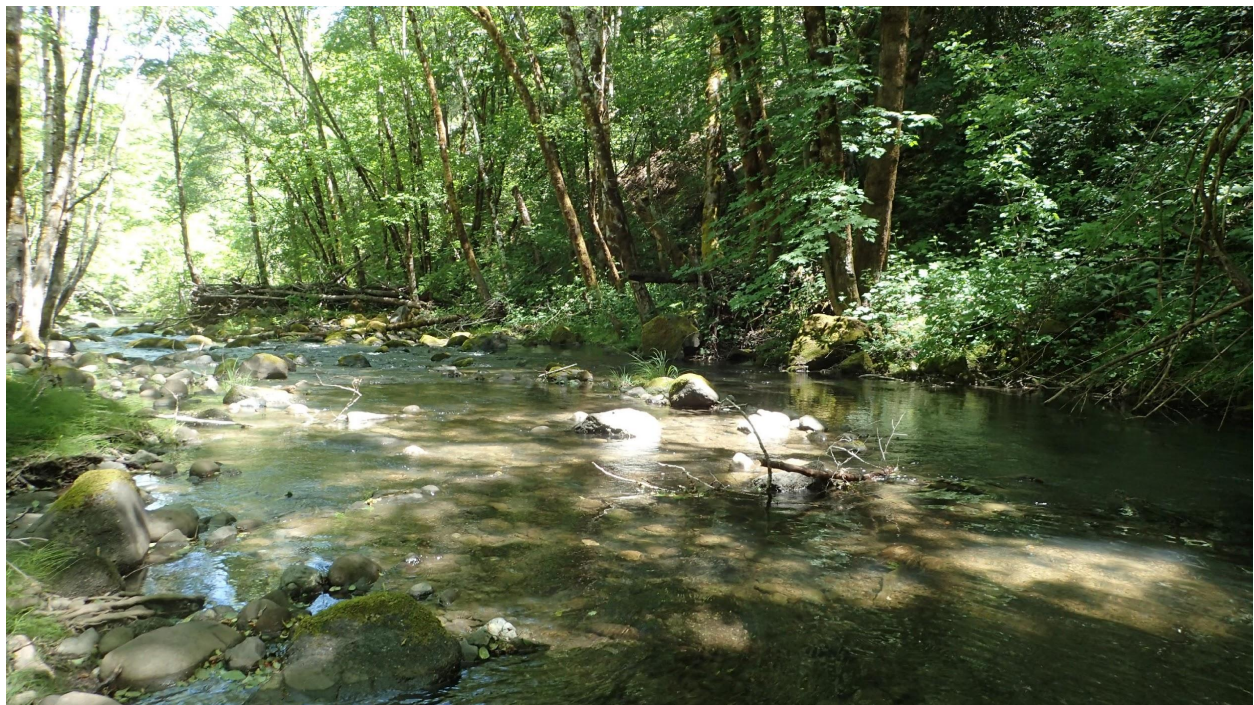
Figure 37. Redwood Creek facing downstream from gaging point 5/23/20.

Pictures were taken upstream and downstream from the stage reference point at each visit. Included in this report is the picture facing downstream of the reference point at the highest flow during a monitoring visit (5/23/20), the lowest flow during a monitoring visit (11/8/20), and more pictures if needed to illustrate the conditions.

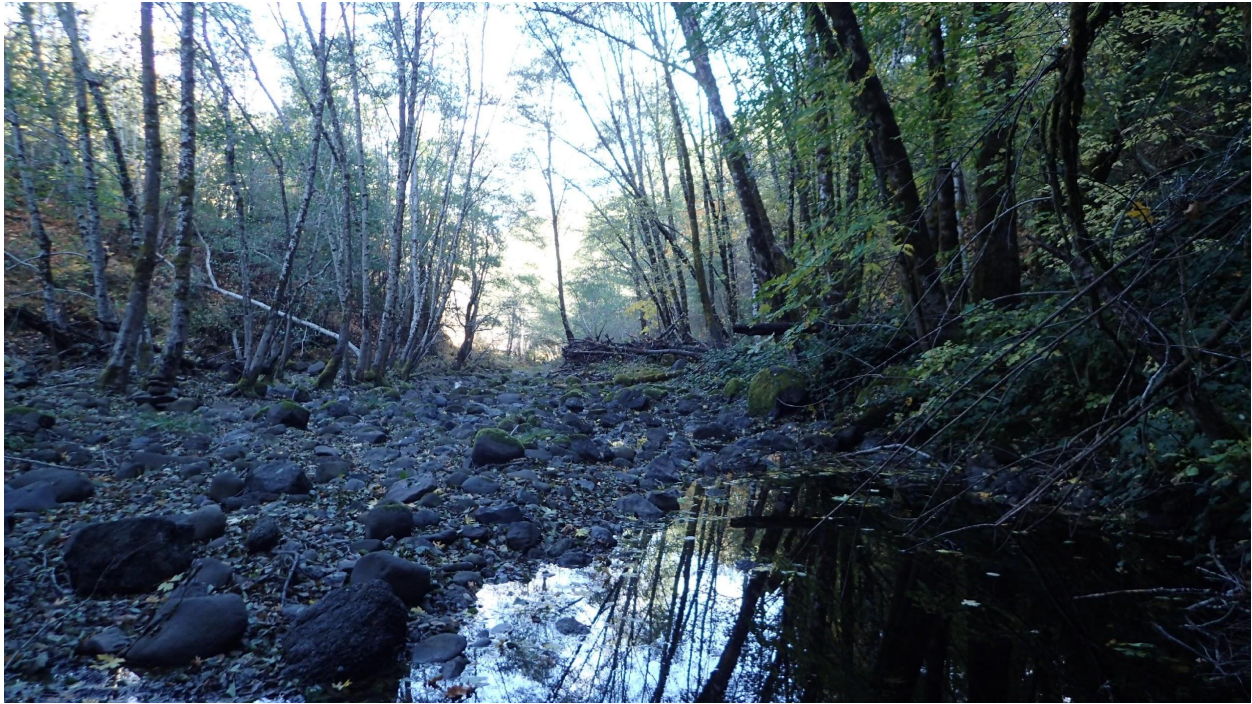
Figure 38. Redwood Creek site RC-2.5 facing downstream of gage pool 11/8/20.

There is a spring just upstream of the gage pool at RC-2.5 that kept a trickle of water coming through the site throughout the dry season (average of 0.006 cfs or 2 gpm). There were no measurements taken the week of 7/3/20. The lowest dissolved oxygen reading was 2.49 ppm on 10/27/20 (Figure 36).

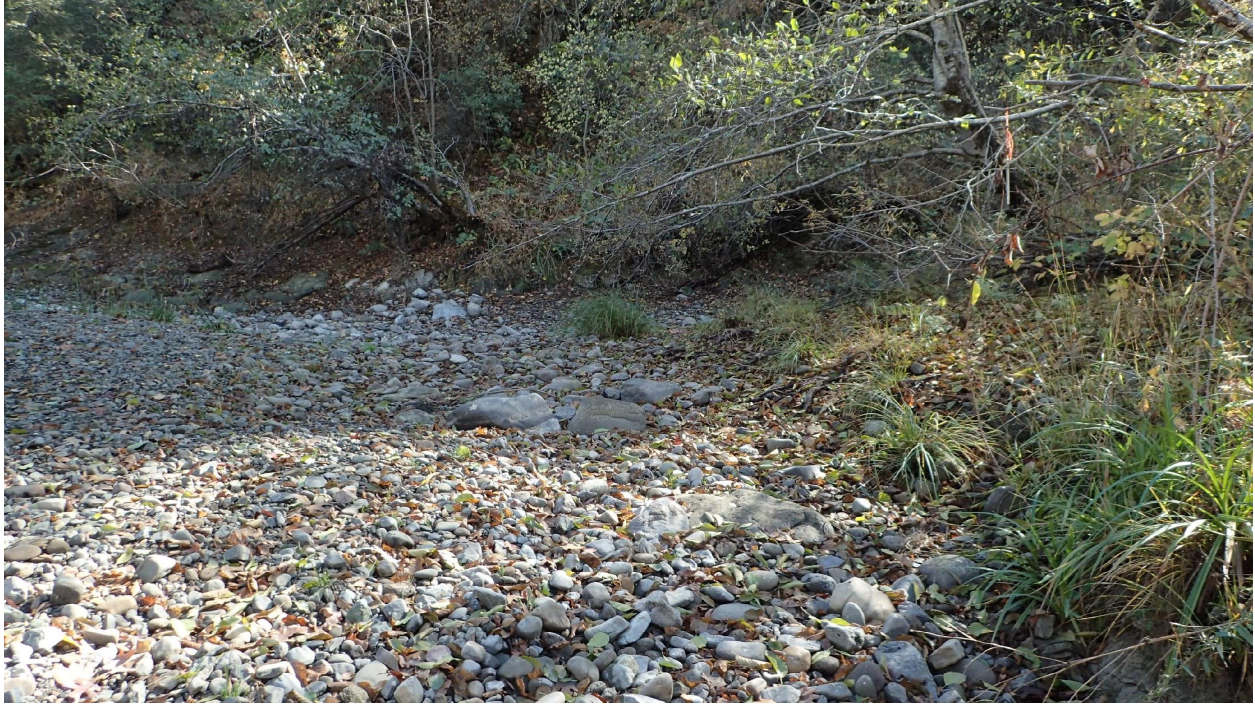
Figure 42. Seely Creek, SC-1 looking downstream, 11/8/20.

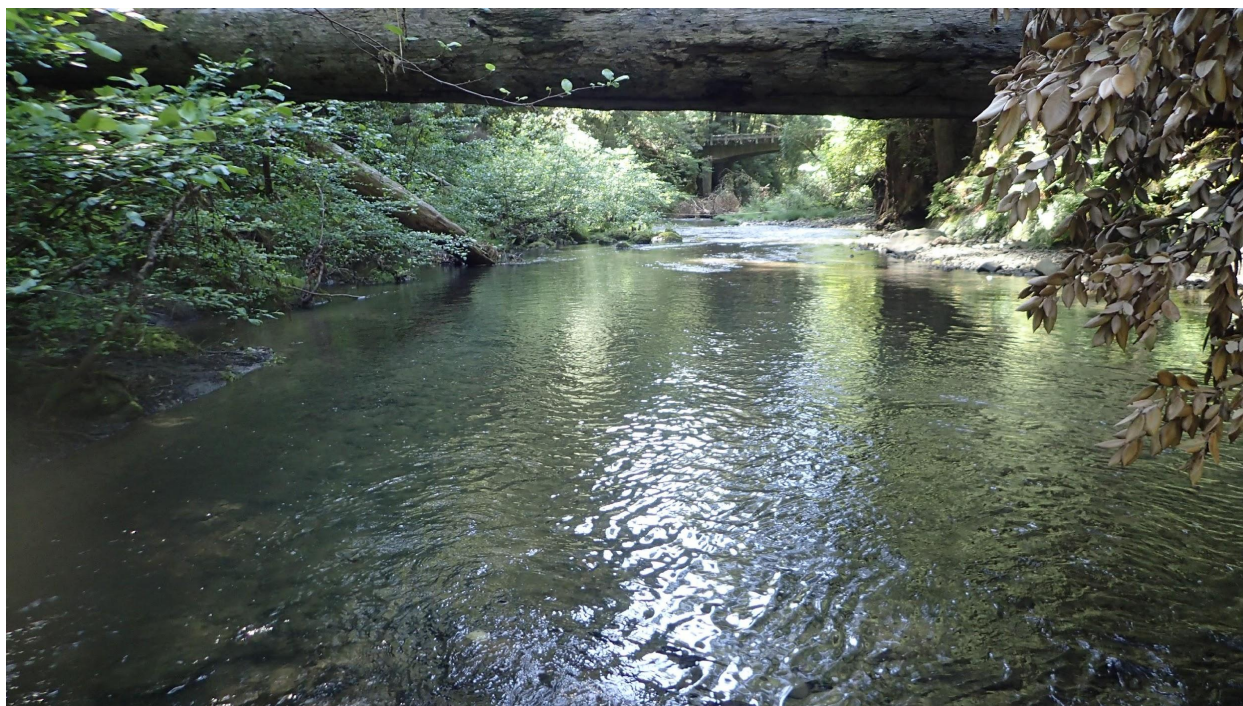
Figure 45. Site RC4 looking downstream from gaging site 5/23/20.

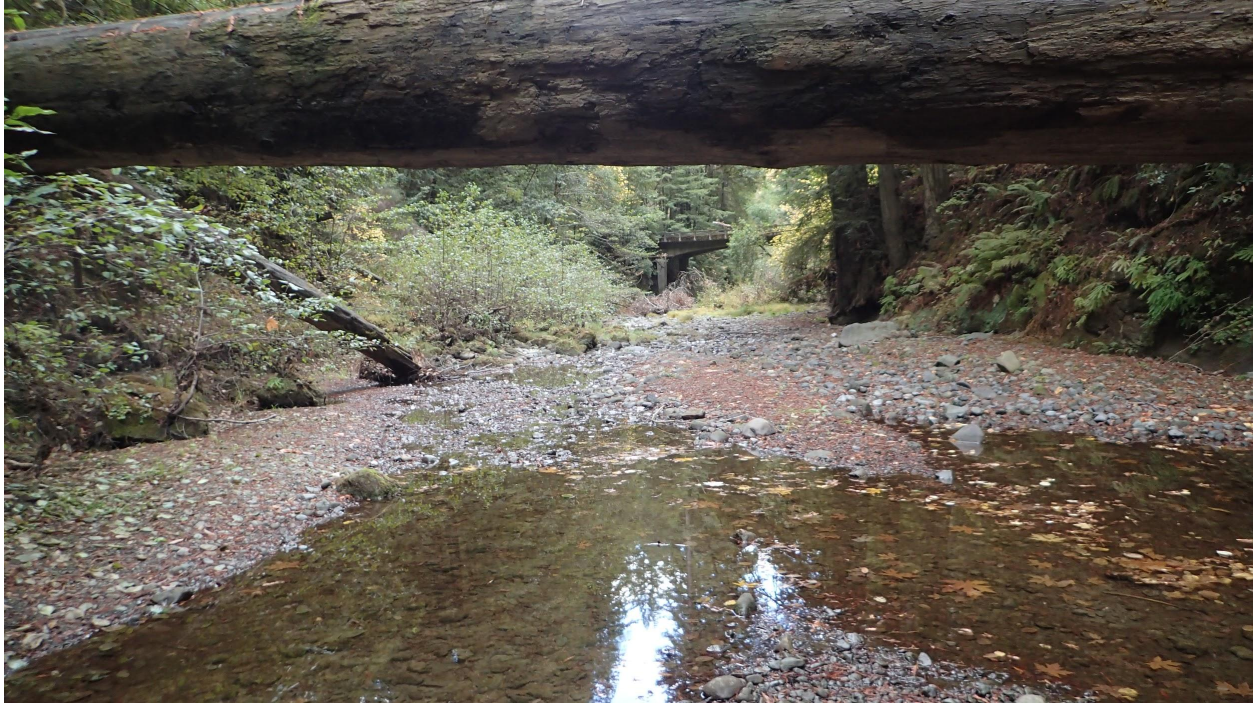
Figure 46. Redwood creek site RC-4 looking downstream from gage on 11/8/20.

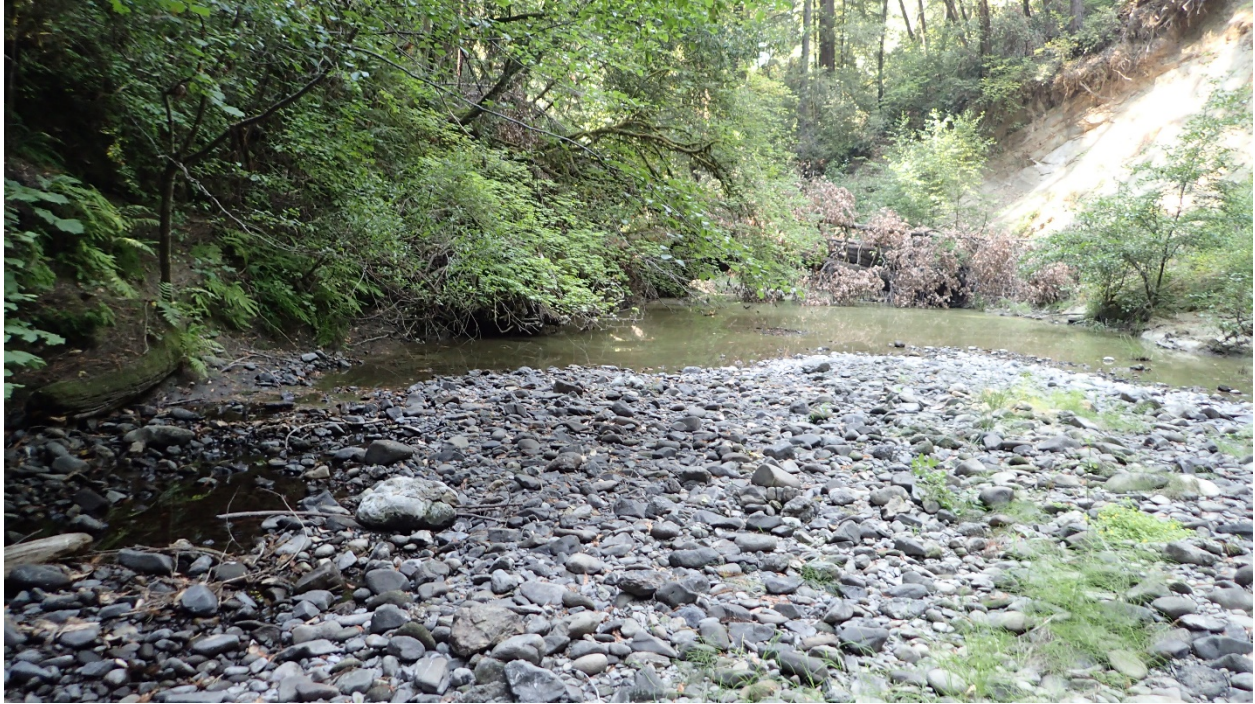
Figure 47. Green film on pool upstream of gage pool 8/13/20.

There was an accident upstream of RC-4 on 8/12/20. KMUD radio reported that hydraulic fluid spilled in the creek, but the residents were able to mop most of it up. On 8/13/20 I observed a green film on the pool upstream of the RC-4 gage pool (Figure 47). I was nervous that it was a result of the spill, but on 8/14/20 I also observed the green film at RC-3 which is upstream of the accident site. A sample of the water was taken and tested for hydraulic fluid, there was no hydraulic fluid in the water.

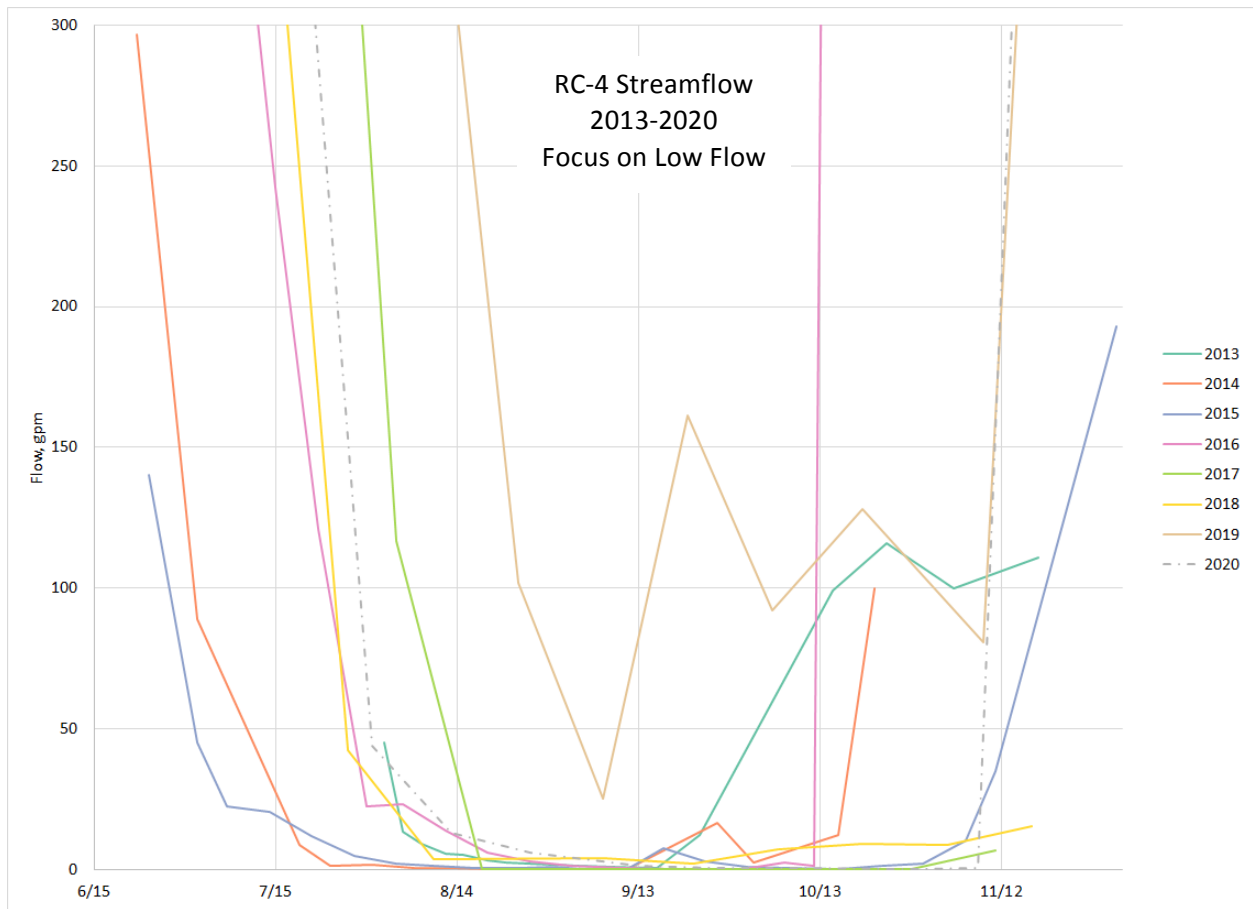
Figure 49. Redwood Creek site RC-4 measurements from 2013 through 2020. The 2020 season has a dashed line. Note y-axis and time scale zoomed in to see the low flow period.
