**Michael Love & Associates, Inc.**  
 PO Box 4477 • Arcata, CA 95518 • (707) 822-2411

FIGURE  
 1

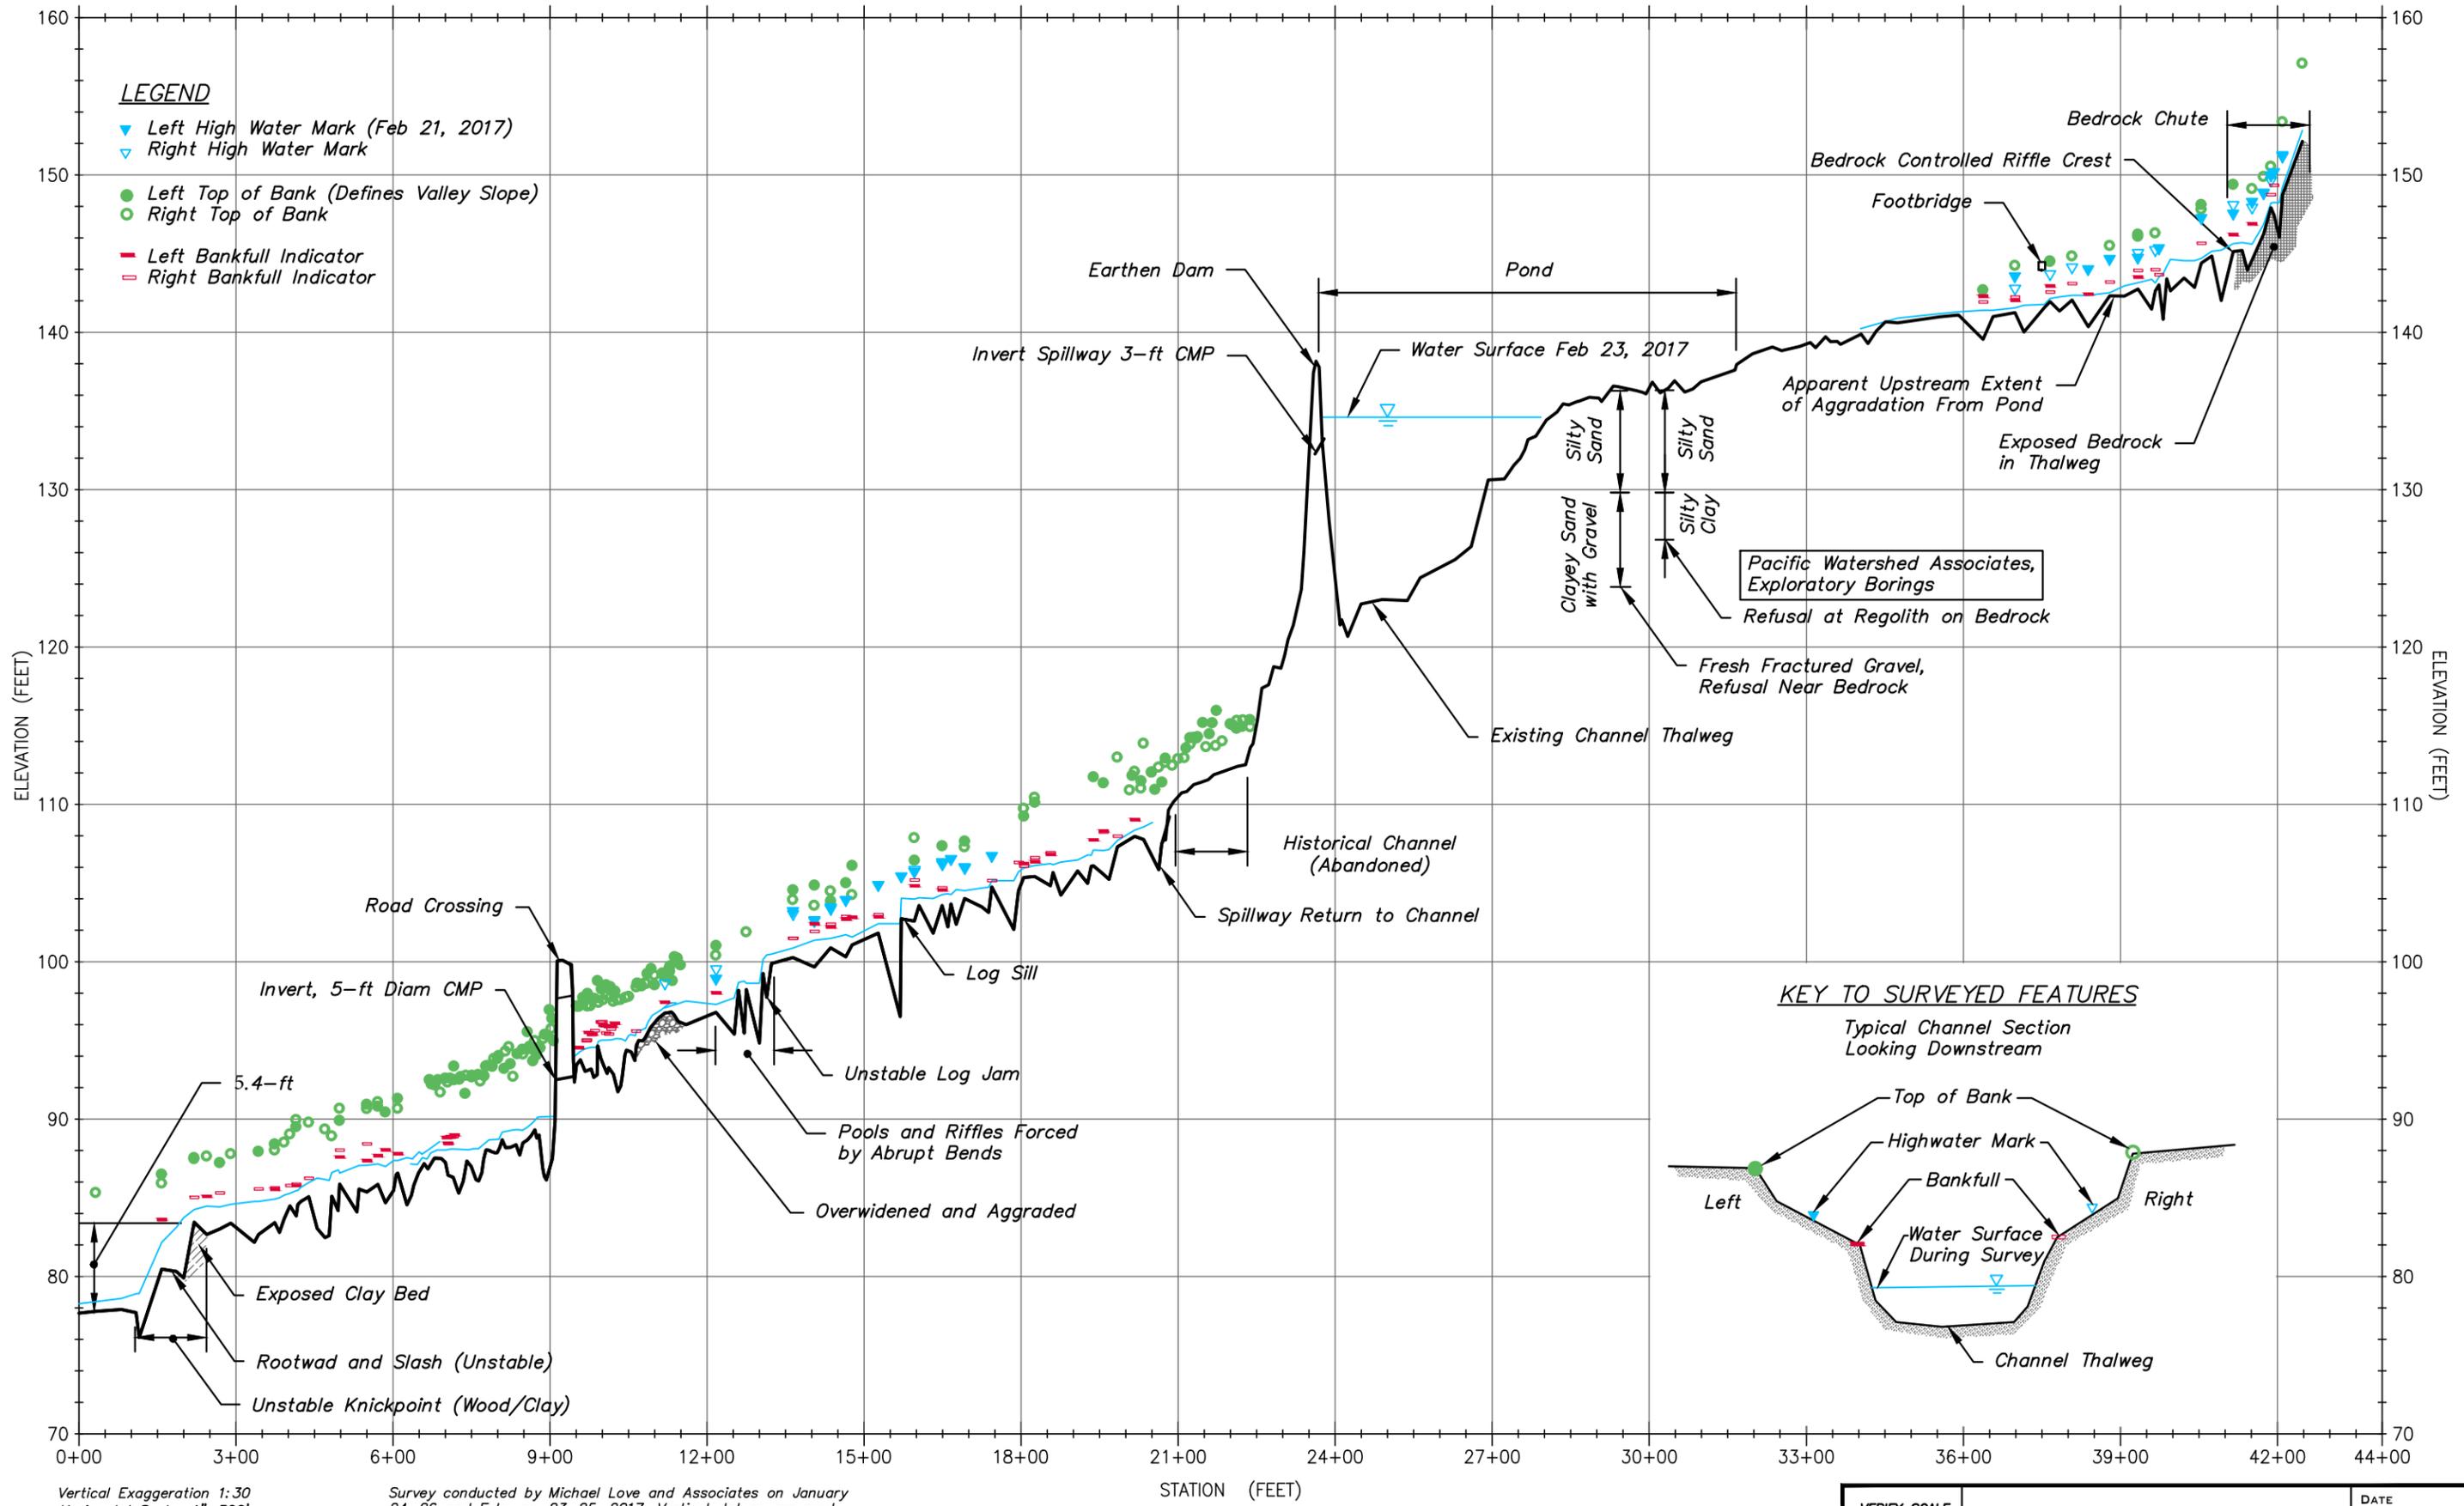
Vertical Exaggeration 1:30  
 Horizontal Scale: 1"=300'  
 Vertical Scale: 1"=10'

Survey conducted by Michael Love and Associates on January 24-26 and February 23-25, 2017. Vertical datum assumed

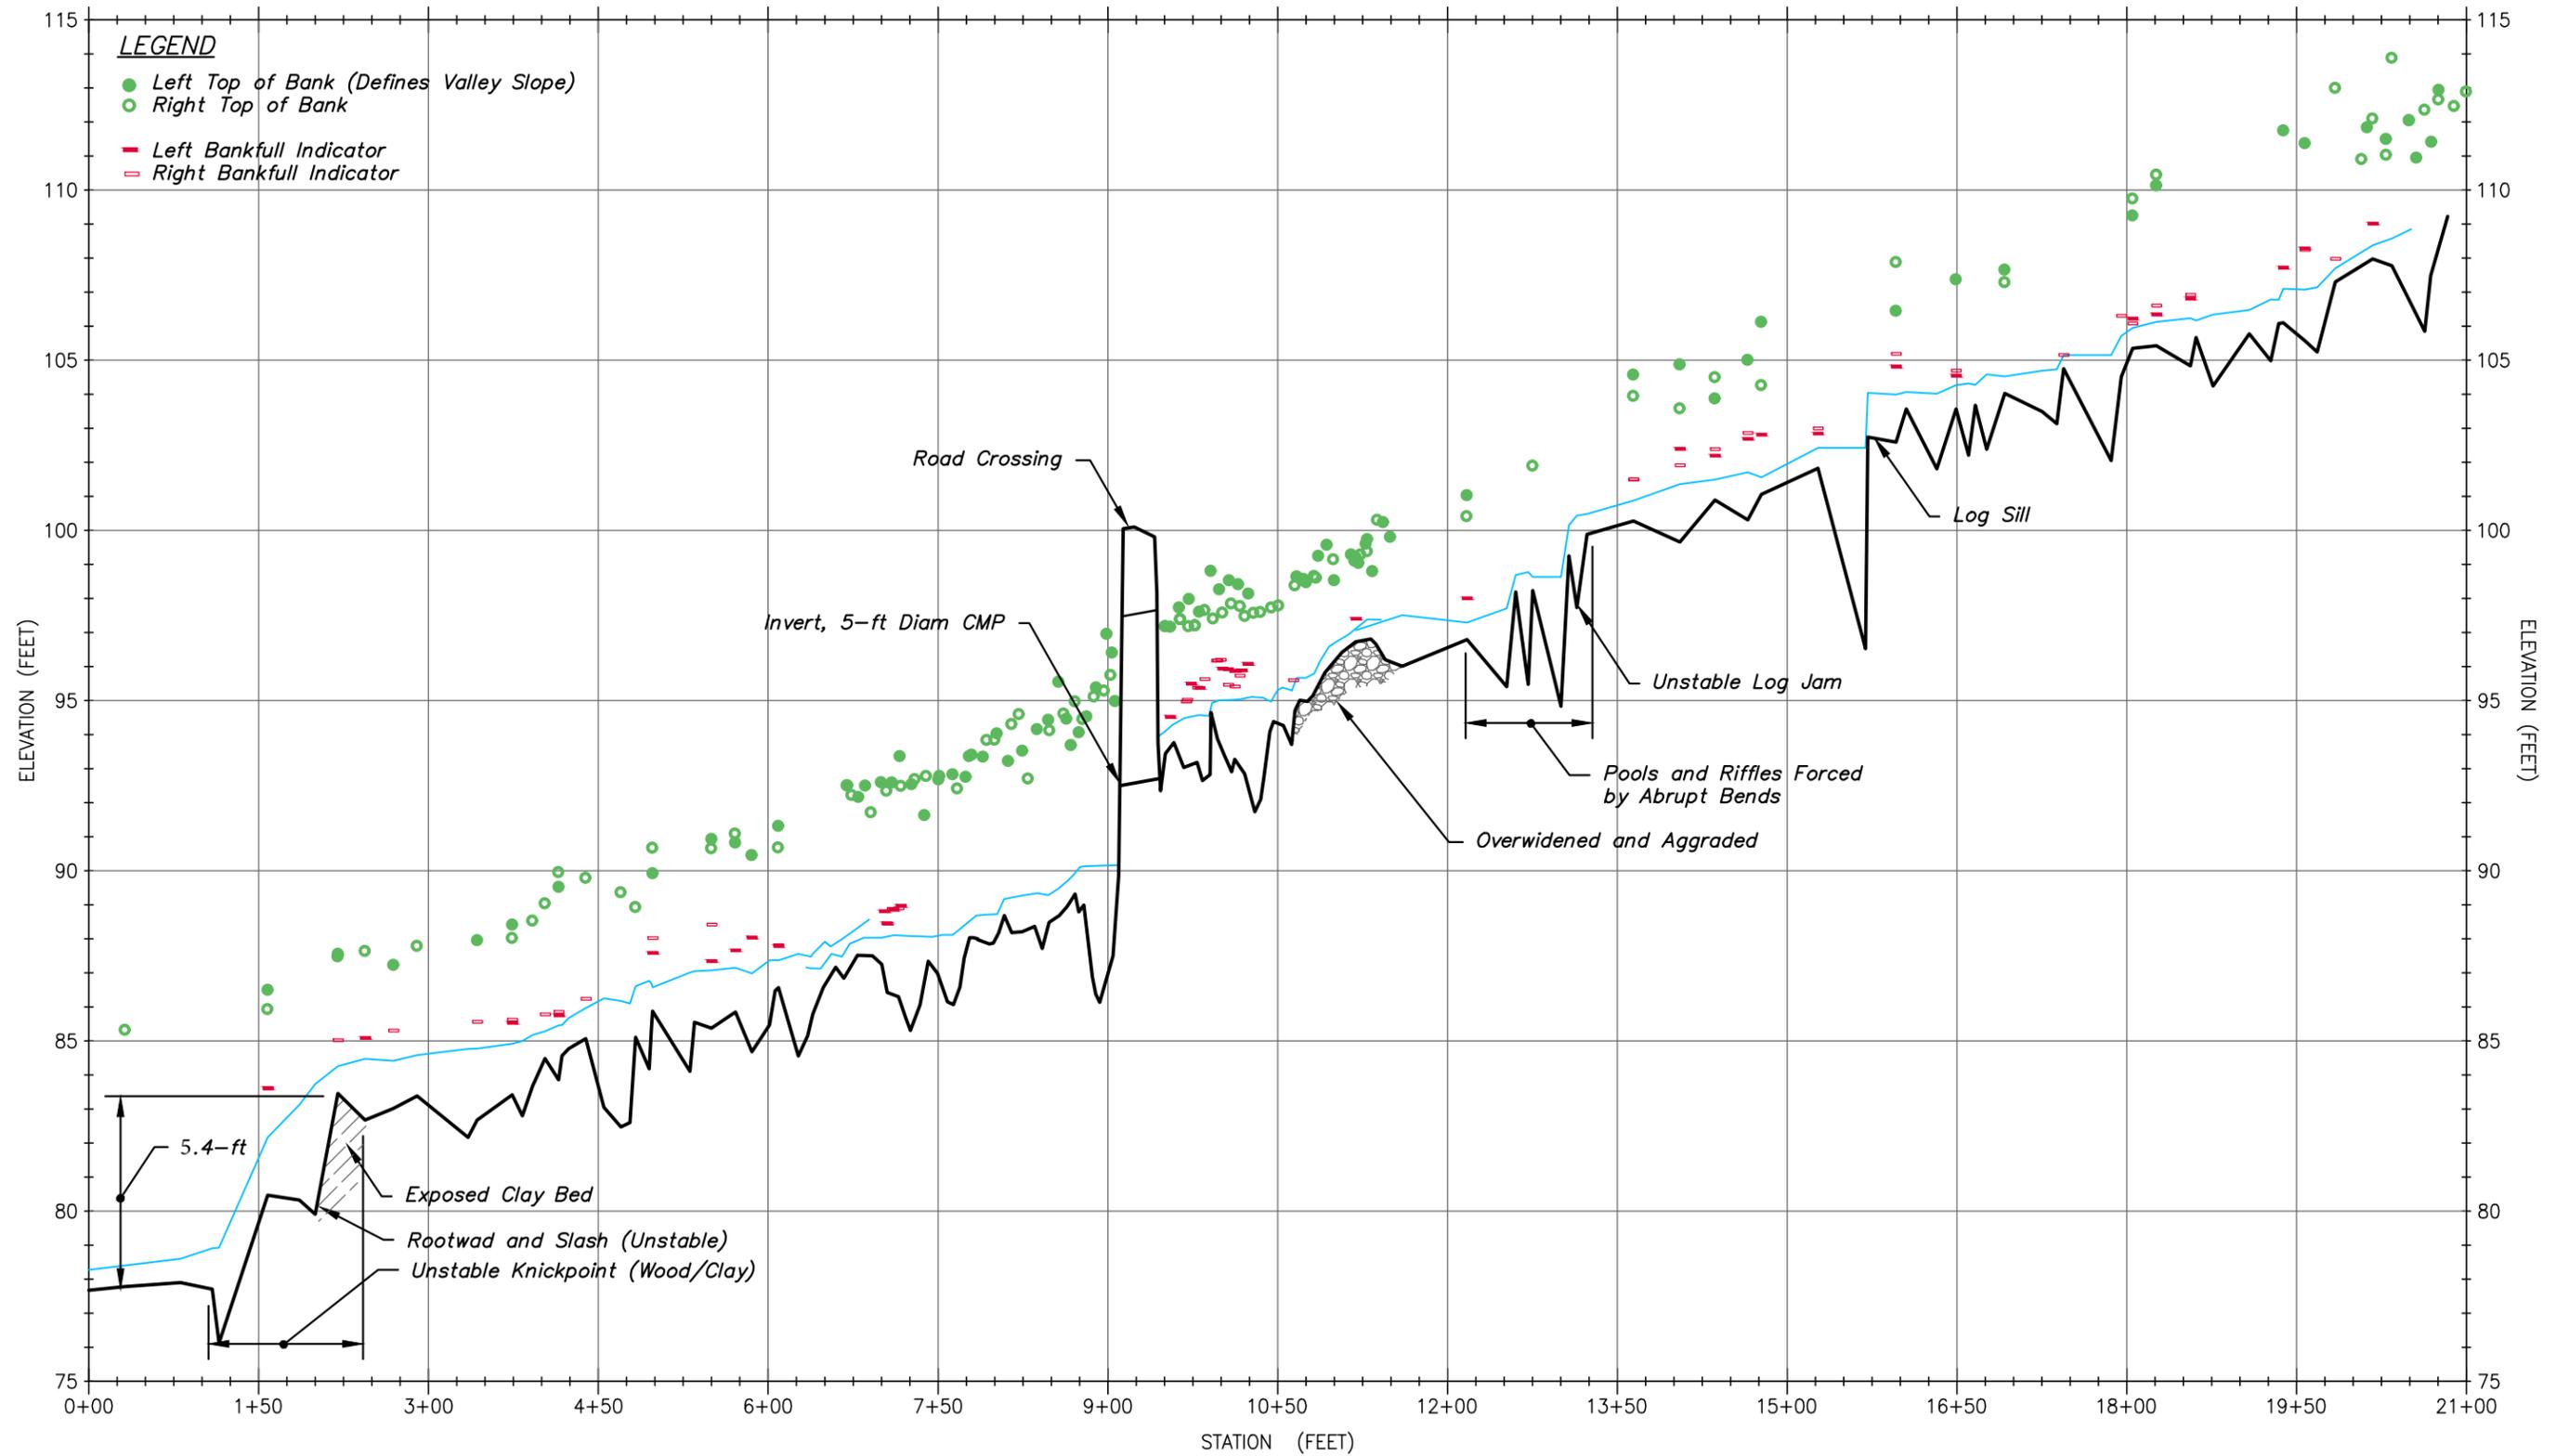
| | | FIGURE<br>2 |

Vertical Exaggeration 1:30  
 Horizontal Scale: 1"=150'  
 Vertical Scale: 1"=5'

Survey conducted by Michael Love and Associates on January 24-26 and February 23-25, 2017. Vertical datum assumed
